San Diego Regional Water Quality Control Board

DATE: September 28, 2015

SUBJECT: INTERNAL PRELIMINARY SITE INVESTIGATION MEMORANDUM-RAMONA MUNICIPAL WATER DISTRICT SANTA MARIA WASTEWATER TREATMENT PLANT

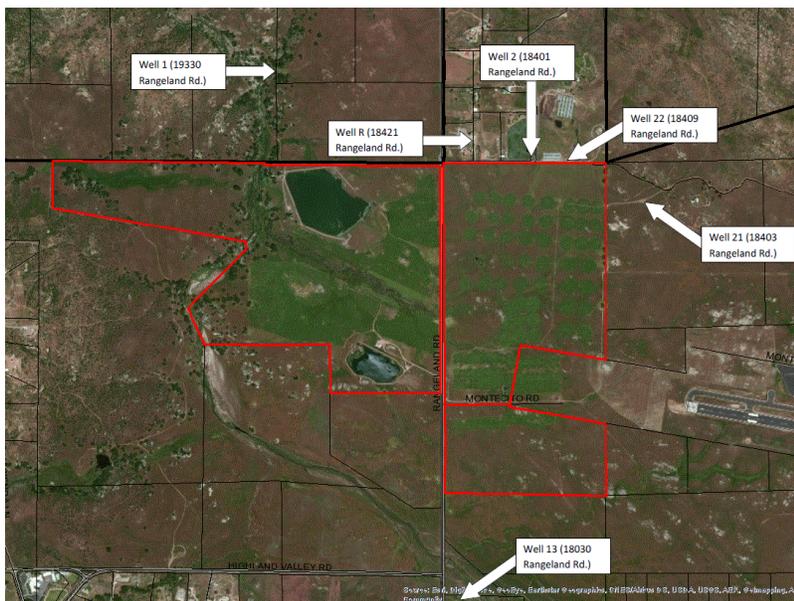
Figure 2- Spray Field and Monitoring Well Location Map

Staff identified elevated concentrations of nitrate and TDS reported in annual groundwater monitoring data submitted by the Discharger. Specifically, elevated concentrations were observed in groundwater samples collected from Monitoring Wells Nos. 2 and 22 located to the north-east of the spray field. Groundwater

Staff recommendation is to require the Discharger to submit a workplan to evaluate the effectiveness of the current groundwater monitoring network. The workplan should be included as a requirement of the Master Recycling Permit tentative Order No. R9-2015-0108. Staff also recommend that the Discharger be required to prepare a Salt and Nutrient Management Plan (SNMP) in compliance with the statewide Recycled Water Policy and to address possible local sources
