**CALIFORNIA REGIONAL WATER QUALITY CONTROL BOARD
SAN DIEGO REGION**

In the matter of:)	
)	
San Diego County)	Order No. R9-2019-0020
Sanitation District)	
)	
February 2017 Sanitary Sewer)	
Overflow, Los Coches Creek,)	Settlement Agreement and
San Diego River)	Stipulation for Entry of
)	Administrative Civil Liability
)	Order
Place ID: 631623)

**CONCEPTUAL MITIGATION PLAN
SIERRA ALTA WAY WASTEWATER EMERGENCY PIPE REPLACEMENT PROJECT
LAKESIDE, SAN DIEGO COUNTY, CALIFORNIA**

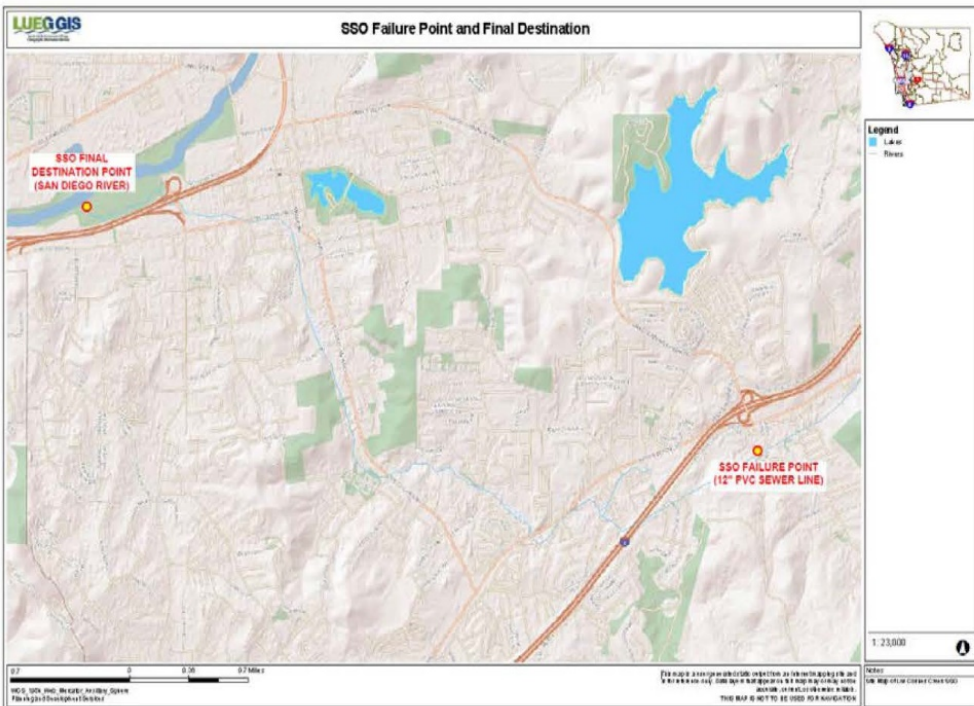
Site Map – SSO Failure Point to SSO Final Destination Point

2. From February 28, 2017 to March 17, 2017 (18 days of discharge) a Sanitation District owned and operated 12-inch sewer main discharged **762,739 gallons** of untreated raw sewage into Los Coches Creek, a water of the United States, in the vicinity of Sierra Alta Way in El Cajon, CA. The sewer main was damaged as result of stream bank erosion that occurred during a 25-year, 24-hour storm event near the end of February 2017. The damaged sewer main was discovered by Sanitation District staff during a routine maintenance inspection. The starting date of the sanitary sewer overflow (SSO) was determined by information obtained from a nearby property owner who noticed the pipe break on February 28, 2017. The eyewitness failed to contact any agency to report the pipe break.

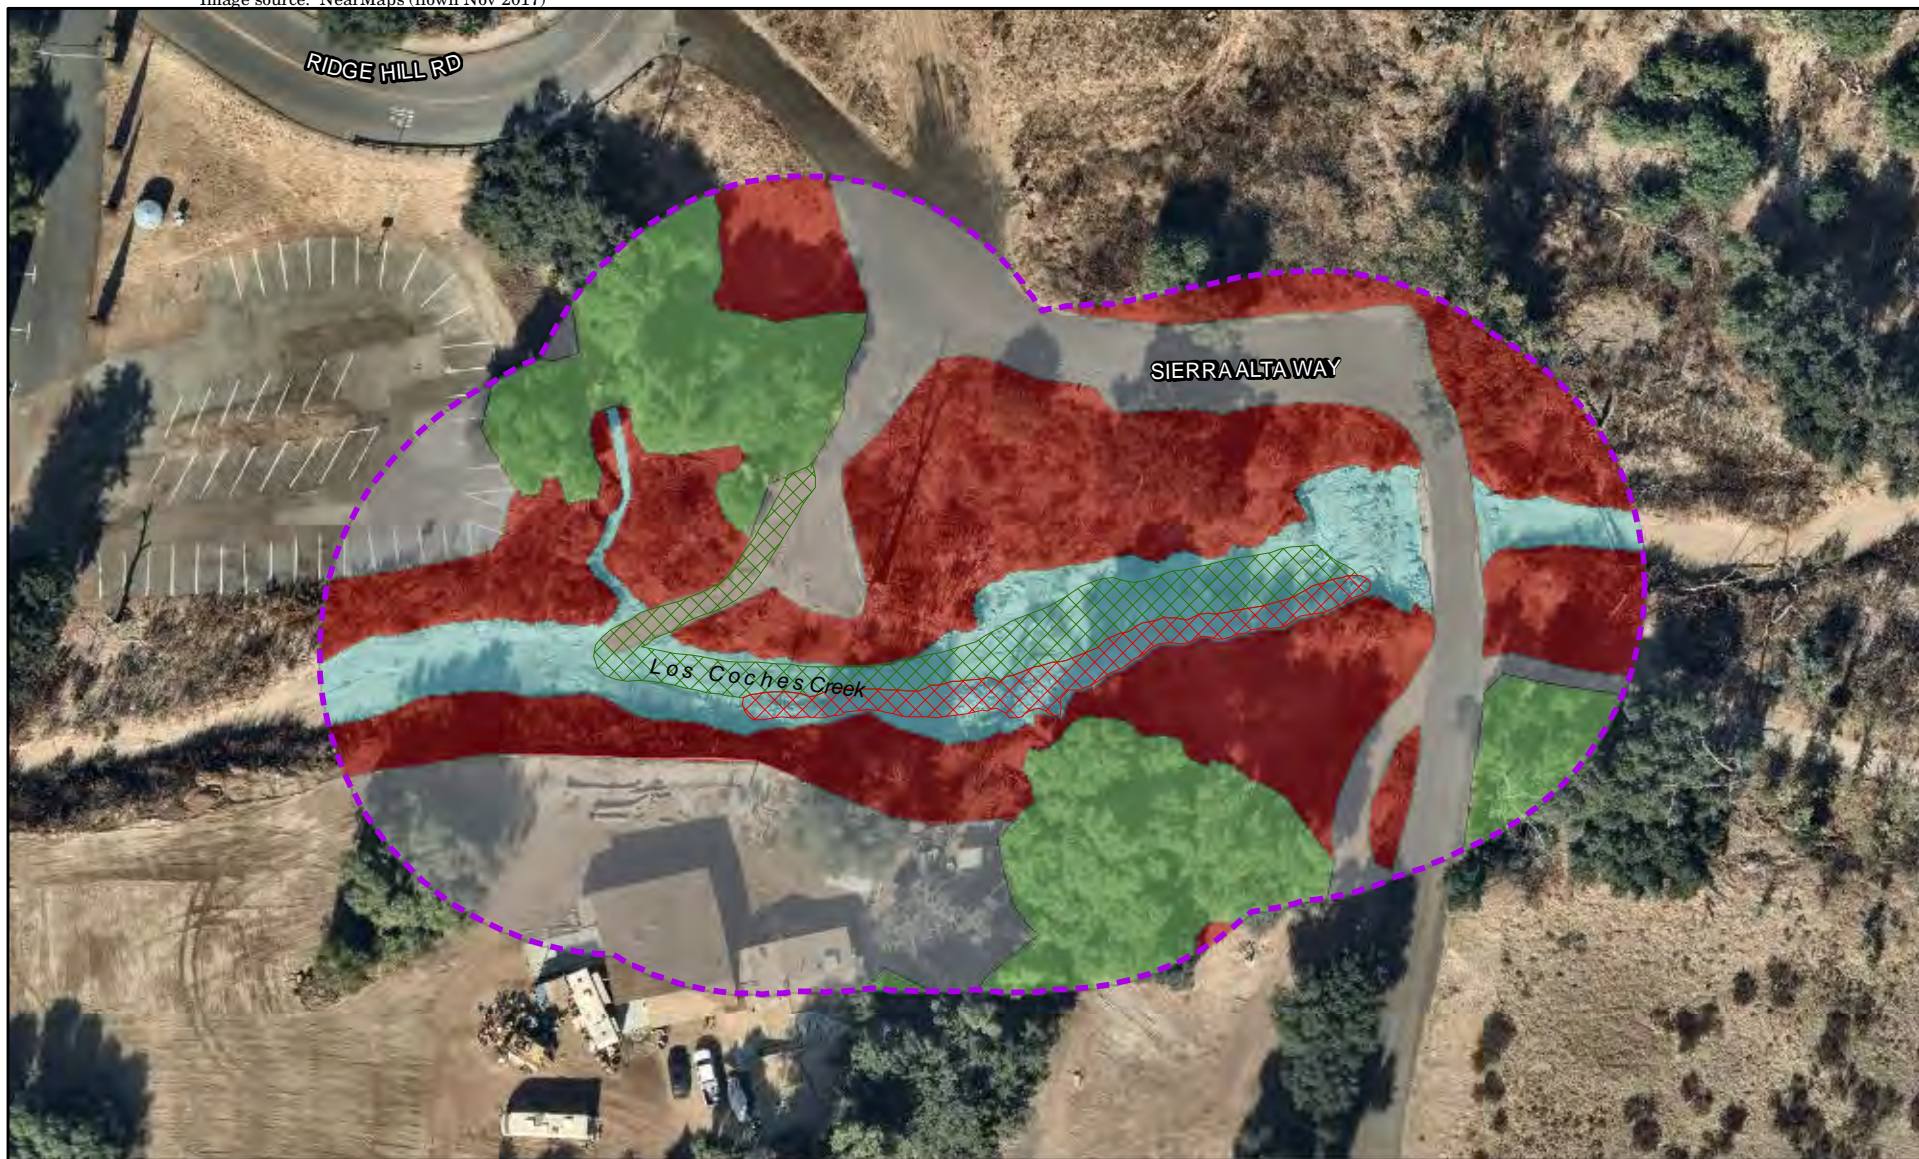
FIGURE 4

Urban/developed land occurs within the survey area as gravel and dirt roads and driveways, including the graded ramp leading into the creek and used during project activities (see Figure 4).

Biological Resources and Project Impacts
