# ASSET MANAGEMENT PROGRAM – YEAR 2

## Vulnerability Assessment

County of San Diego

8 FEBRUARY 2018

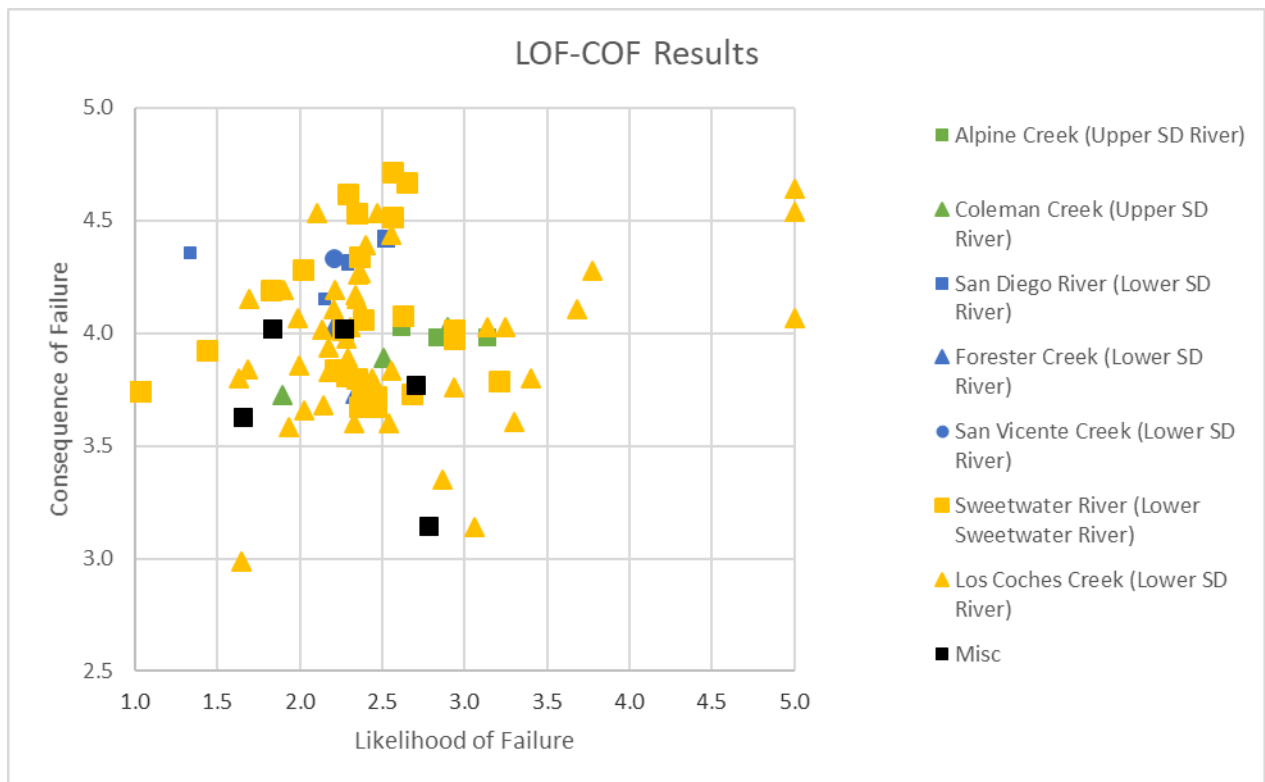
Figure 15 Chart of LoF-CoF Results

As shown in Figure 15, the results of the risk assessment display relatively high CoF for all pipe segments with variable LoF. This is expected as all pipe segments in this study are inherently vulnerable due to their proximity to the water bodies.

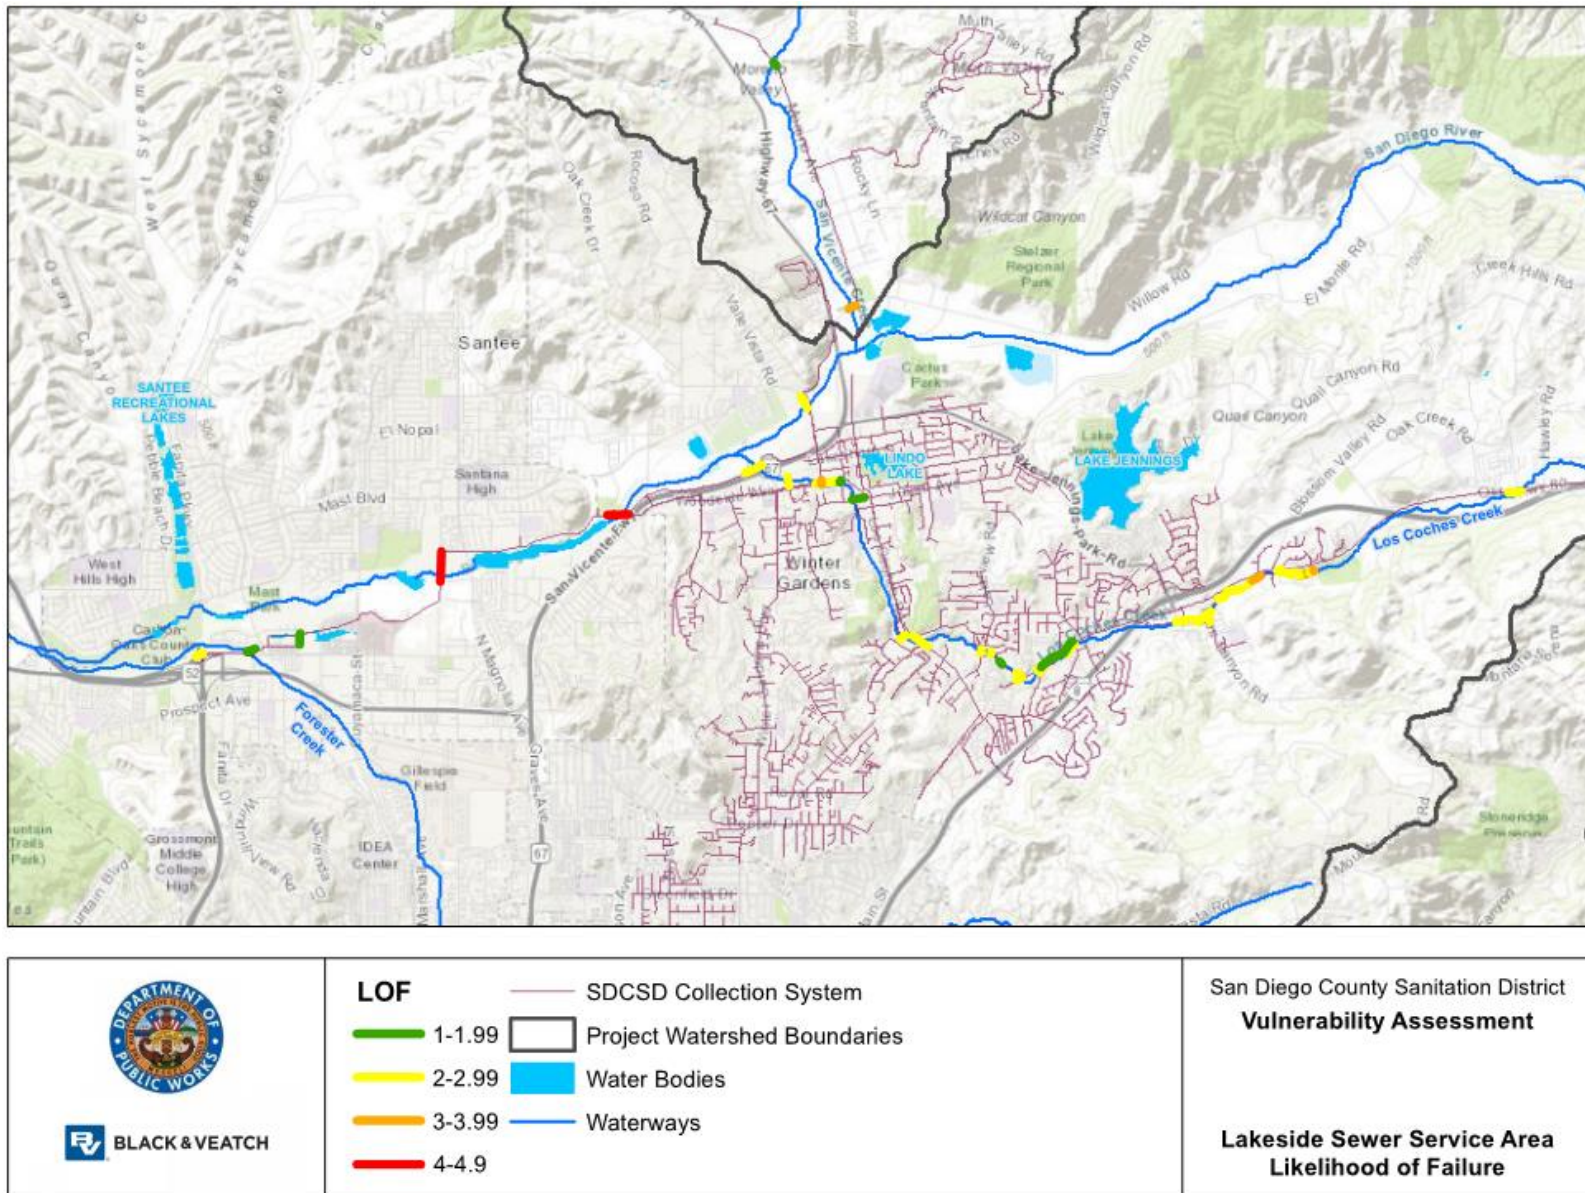
Figure 16 Likelihood of Failure Results – Lakeside

Heat maps showing LoF scores are presented in Figure 16 through Figure 19. Heat maps showing CoF scores are presented in Figure 20 through Figure 23. The detailed scoring results are provided in Appendix C.
