**CALIFORNIA REGIONAL WATER QUALITY CONTROL BOARD - SAN DIEGO REGION
WATERSHED MANAGEMENT PROGRAM**

FACILITY INSPECTION REPORT

Sprinter Rail Project
FACILITY OR DEVELOPER NAME (if different from owner)

FACILITY: __North County Transit District Sprinter Rail_ (WDID)_9 37C322900__ INSPECTION DATE: _11/30/07__

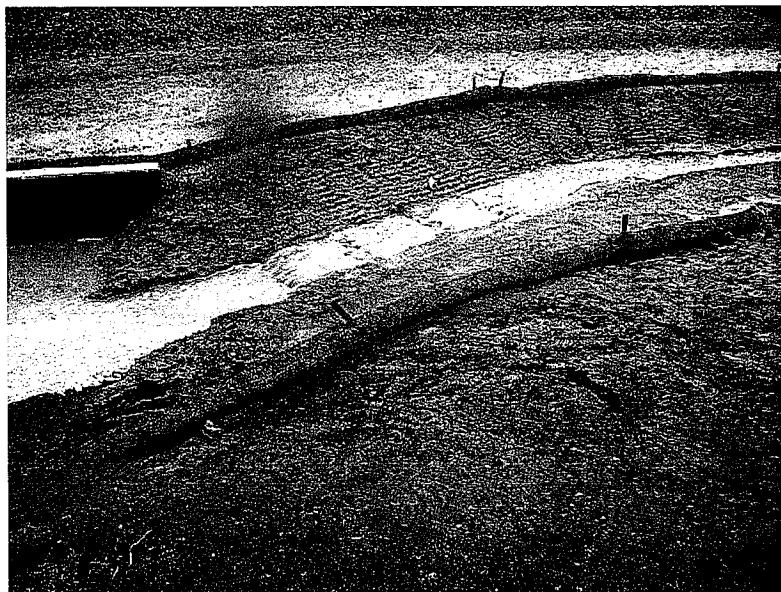
673. The bed of the unlined dirt channel is eroding away.

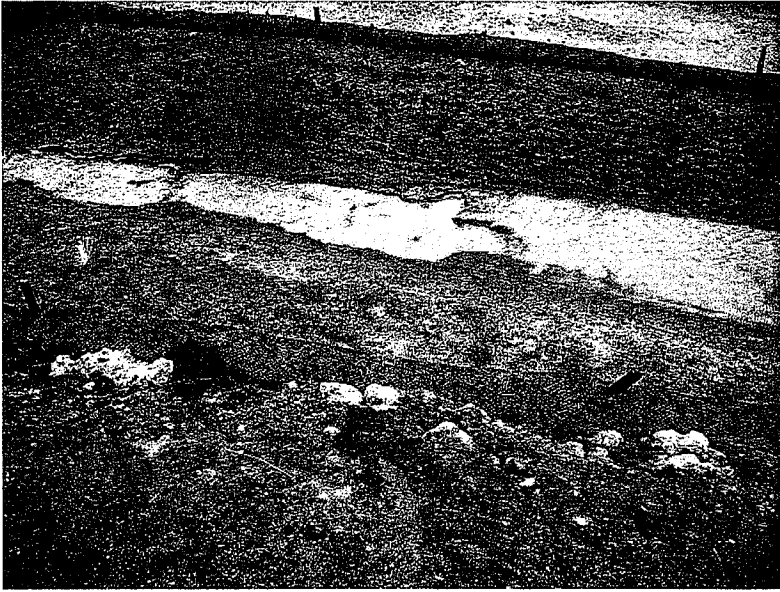
675. The bed of the unlined dirt channel is further eroding away.

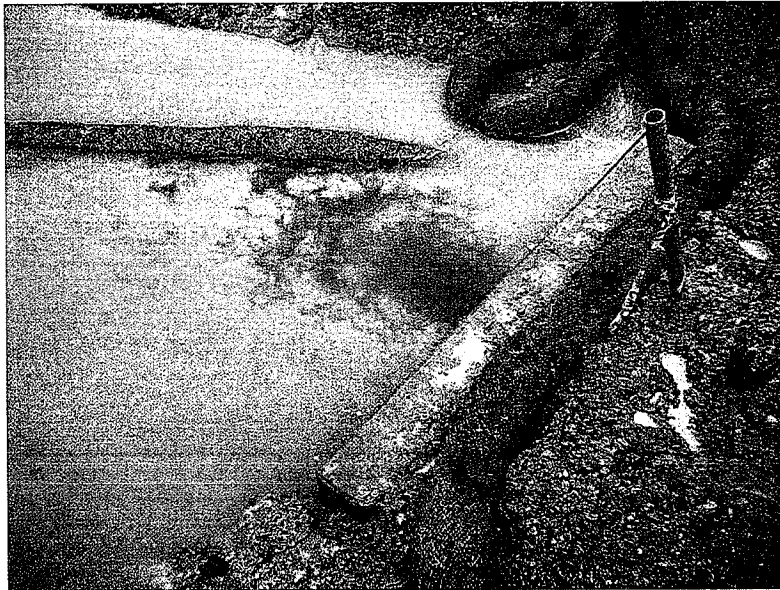
679. This is the inlet receiving the sediment laden water in photo 678. The inlet has backed up and clear water was bubbling out.

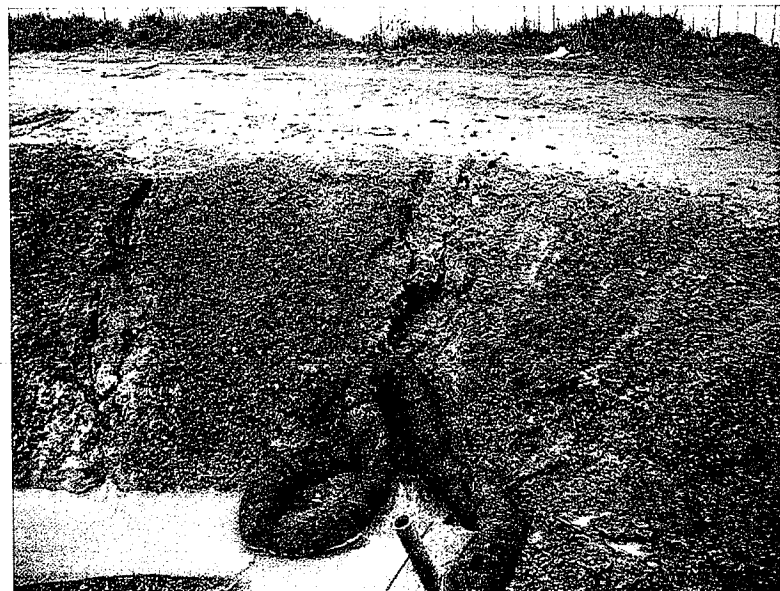
680. A closer look at erosion gullies on the slope in photo 678.

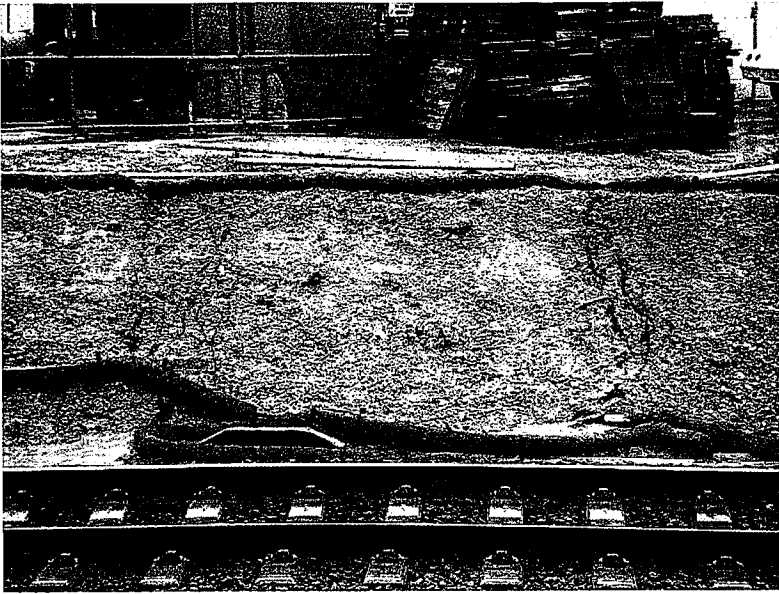
681. Erosion gullies are present on a slope.

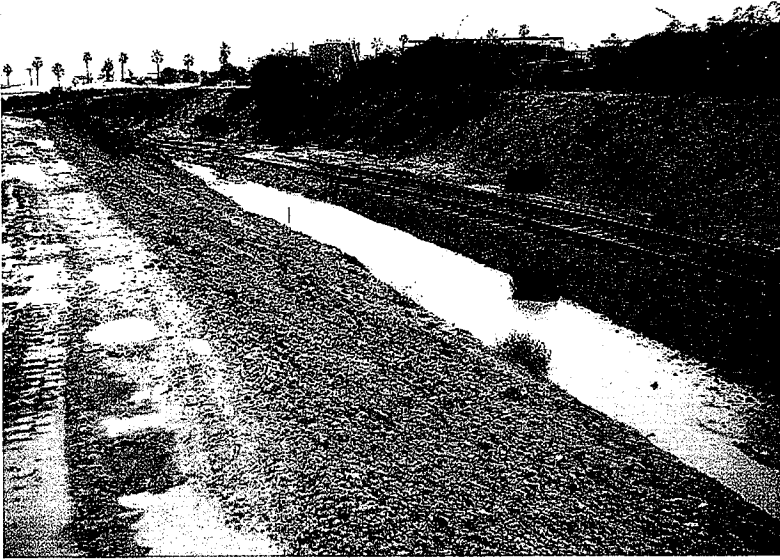
689. This photo shows where construction ended. The far slope is vegetated and the rail ballast rock is a different color. The slopes have no erosion or sediment controls.

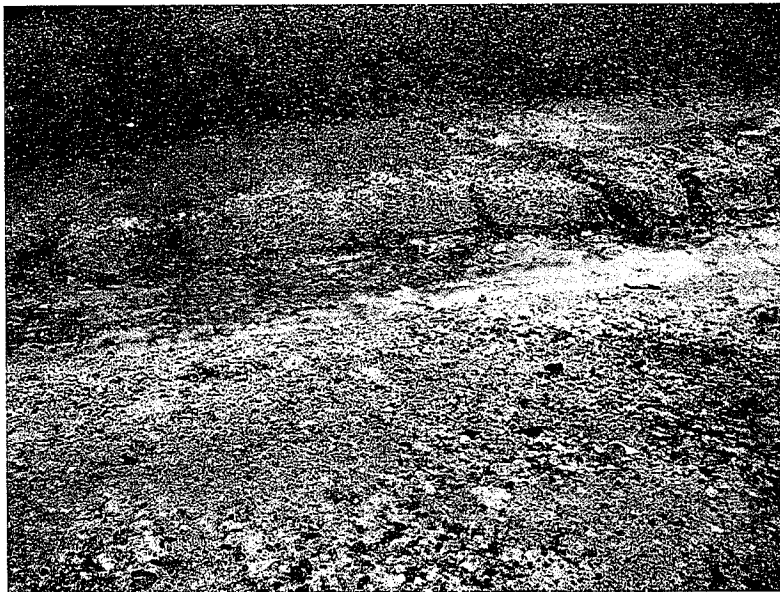
690. The storm water in the channel is clear on the left of the photo and then picks up sediment as it flows to the right in the unlined dirt channel.

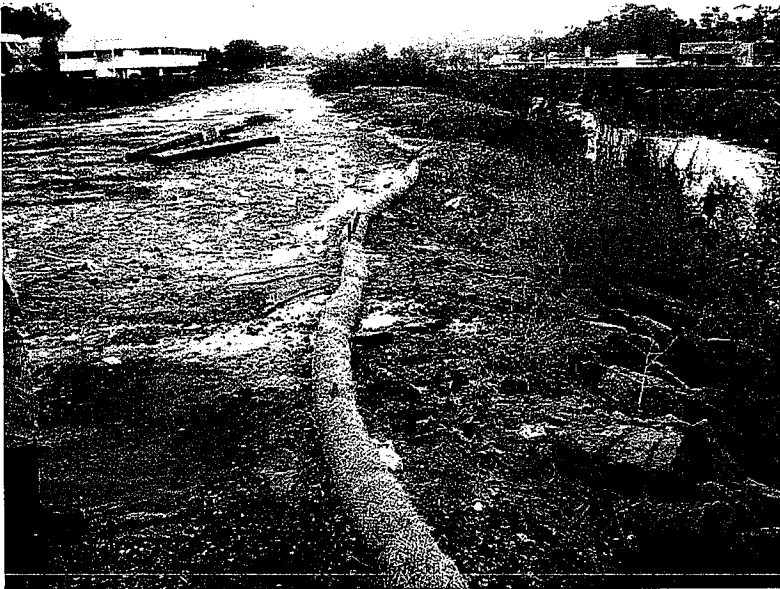
3. Crouch Street Station, Oceanside - The remnants of an old asphalt cold mix stockpile had been covered with black plastic to prevent contact with storm water (Photo 694). Loma Alta Creek goes under the station. Adjacent to Loma Alta Creek, fiber rolls have not been trenched in and were ineffective. Sediment laden water was flowing under the fiber rolls and into Loma Alta Creek (Photos 695 and 697). The banks of Loma Alta Creek have been sprayed with an erosion control binder (Photo 698). The storm drain inlets in the station appeared to be adequately protected (699 and 700).

695. Fiber roll along the top of the bank to Loma Alta Creek has not been trenched in.

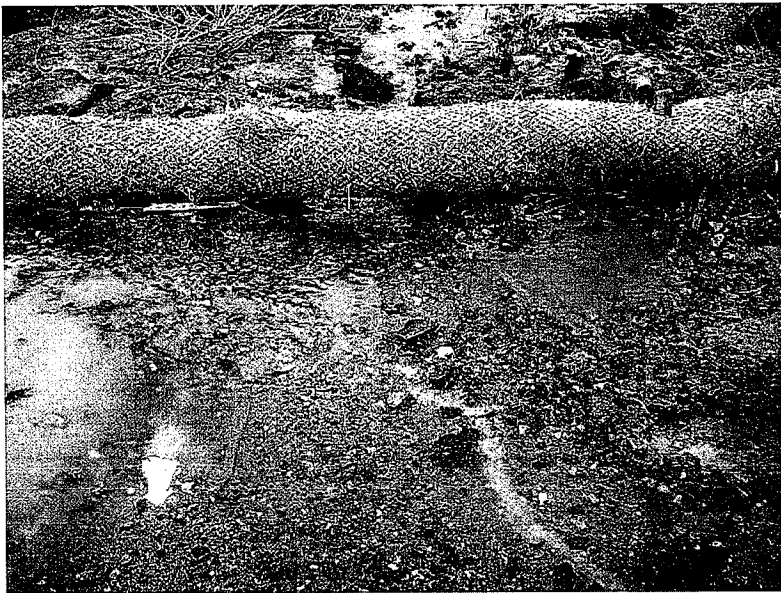
697. Sediment laden water from the construction site is running under the fiber roll in photo 695 and discharging into Loma Alta Creek.
