San Diego Regional Water Quality Control Board

Subject: August 11, 2015 San Diego Water Board Inspection Report

**MUNICIPAL SEPARATE STORM SEWER SYSTEM (MS4)
AUDIT INSPECTION REPORT**

FACILITY: City of Escondido MS4

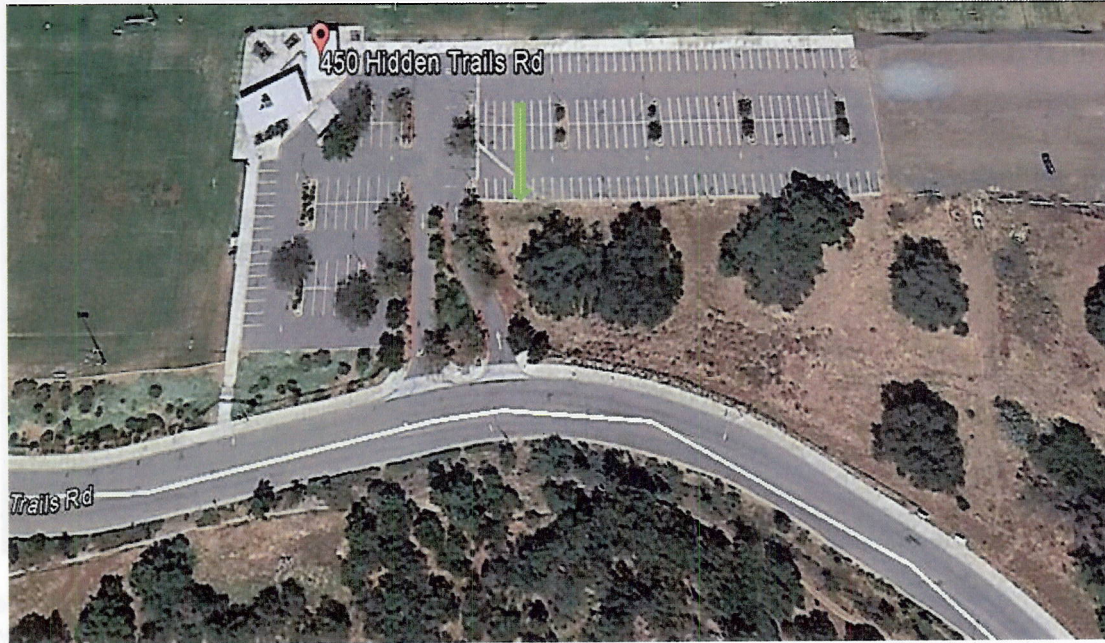
1. PUB-03-004, Ryan Park, 450 Hidden Trails Road; Medium Priority

- a) According to City's design plans, Ryan Park is intended to have 1 bioswale to address runoff from the parking lot (see photo 1(a)).
- b) City inspections of the site indicate "BMP Operational, in compliance" from 2009-2014. Notes from City's 2015 inspection indicate issues with sediment buildup and grade problems.
- c) Site observations were as follows:
 - The bioswale was in designed location and vegetated.
 - Sediment buildup was evident in the parking lot and inlet appears to be constructed higher than bioswale.
 - Trash was noted in the bioswale.
- d) The City reported that, based on the City's inspection findings, they intend to do street sweeping and regrade the bioswale.

Photo 1(a): Google earth aerial view of Ryan Park parking lot, and location of bioswale BMP.

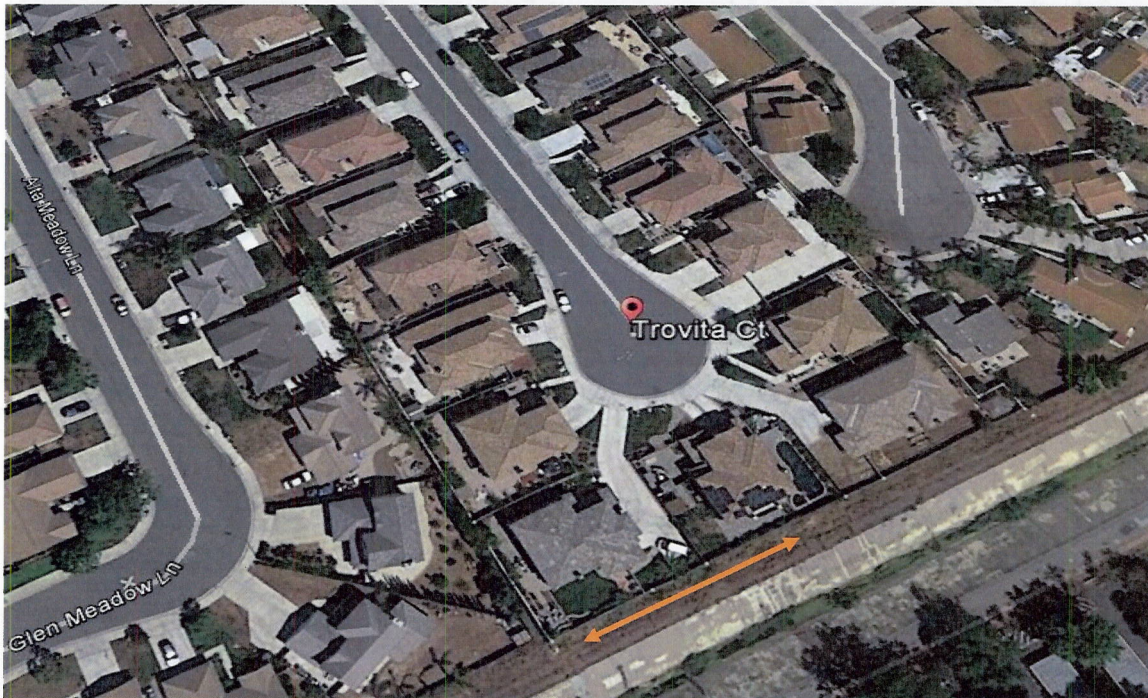
2. PRI-06-0134 Tract 881 / Washington Hills II, Trovita Court; Medium Priority

a) According to City design plans, the structural post-construction treatment control BMPs for this residential area include a bioswale behind the development and parallel to Escondido Creek designed to capture and treat low flows with a bypass for higher flows directly to Escondido Creek (see photos 2(a) and 2(b)).

Photo 2(a): Google earth aerial view of Washington Hills II, and location of bioswale BMP.

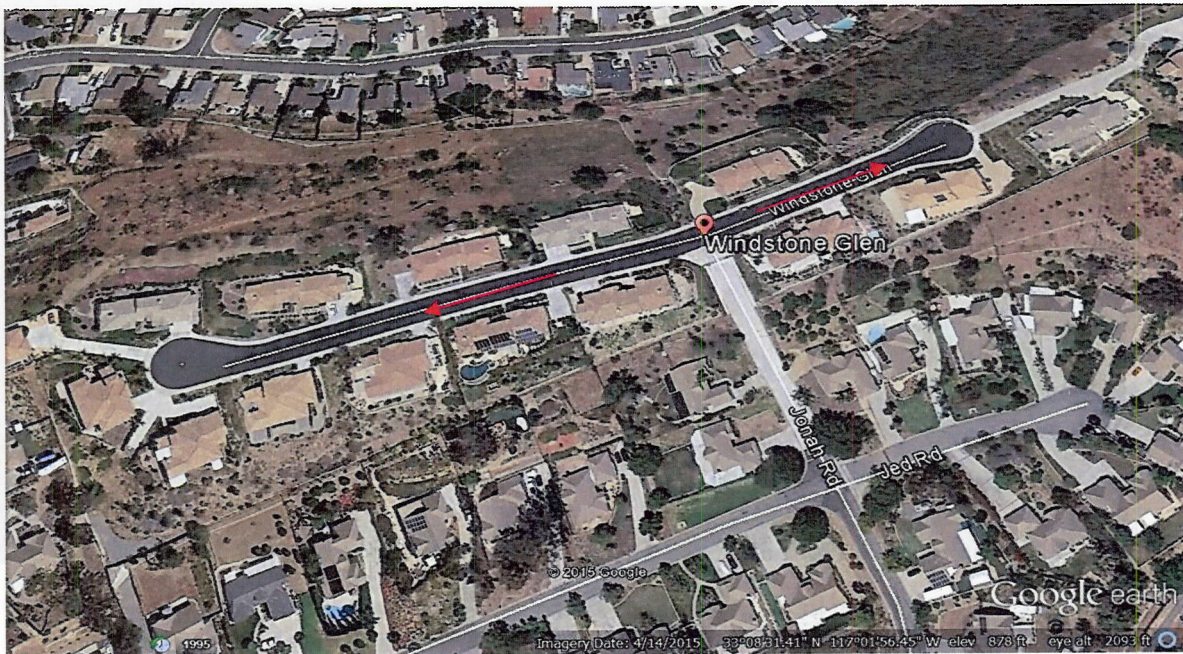
3. PRI-05-129, Tract 857/ Falcon Crest, Windstone Glen Rd.; Medium Priority

Photo 3(a): Google earth aerial view of Falcon Crest PDP on Windstone Glen Road. Stormwater flows in two directions toward the street ends.

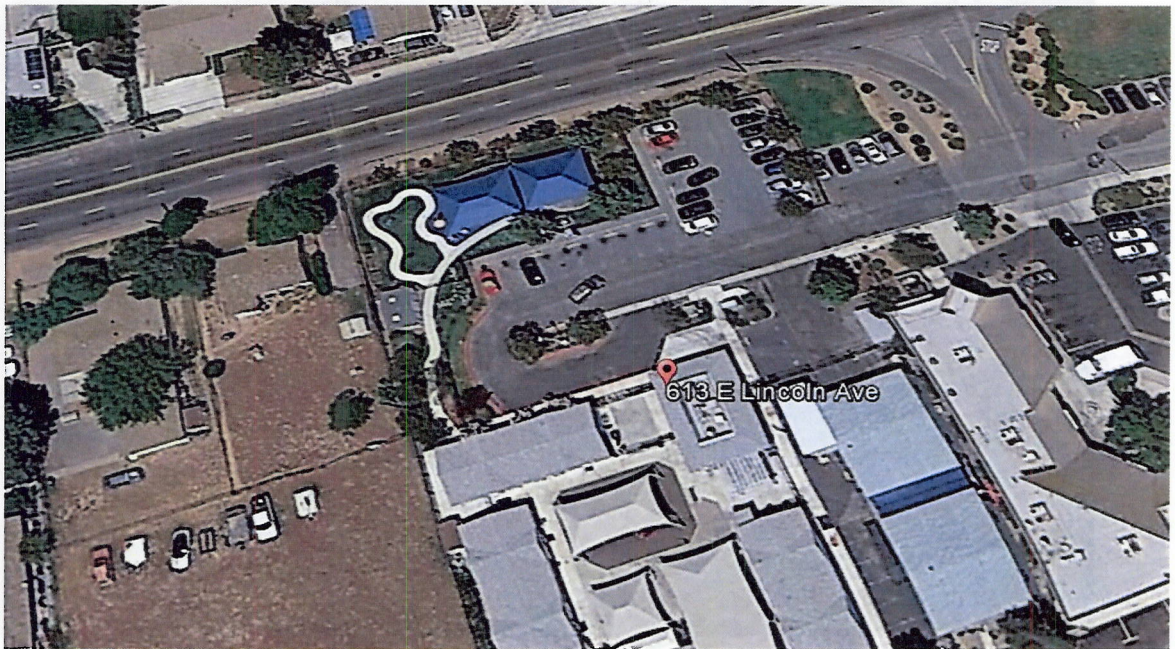
4. PRI-08-150 613 E. Lincoln Ave.; Medium Priority

- a) Although this site is a commercial day care facility, the City of Escondido is listed as the responsible party because they own the property and leases it to the day care (see Photo 4(a)). According to City design plans the structural post-construction treatment control BMPs for this site include two inlet filters and two bioswales.
- b) City's inspection findings for the site are as follows:

Photo 4(a): Google earth aerial view of 613 E. Lincoln commercial day care center.

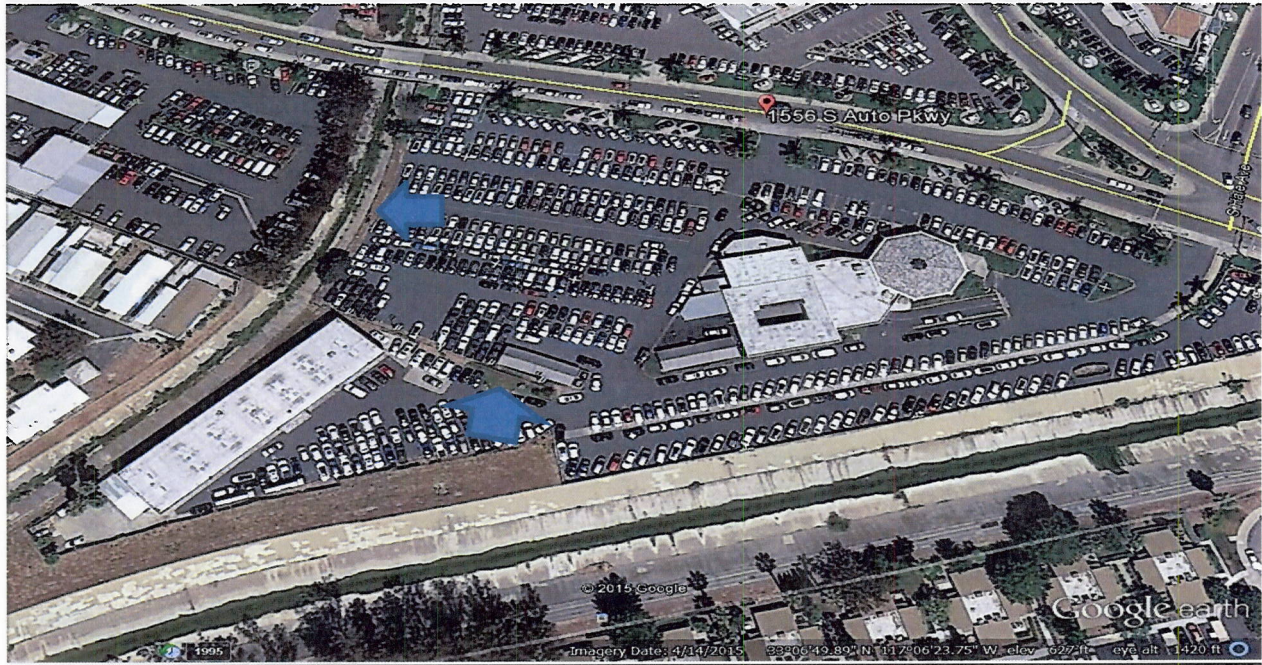
6. PRI-08-149, 1556 Auto Parkway; High Priority

Photo 6(a): Google aerial view of Audi dealership, 1556 Auto Parkway. Arrows indicate location of bioswales.

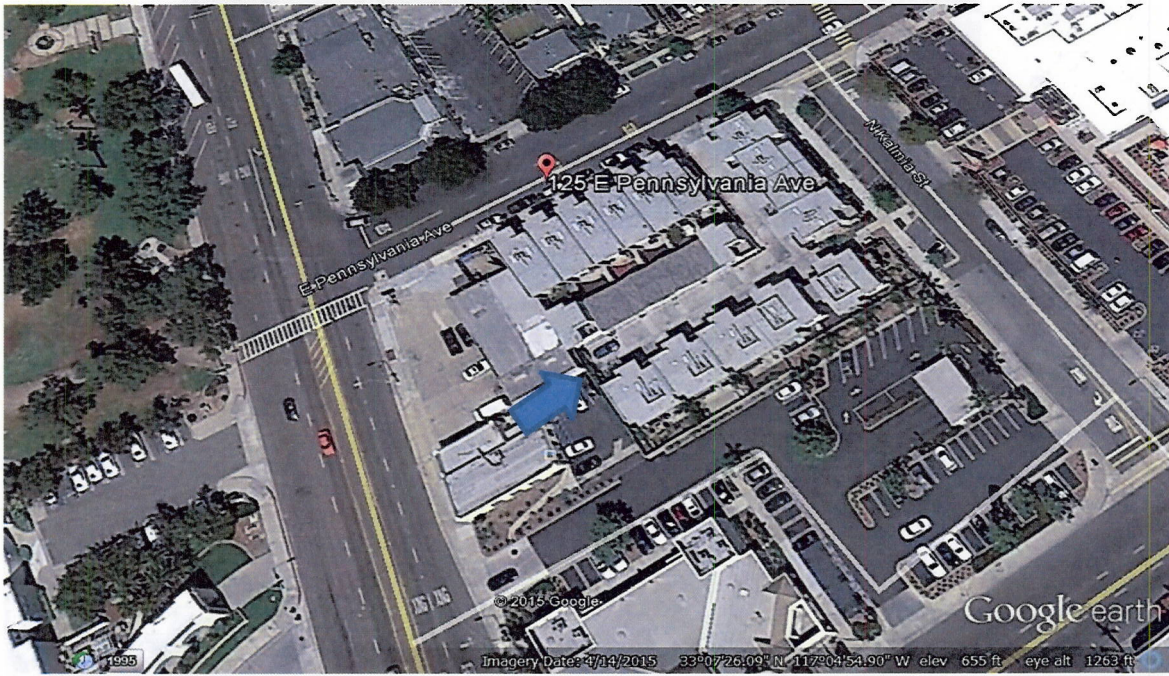
7. PRI-05-130, Tract 865/ 125-133 Pennsylvania Ave; Medium Priority

a) This site consists of residential apartment housing. According to City design plans the structural post-construction treatment control BMP for this site includes 1 bioswale. The bioswale drains the interior pavement of the complex, passes under a residential fence (see photo 7(b)), through the side yard, and into the City MS4 (see photo 7(c)).

Photo 7(a): Google aerial view of 125-133 Pennsylvania Ave. Blue arrow denotes approximate location of bioswale.
