March 1, 2013

Subject: Amended Report of Waste Discharge, Big Oak Flat (Groveland) Landfill,
Tuolumne County, California

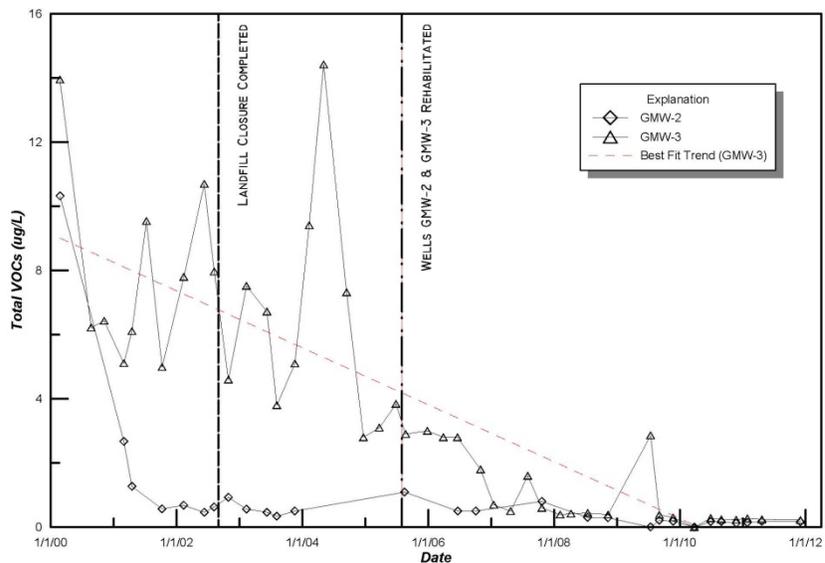
This statement is factually incorrect; to the best of our knowledge no monitoring report ever indirectly or directly related the improvements in groundwater quality at the site to the rehabilitation work on wells GMW-2 and GMW-3. This is because site data show a significant improvement in groundwater quality in GMW-2 before closure of the landfill in 2003 and before rehabilitation of the wells in 2005. Moreover, as described in more detail below and shown in Figure 1, wells GMW-2 and GMW-3 monitor the same fracture zones both before and after well rehabilitation.

Therefore, the data show no correlation between groundwater quality in these wells and the well rehabilitation work and we request that this finding be revised accordingly. The AD Information Sheet that is associated with the AD WDRs should also be revised in the same manner.³
