**GEOLOGY AND SOILS EVALUATION  
SHIPYARD SEDIMENT  
ALTERNATIVE ANALYSIS  
CONVAIR LAGOON  
SAN DIEGO, CALIFORNIA**

May 27, 2011  
Project No. 106997002

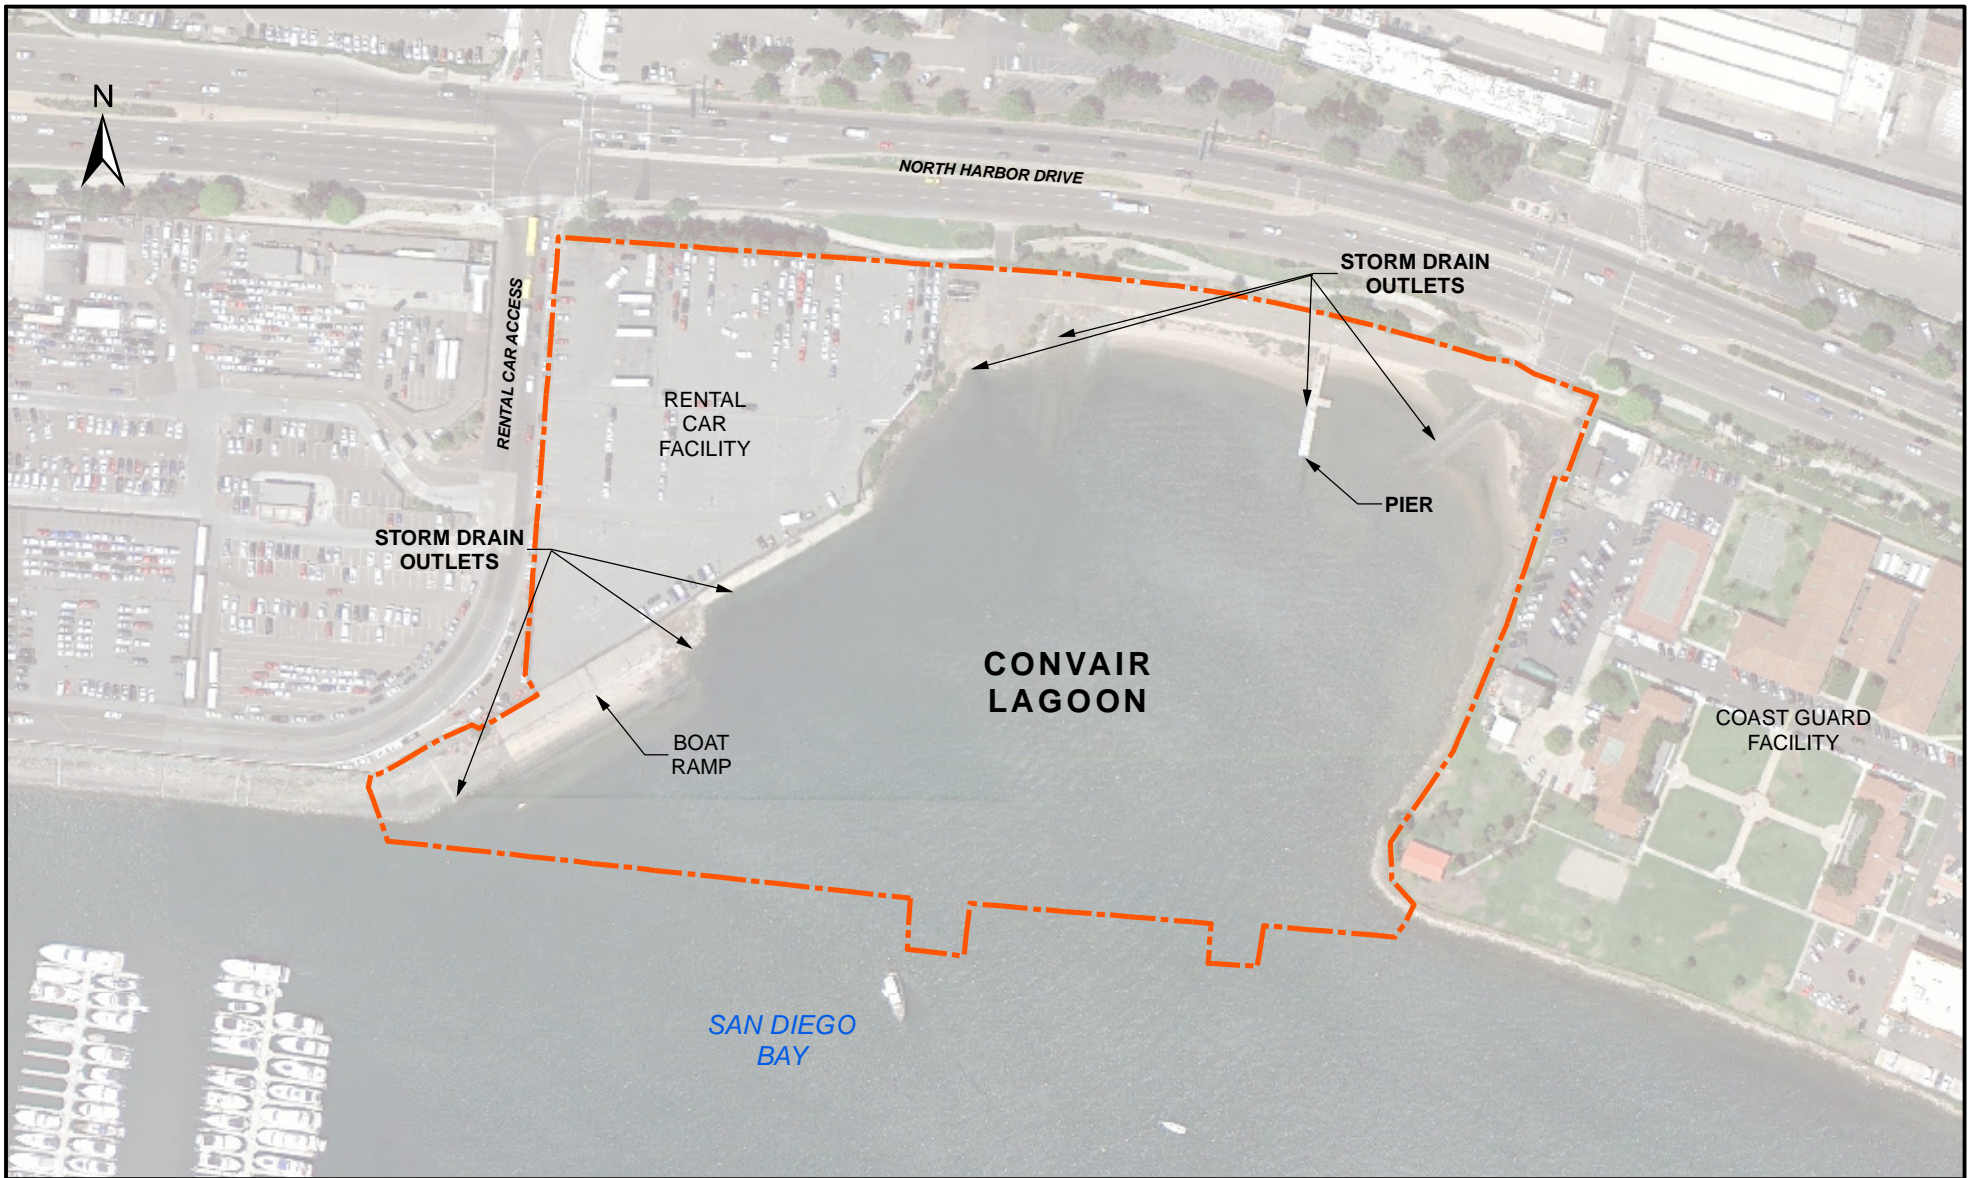
<b><i>Ninyo &amp; Moore</i></b>		<b>SITE AND VICINITY</b>	FIGURE  <b>2</b>
PROJECT NO. 106997002	DATE 5/11

SOURCE: SOURCE: Aerial Imagery - Photo Date: August, 2010; (c) Google Earth, 2011

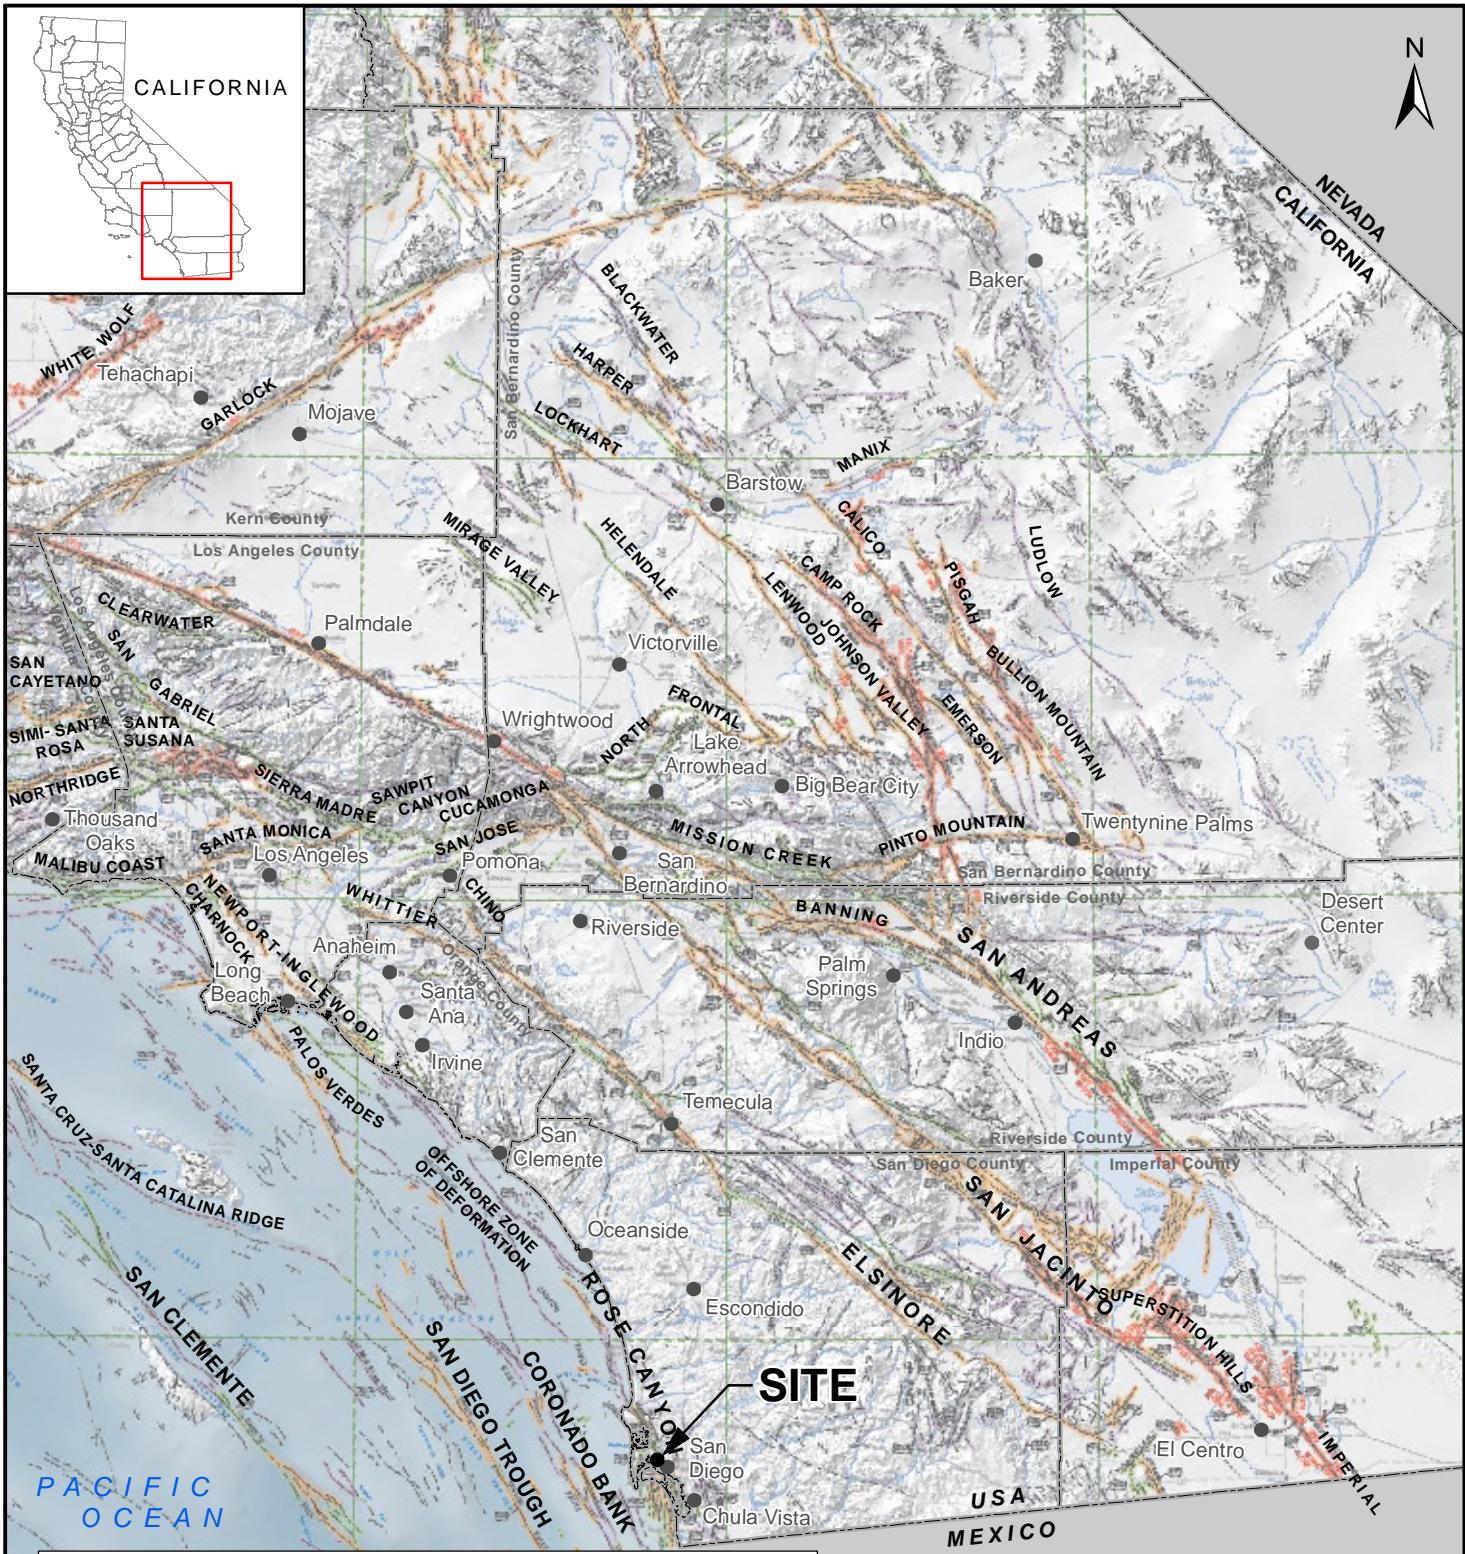
<b>Ninyo &amp; Moore</b>		<b>FAULT LOCATIONS</b>	FIGURE
PROJECT NO.	DATE	SHIPYARD SEDIMENT ALTERNATIVE CONVAIR LAGOON SAN DIEGO, CALIFORNIA	<b>4</b>
106997002	5/11

**CALIFORNIA FAULT ACTIVITY**
