Demonstrative Exhibits Summary

Shipyard COC Sources

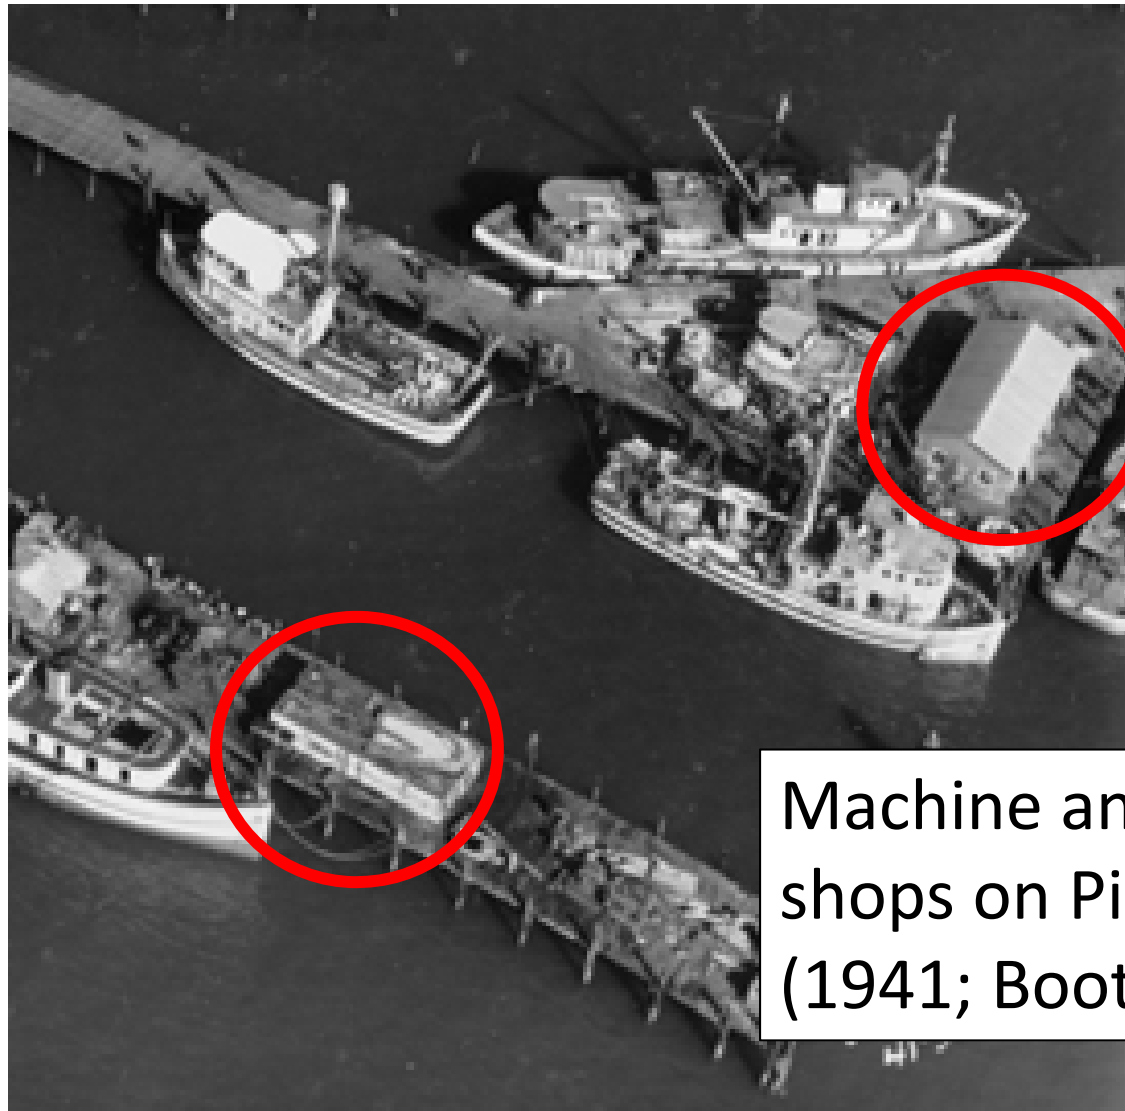
Machine and electrical shops on Piers 1 & 2
(1941; Booth et al., 2004)

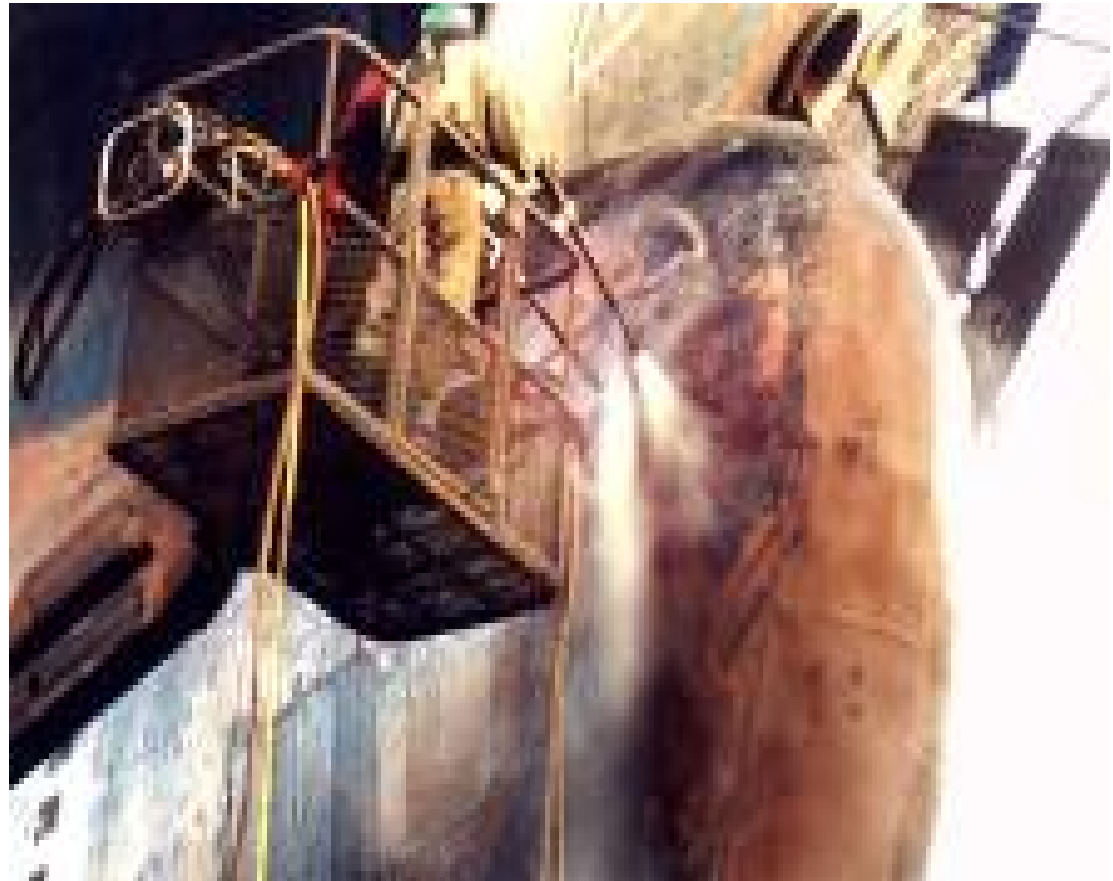
Widespread Shipyard PCB Use in Marine Paint

- 1971 inventory of pervasive use of PCBs in shipyard marine paint in Southern California, including San Diego (Young and Heesen, 1974)

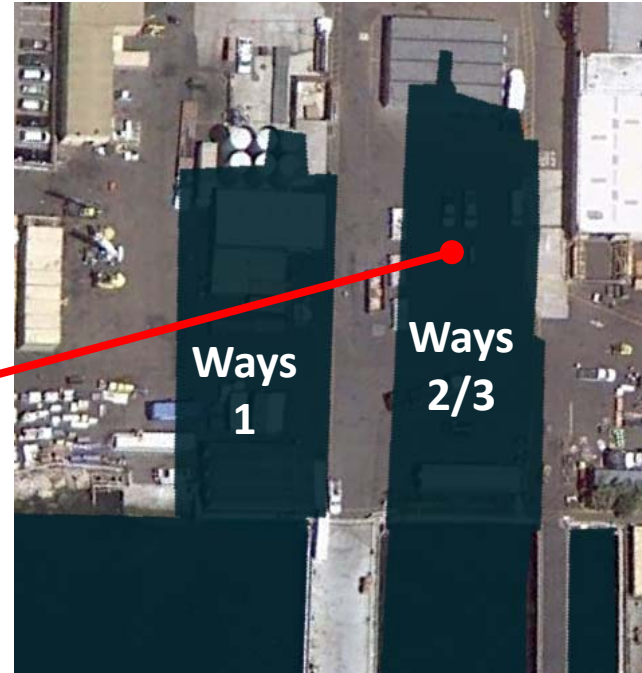
Ubiquitous Oil Saturation Noted in SWM/BAE Shipways During Marine Railway Removal (1998)

1) Appearance of oil or other materials of petroleum origin	<i>yes</i> /no <i>thin oil/water "mousse" layer on NW corner of ways 1</i>	<i>yes</i> /no	<i>Thin oil/water "mousse" layer on NW corner of ways 2/3. Retrieved during excavation of E2-4</i>
---	---	----------------	--

Thin oil/water "mousse" layer on NW corner of ways 2/3. Retrieved during excavation of E2-4

Exhibit 7a-b - Ubiquitous Oil Saturation Noted in SWM/BAE Shipways During Marine Railways Removal (1998)

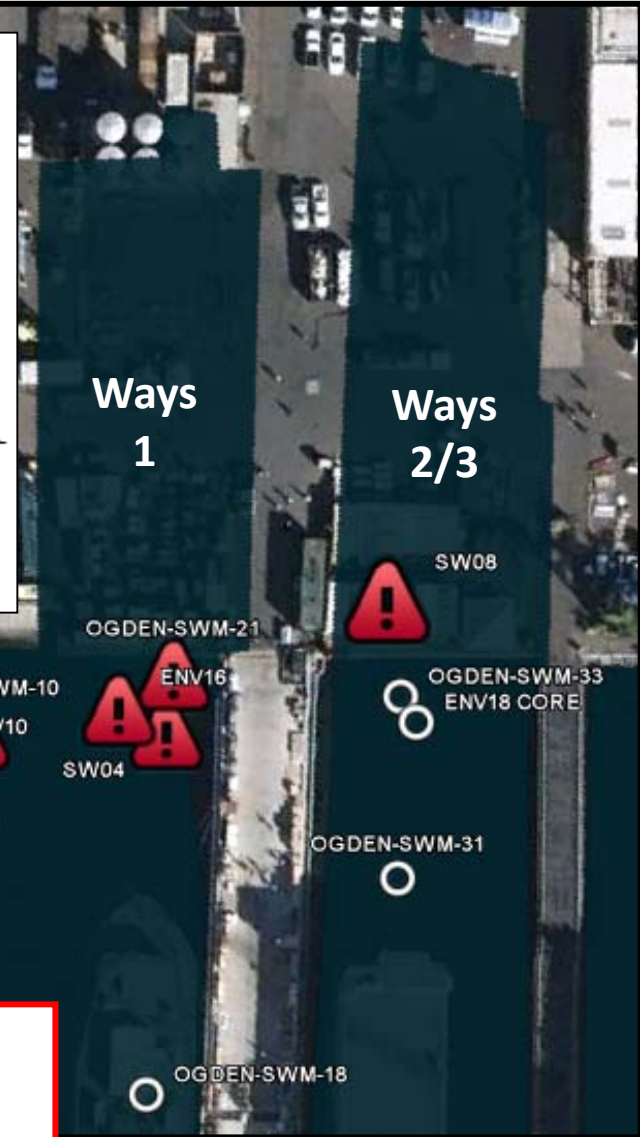
Extensive Oil Saturation in Shipways Migrated to Bay

TOP OF CORE

Black to Tan
unconsolidated
sand & silt

Tan dense to
slightly unconsolidated
sand
some small shell
debris

Does retrieval of core cause an OIL SHEEN?
 YES / NO
+ Top 2 feet only

Oil sheen noted
in sediment
cores

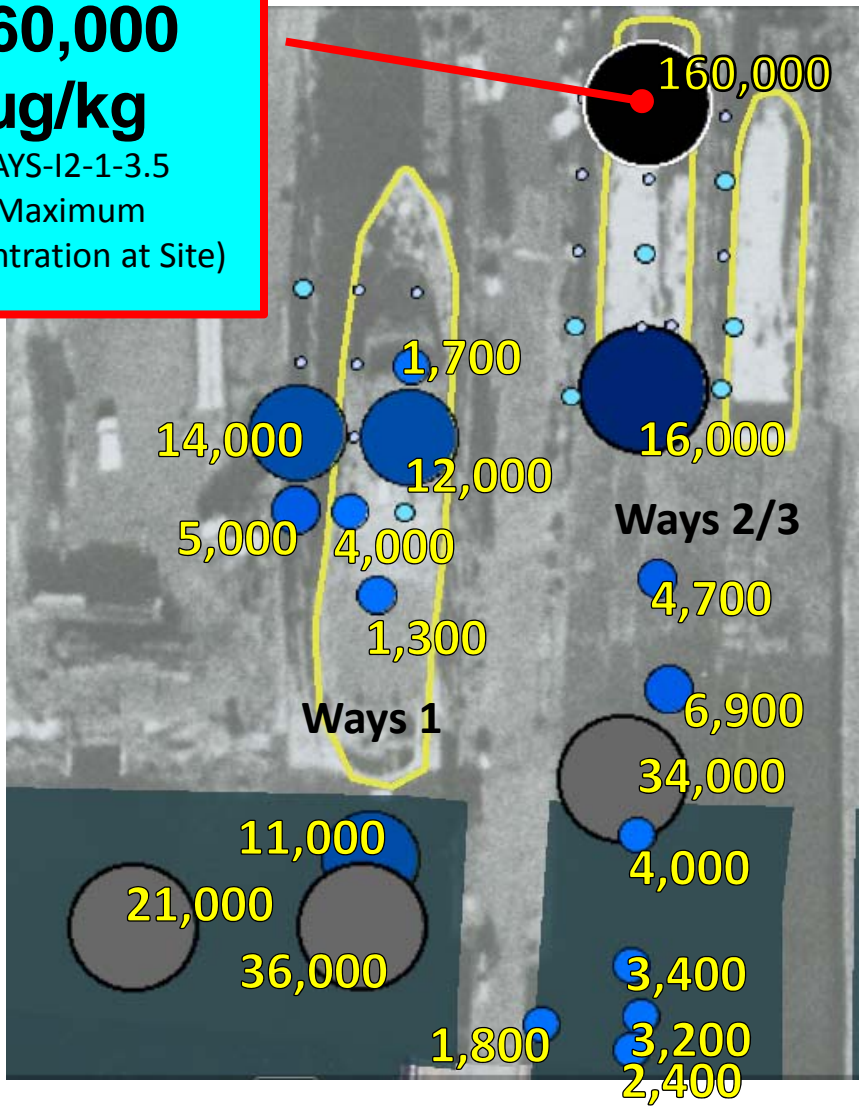
PCB Data Confirm SWM/BAE Shipways as PCB Source

160,000
µg/kg
 WAYS-12-1-3.5
 (Maximum concentration at Site)

Ships in shipways

Concentrations represent maximum concentration of total PCB Aroclors at each location

Samples in shipways collected post-excavation of contaminated soils/sediments

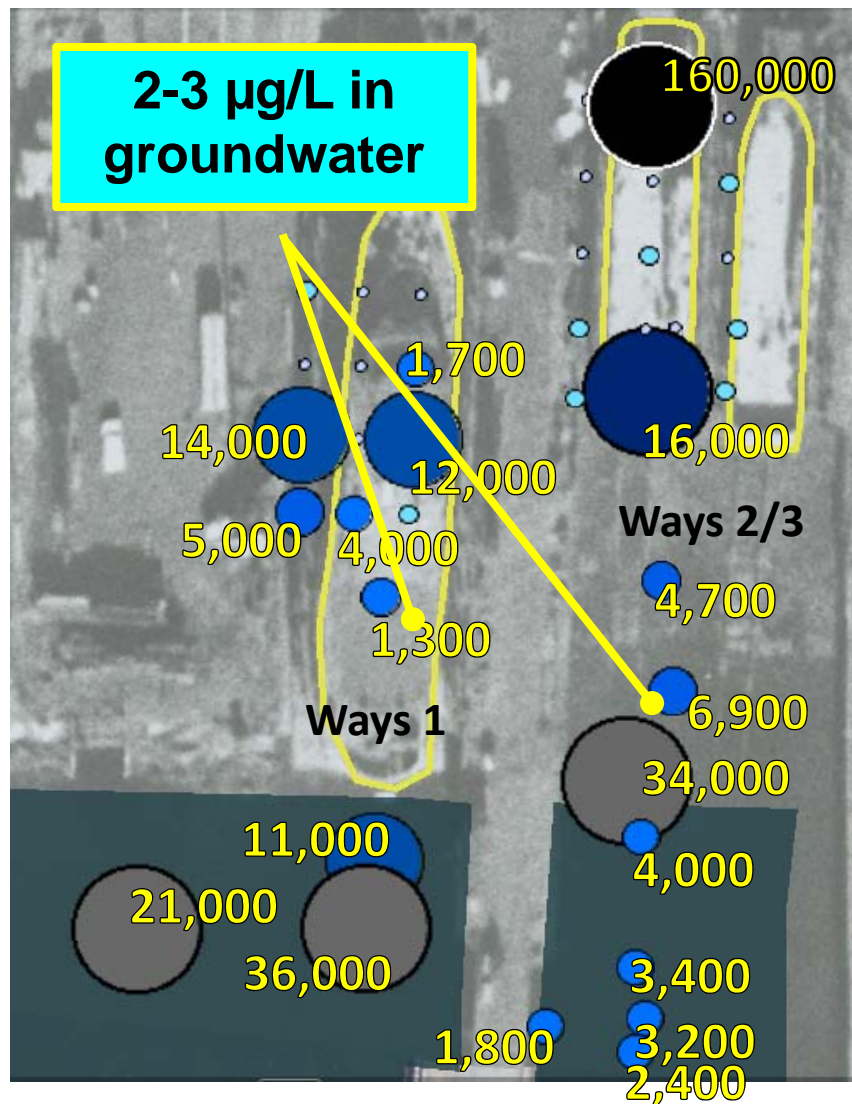
PCB Contamination Persists in SWM/BAE Shipways as Late as 2005

Ships in shipways

Concentrations represent maximum concentration of total PCB Aroclors at each location

Samples in shipways collected post-excavation of contaminated soils/sediments

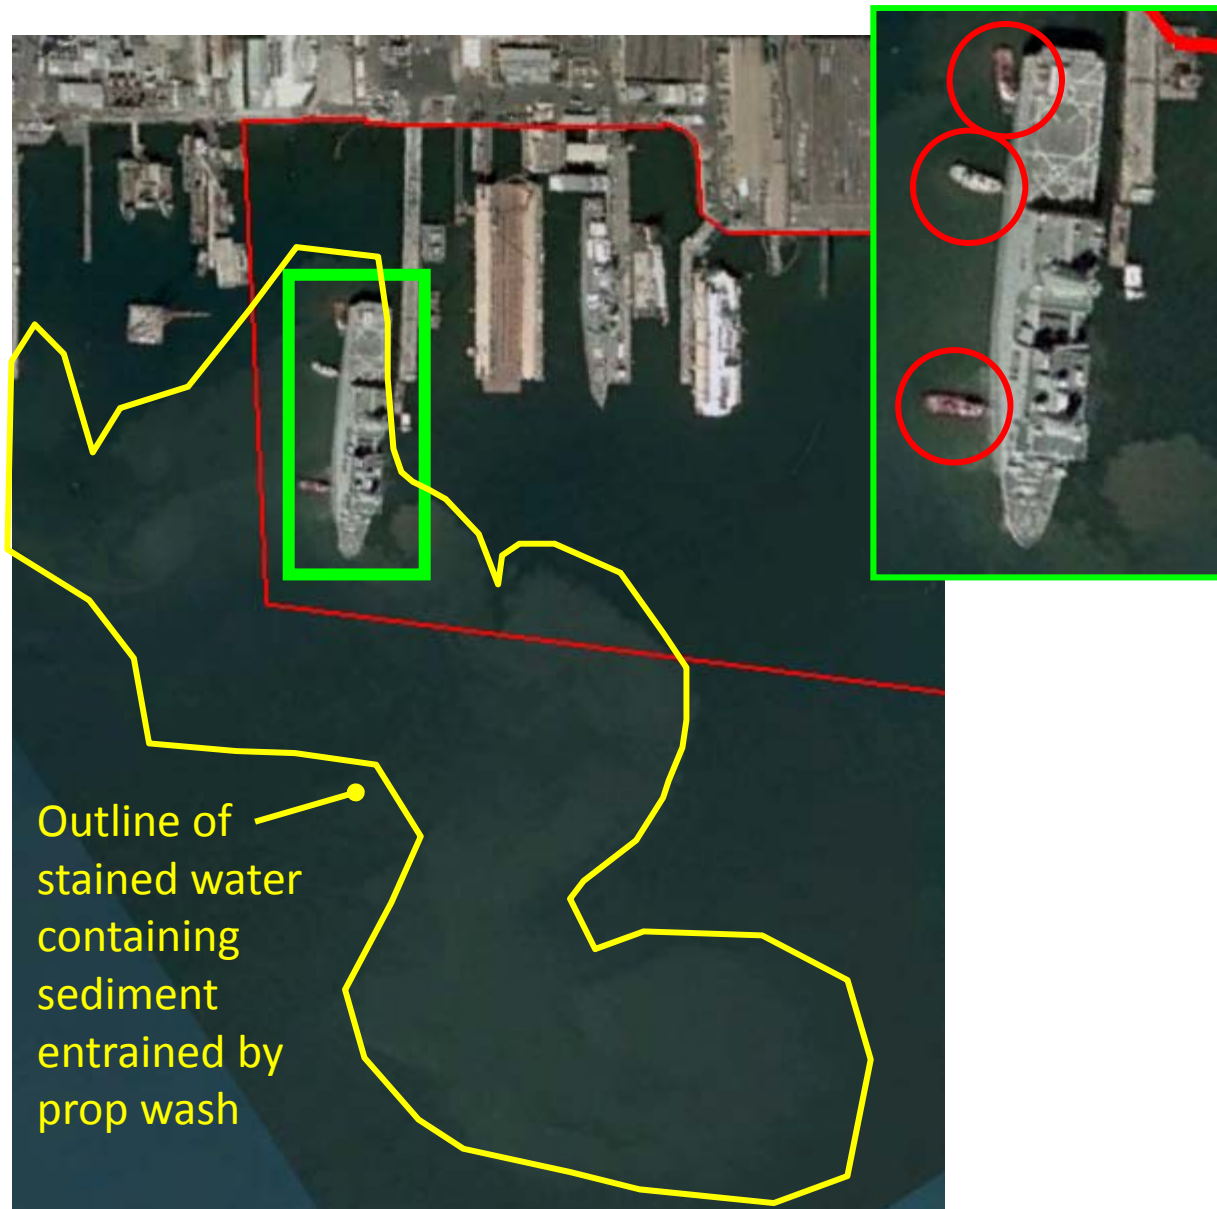
SWM/BAE Operations Spread Historical Contamination

- Physical movement of sediment by shipyard activity:
 - Propeller wash (shown at left)
 - Dredging
 - In-water construction

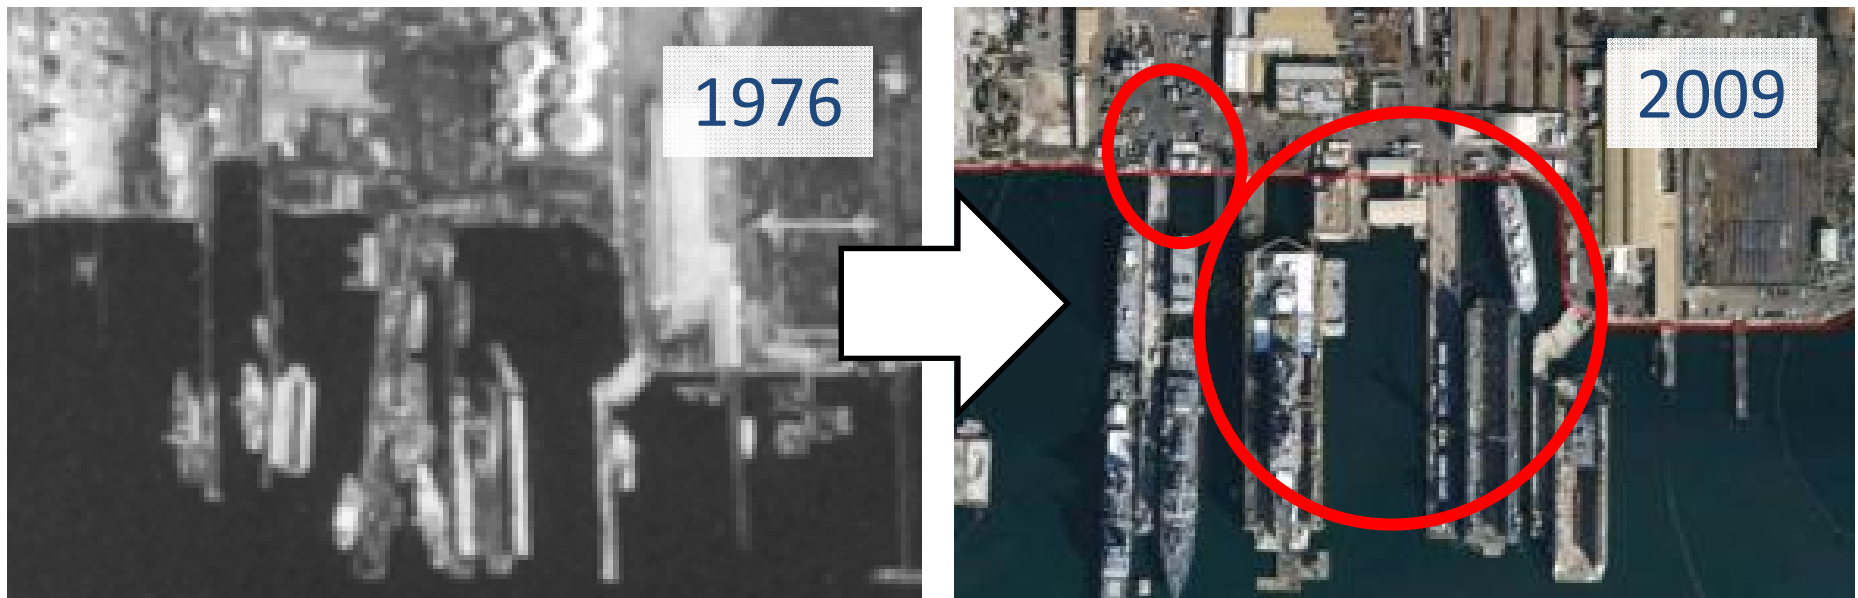
SWM/BAE Operations Spread Historical Contamination

1970s-2000s: Major Pier Construction
(Including complete replacement and
extension of Pier 1); Filling of Shipways 1
and 2/3

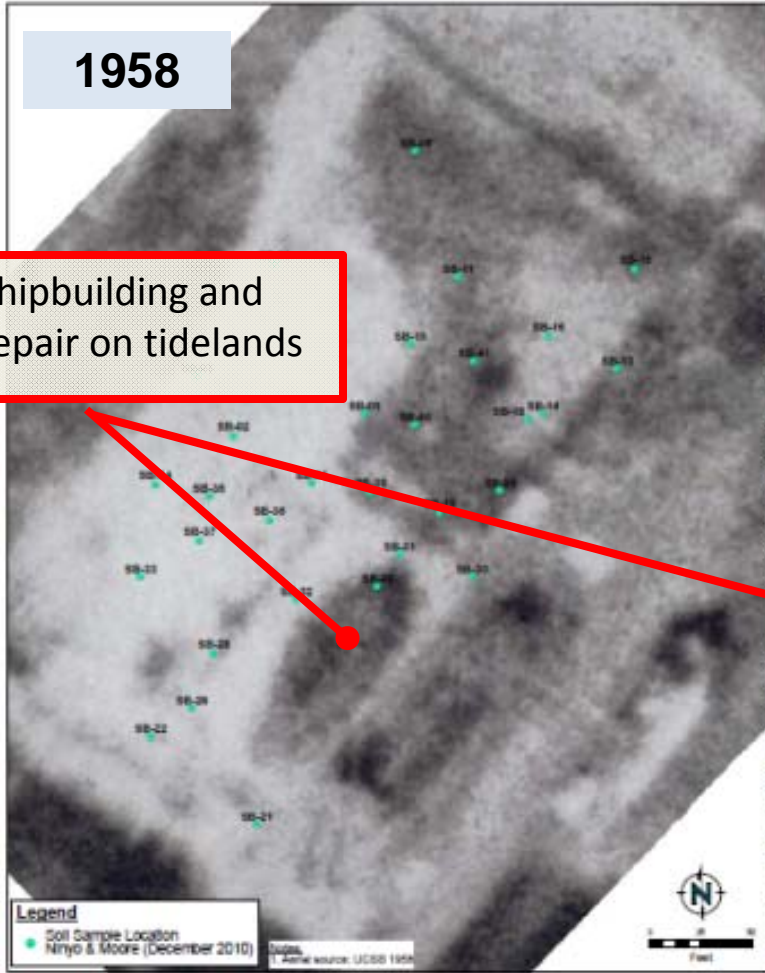
Shipyard Use of SDG&E Tidelands Began in 1958

Shipbuilding and repair on tidelands

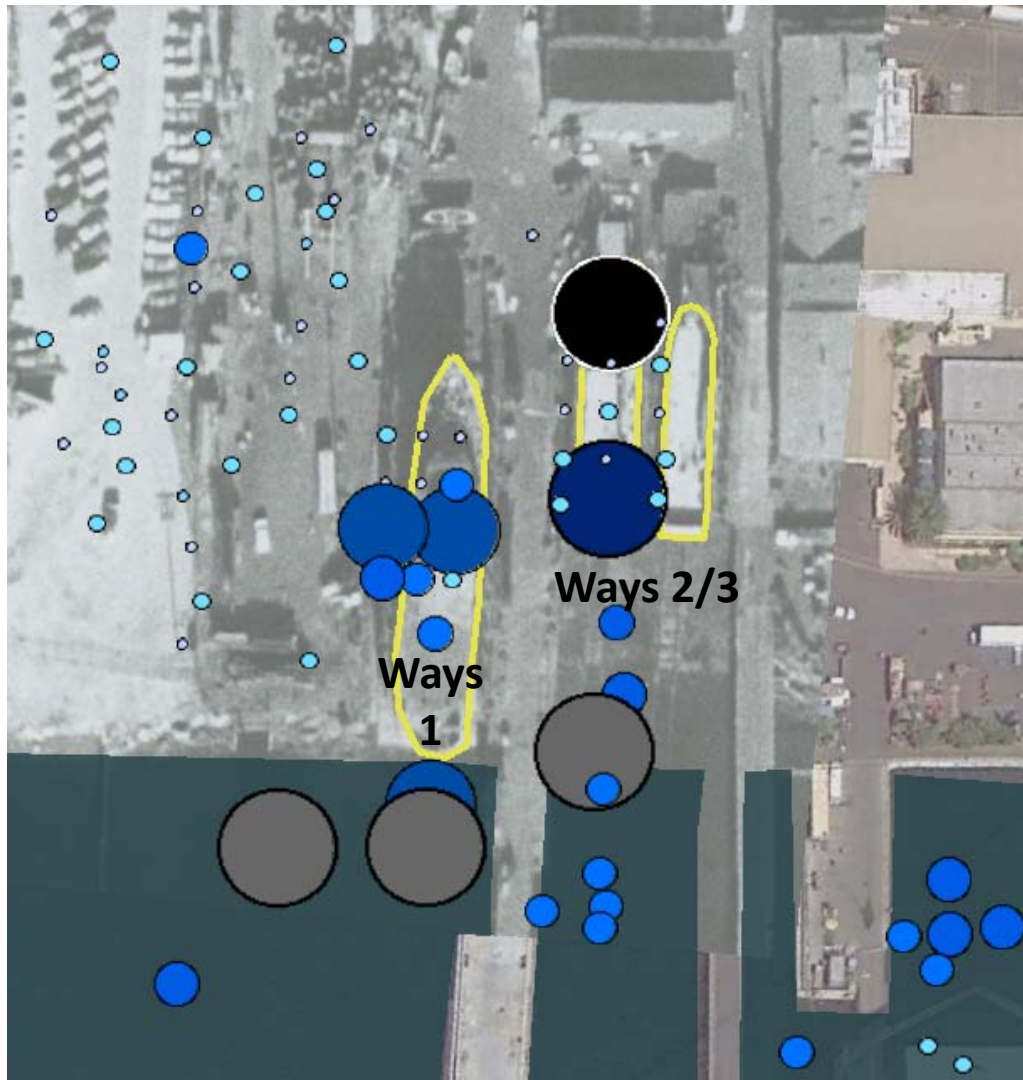
Ships in shipways

Concentrations represent maximum concentration of total PCB Aroclors at each location

Samples in shipways collected post-excavation of contaminated soils/sediments

Exhibit 13a-b - Runoff from Tidelands Insufficient to Cause a Condition of Pollution or Nuisance

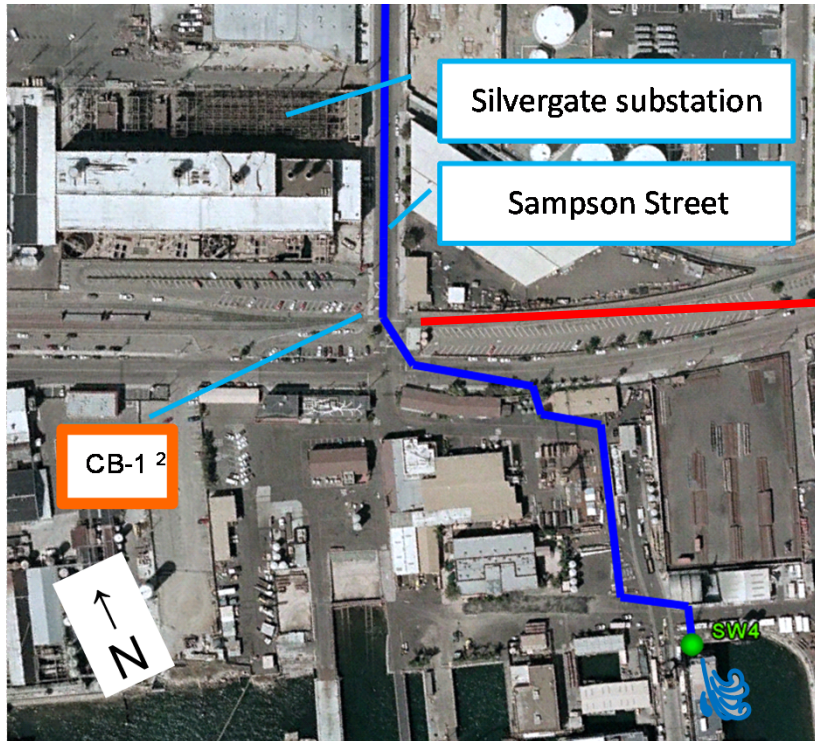
Runoff from Silvergate Substation Did Not Flow Through CB-1

SW4 stormwater outfall location
-

SW4 stormwater main

1. December 30, 2004 USGS aerial photo.
2. CB-1 is upgradient of the Sampson Street gutter vault.
