DATA BASE FILE INFO FOR SUISUN MARSH DUCK CLUBS

Annie Mason Point Club

Club No. 801 Acres: W 30 T 15 Hi 6 Total 51

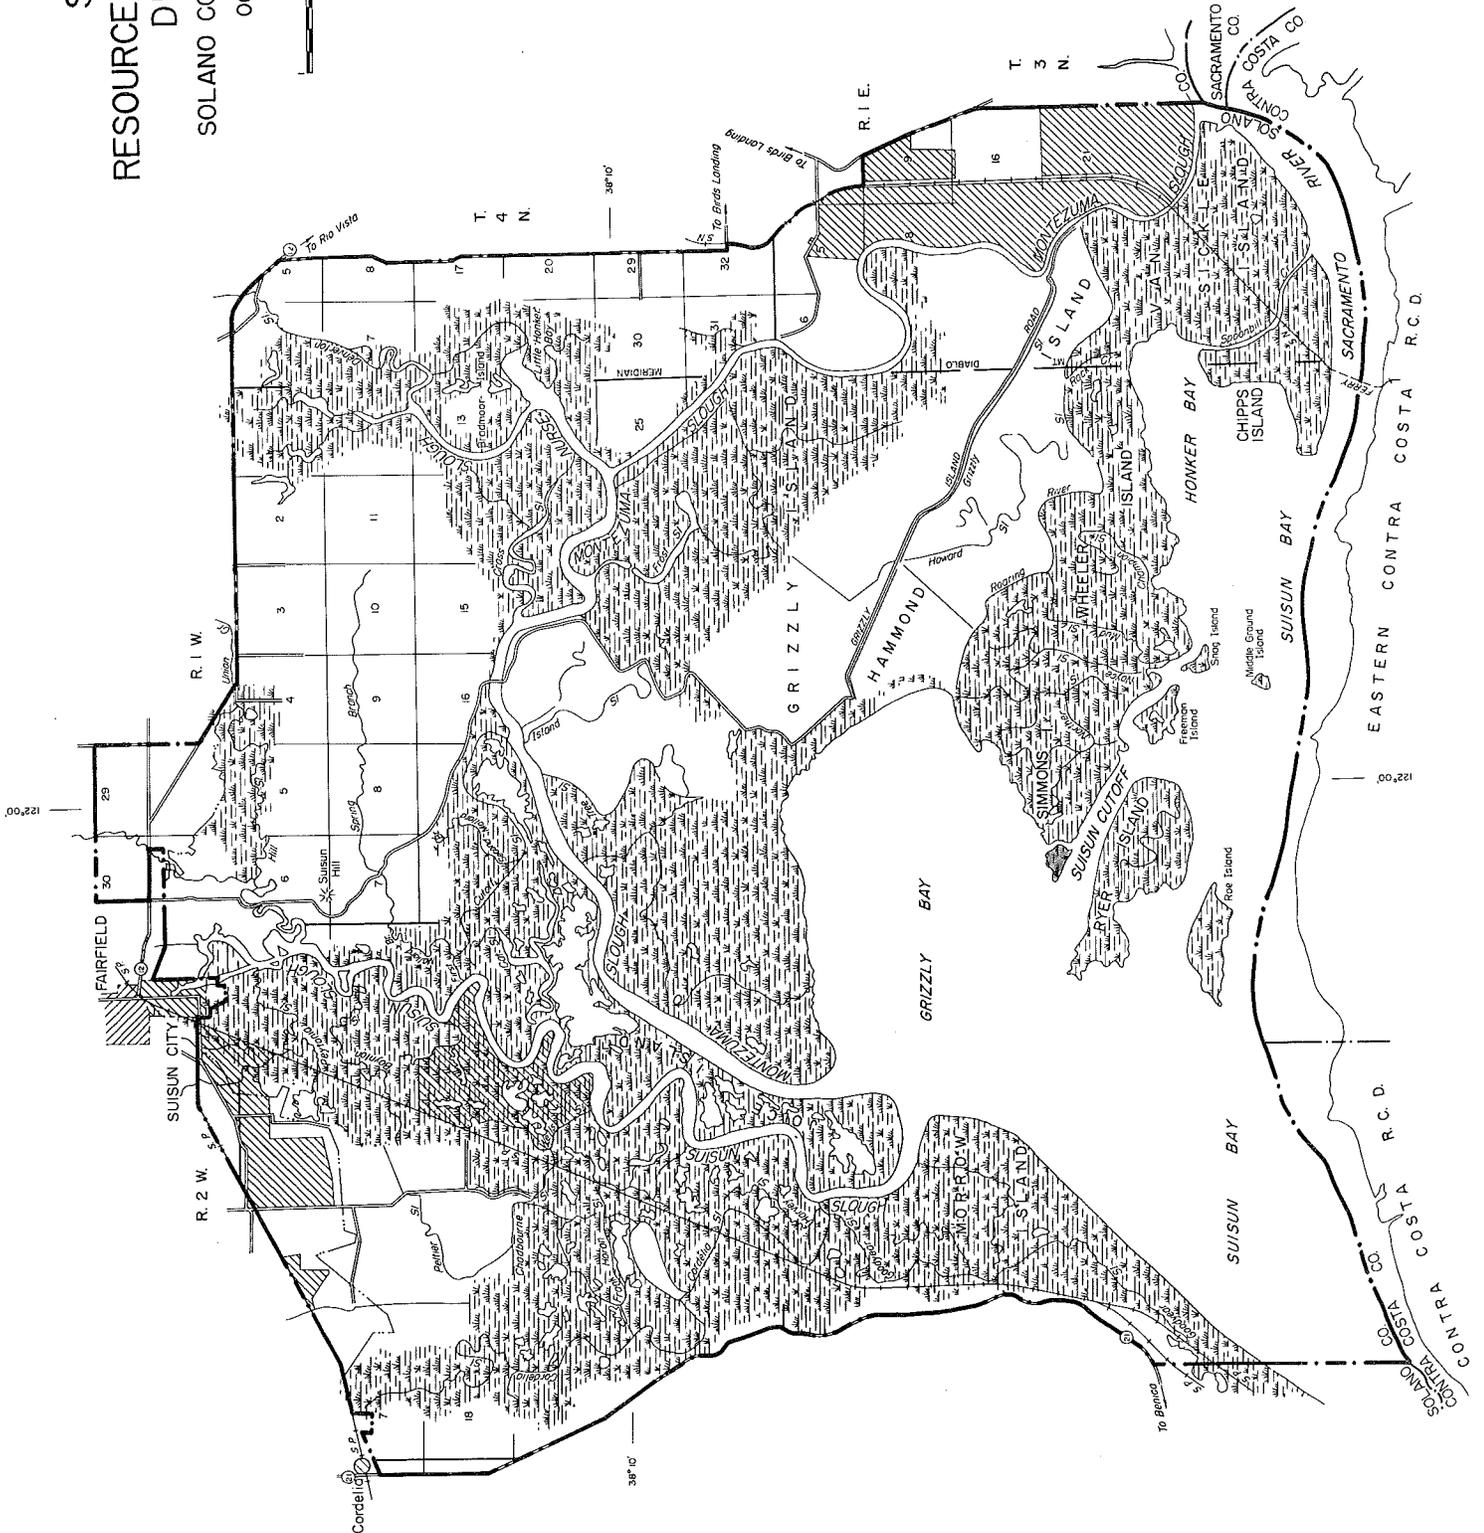
CONSERVATION PLAN MAP

Owner Taylor, James F. Operator _____
County Solano State CA Date _____
Approximate acres 51.51 Approximate scale 1"=660'
Cooperating with Suisun Resource Conservation District _____
Plan identification 801 Photo number _____
Assisted by _____ USDA Soil Conservation Service

The existing levee system is in poor condition and needs work including the installation of irrigation structures. If this is done adequate water control will be achieved to properly manage the marsh for waterfowl.

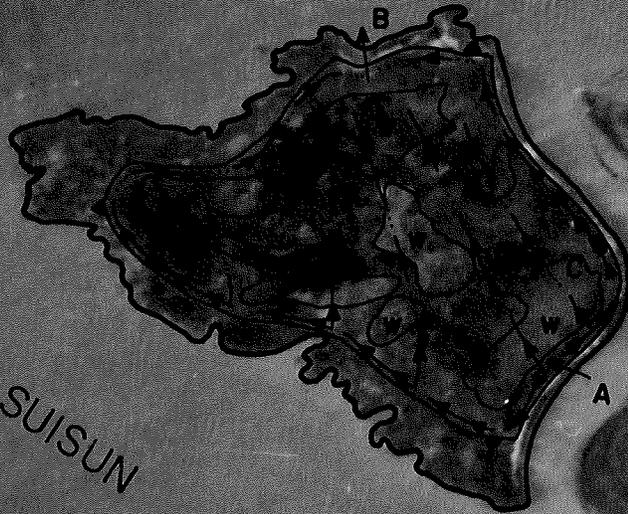
GRIZZLY BAY

SUISUN
CUTOFF

FLOODED AREA - 30ac

Annie Mason Point Club is a small lone club located on Buckley Island. It is contained within a single levee surrounded by Grizzly Bay to the north and Suisun Cutoff to the south. Structure A on the east side of the club functions as the main flood gate and brings water into the club via a perimeter ditch system. A system of interior ditches running from south to north further distributes water to the pond. Structure B is used to drain the club into Grizzly Bay. Two small check dams (C and D) are located in the perimeter ditch. These structures aid in circulation by putting a head on the inlet water and forcing it to circulate across the club in a south to north direction. Removing the boards in the dam enables the ditch to drain.
