Water Quality Report Card

pH in Forester Creek

Regional Water Board:	San Diego, Region 9
Beneficial Uses Affected:	WARM, WILD
Implemented Through:	Restoration
Effective Date:	2008 (restoration construction completed)
Attainment Date:	2016 (Delisted in 2016 Integrated Report)

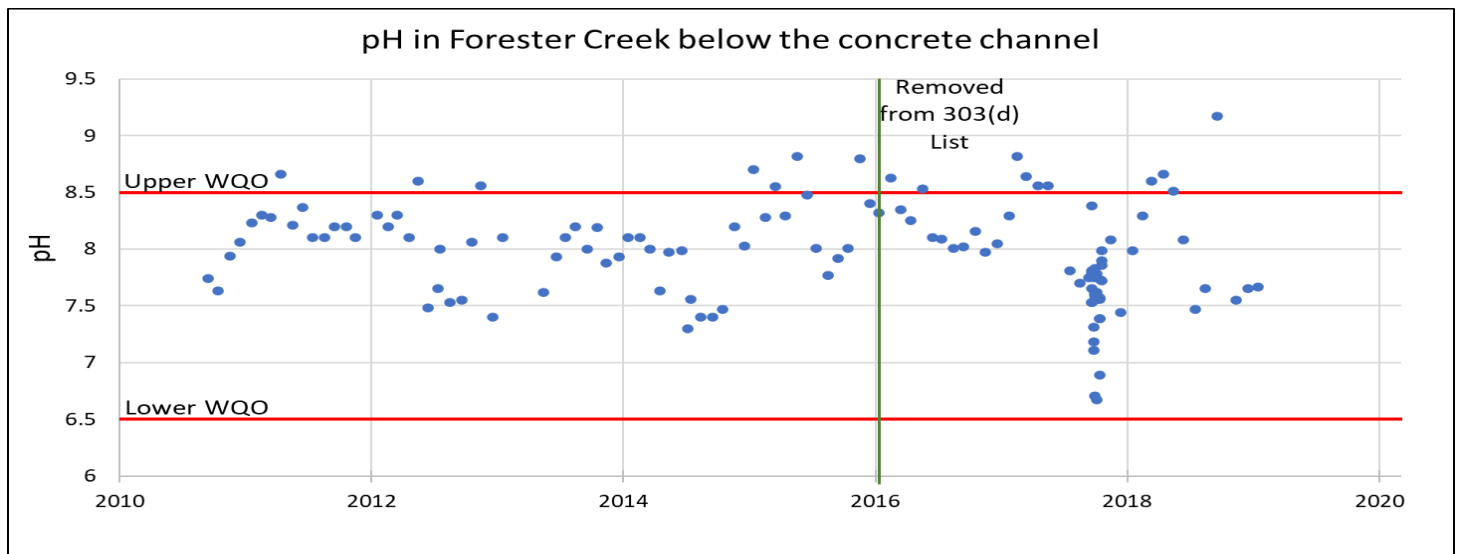
Water Quality

- The average pH within and below the restored reach over the past ten years is 7.96, with 13% of the samples exceeding the upper pH water quality objective (WQO) of 8.5.
- While improvement in pH is a successful outcome of the Forester Creek Improvement Project, the creek and restoration area are impacted by stormwater runoff, and additional water quality improvements are needed.

- pH in the restored section of Forester Creek improved upon project completion and was removed from the 303(d) List for pH.
