Water Quality Report Card		Metals and Other Pollutants in San Diego Bay Shipyard Sediment Site		
Regional Water Board:	San Diego, Region 9	STATUS	<input checked="" type="checkbox"/> Conditions Improving <input type="checkbox"/> Data Inconclusive <input type="checkbox"/> Improvement Needed <input type="checkbox"/> Targets Achieved/Water Body Delisted	
Beneficial Uses Affected:	MAR, WILD, COMM, BIOL, EST, SHELL, MIGR, RARE			
Implemented Through:	CAO, WDR	Pollutant Type:	<input checked="" type="checkbox"/> Point Source <input checked="" type="checkbox"/> Nonpoint Source <input checked="" type="checkbox"/> Legacy	
Effective Date:	March 14, 2012 (CAO)	Pollutant Source:	Urban Storm Water Runoff	Wastewater Discharges
Attainment Date:	2016		Non-Point Source Runoff	Construction/Land Development

Water Quality Improvement Strategy

San Diego Bay Shipyard Sediment Site (SSS)

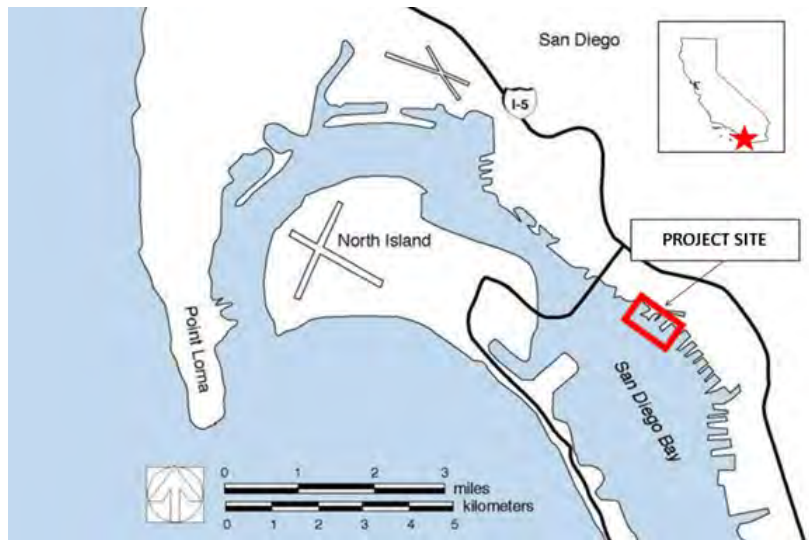
The Shipyard Sediment Site (SSS) covers approximately 53 acres of tidelands along the eastern shore of central San Diego Bay. Discharges of metals and other pollutants to San Diego Bay marine sediment and water are caused by industrial activities at the SSS, the City and Port of San Diego, and the U.S. Navy. The SSS is comprised of near-shore areas within the National Steel and Shipbuilding Company (NASSCO) shipyard property to the south, and BAE Systems, Inc. shipyard property to the north. Both of these entities contribute to pollutant loading at the SSS. In 1990 and 1992, the SSS was listed on the 303(d) List for zinc, mercury, copper, polychlorinated biphenyls (PCBs), and polycyclic aromatic hydrocarbons (PAHs) impairments in sediment. In March 2012, the San Diego Water Board adopted a Cleanup and Abatement Order (CAO) directing responsible parties to clean up contaminated sediments in the Bay within five years. On July 10, 2013, the Regional Water Board issued Waste Discharge Requirements (WDRs) for remediation actions proposed by dischargers, in order for them to comply with the CAO, including dredging and clean sand cover of the contaminated sediment.

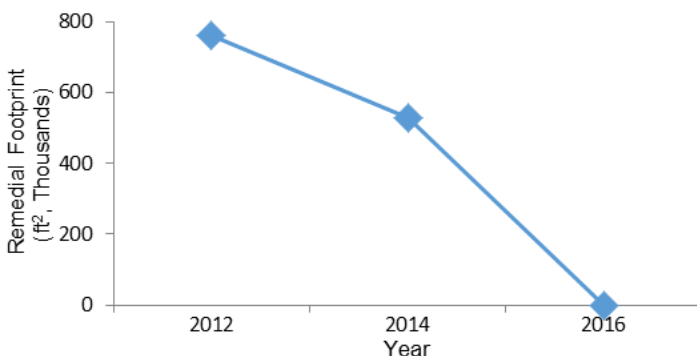
Area To Be Remediated At SSS

- In 2012, the Regional Water Board issued a CAO that sets a remediation footprint, cleanup levels, and deadlines for the dischargers to remediate the SSS.
- Dredging and clean sand cover placement at the NASSCO property was completed in March 2014, representing approximately 30 percent of the entire remediation footprint.
- Dredging and clean sand cover placement at the BAE Systems Inc. property was completed in March 2016, representing the remaining 70 percent of the entire remediation footprint. All dredging at the SSS has been completed.
- Post-remediation monitoring will continue for at least five years to evaluate and confirm the success of cleanup actions and verify the attainment of water quality standards for all constituents.
