Water Quality Report Card		Dissolved Oxygen in the San Joaquin River/Stockton Deepwater Ship Channel	
Regional Water Board:	Central Valley, Region 5	STATUS	<input checked="" type="checkbox"/> Conditions Improving <input type="checkbox"/> Data Inconclusive <input type="checkbox"/> Improvement Needed <input type="checkbox"/> Targets Achieved/Water Body Delisted
Beneficial Uses Affected:	SPWN, COLD, WARM		Pollutant Type:
Implemented Through:	401 Certifications, NPDES Permits, MS4 Permits, WDR, ILRP	Pollution Source:	Wastewater      Hydromodification Irrigated Agriculture      Reduced Flows Urban Storm Water
Effective Date:	February 27, 2007		
Attainment Date:	2016

### Water Quality Improvement Strategy

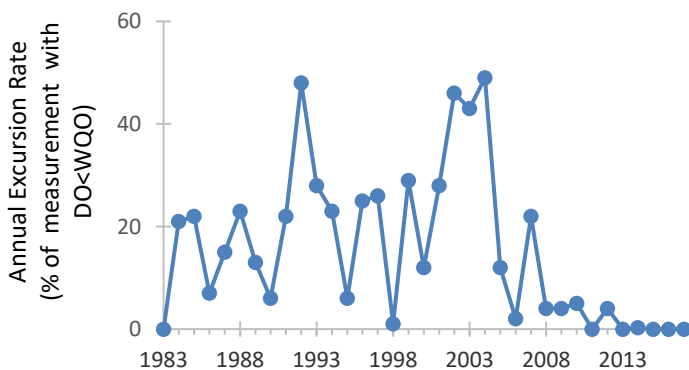
### Stockton Deep Water Ship Channel DO Conditions

- The Stockton RWCF was upgraded in 2007, which significantly reduced ammonia discharges to the SJR.
- An aerator was installed by DWR in 2007.
- A funding agreement between the Port and stakeholders allows for aeration to meet WQOs.
- The SJR is now consistently meeting DO WQO, and will be considered for de-listing in future 303(d) list updates.
- Aeration will continue to be needed to attain the DO WQO during occasional periods of low DO.
