**California Regional Water Quality Control Board
Central Coast Region**

**Total Maximum Daily Loads for Fecal Coliform
in Soquel Lagoon, Soquel Creek, and Noble Gulch**

**Final Project Report
Prepared on February 27, 2008
For the March 20-21, 2008 Water Board Meeting**

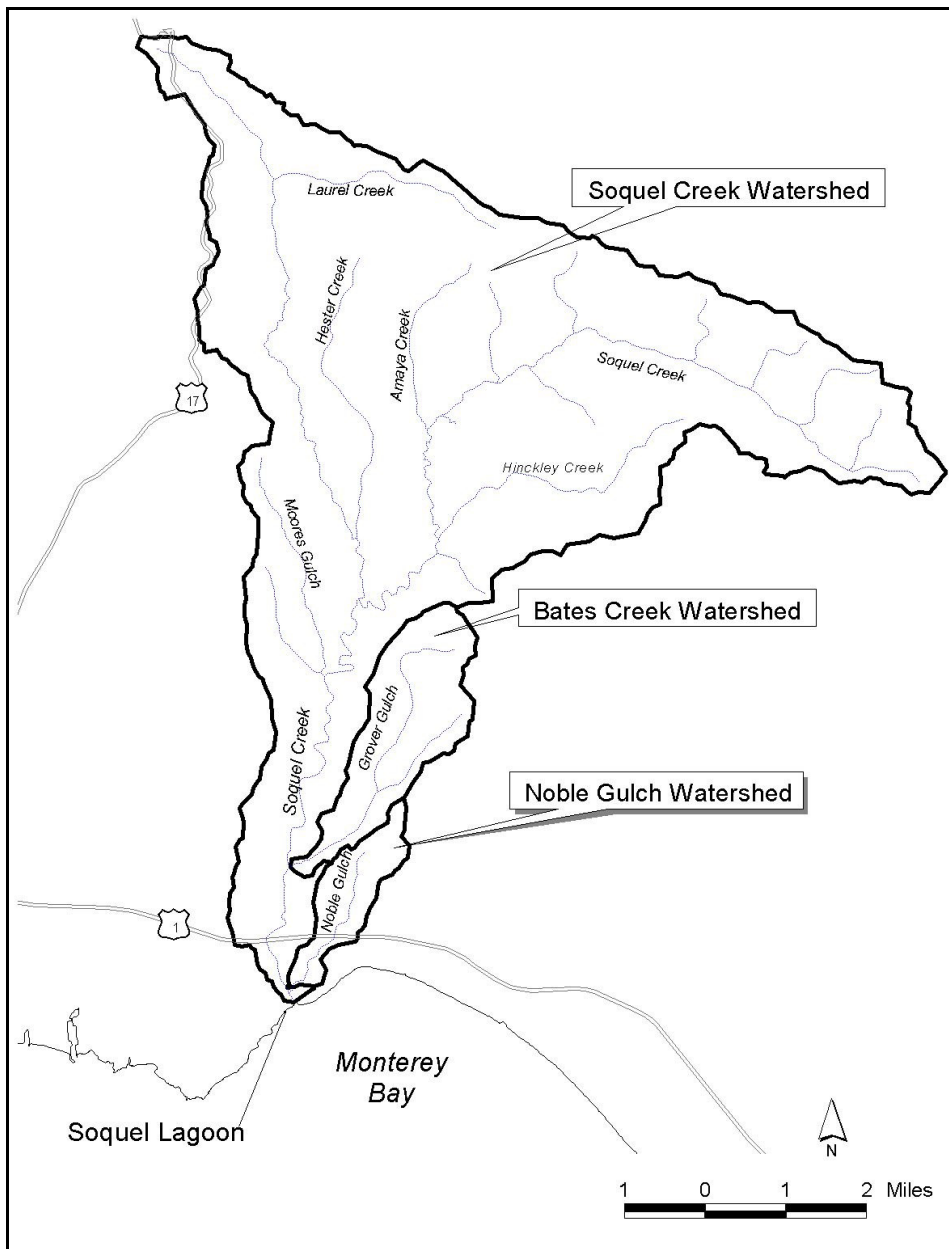
Figure 2-1. Waterbodies within the Soquel Watershed

Two waterbodies, Noble Gulch (the Gulch) and Bates Creek, drain into the downstream most, and most urbanized, two miles of Soquel Creek. Noble Gulch is piped underground for the last 0.4 mile prior to draining into the Lagoon from the northeast. Bates Creek drains into Soquel Creek from the northeast approximately two miles north of the mouth of the Lagoon. Several other creeks flow into Soquel Creek in the upper Soquel Watershed (Figure 2-1).

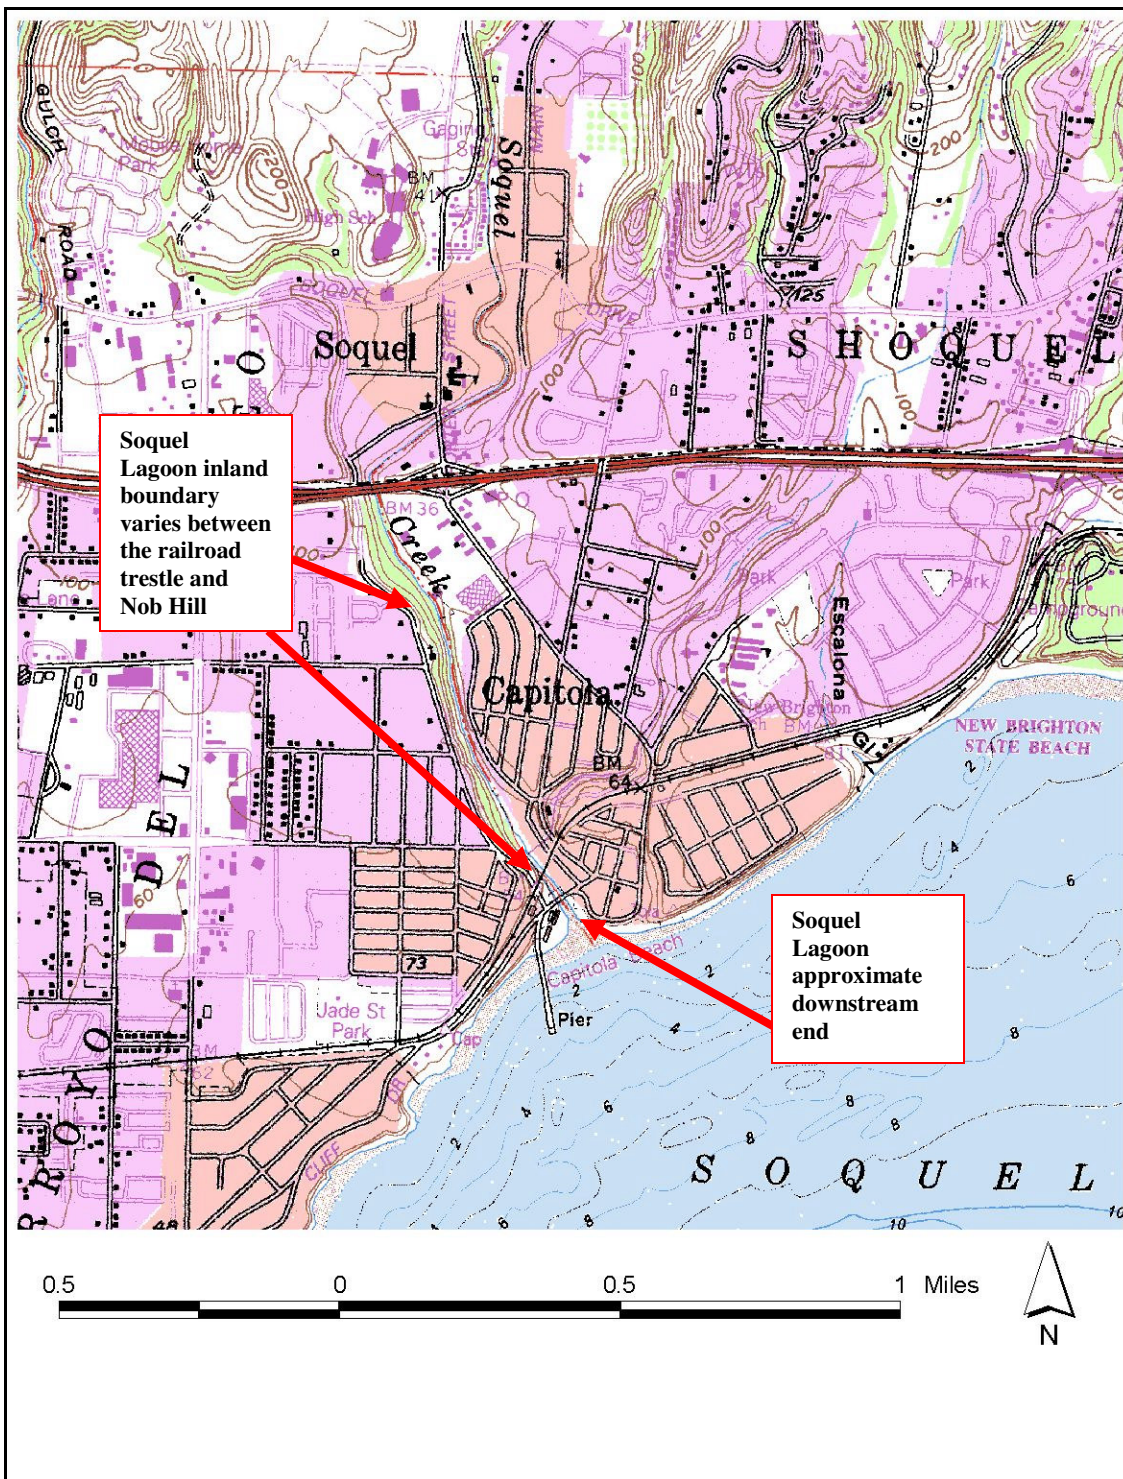
Figure 2-2. Soquel Lagoon Boundaries

Capitola Public Works Department constructs a sandbar across the mouth of the Lagoon each year in May and monitors breaching in the winter to avoid flooding. The Lagoon's northernmost boundary is loosely defined as "somewhere between the Railroad Trestle and Nob Hill," based on the observance of "the saltwater prism, which during high tide can extend as far upstream as Nob Hill" (personal communication, Steve Peters, Water Quality Specialist, Health Services Agency, County of Santa Cruz, March 9, 2006). Nob Hill is a market located adjacent to the Lagoon approximately 0.7 miles north of the mouth of the Lagoon. Figure 2-2 illustrates the approximate location of the Lagoon in relation to other land references.

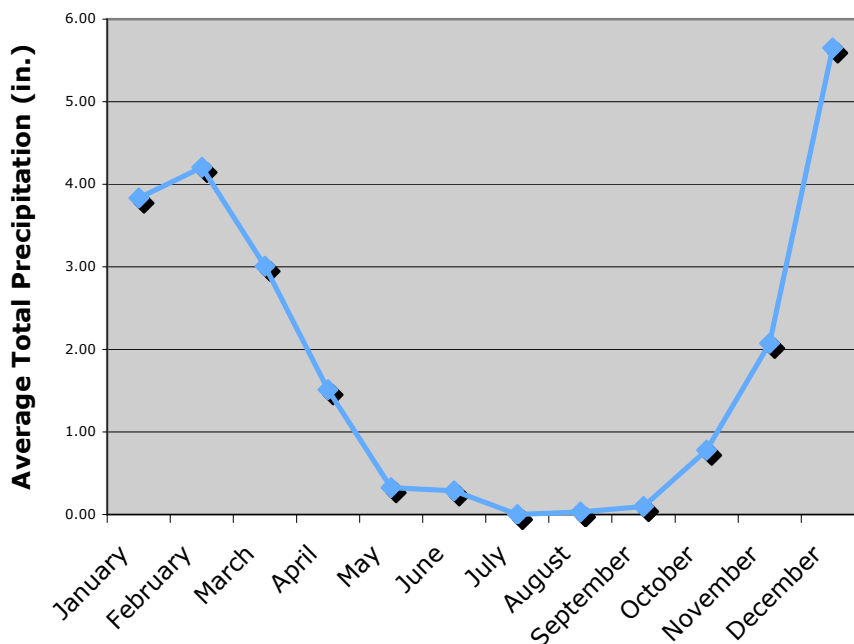
Figure 2-3. City of Capitola Average Monthly Precipitation from October 1996 through April 2006

The Watershed has a Mediterranean climate. Summers are warm and dry, cooled at times by fog at lower elevations due to the proximity of the Pacific Ocean. Winters are cool and wet. Average annual precipitation from October 1996 through April 2006 was approximately 21.80 inches at the City of Capitola (Figure 2-3). The wettest time of the year was generally from December to April.

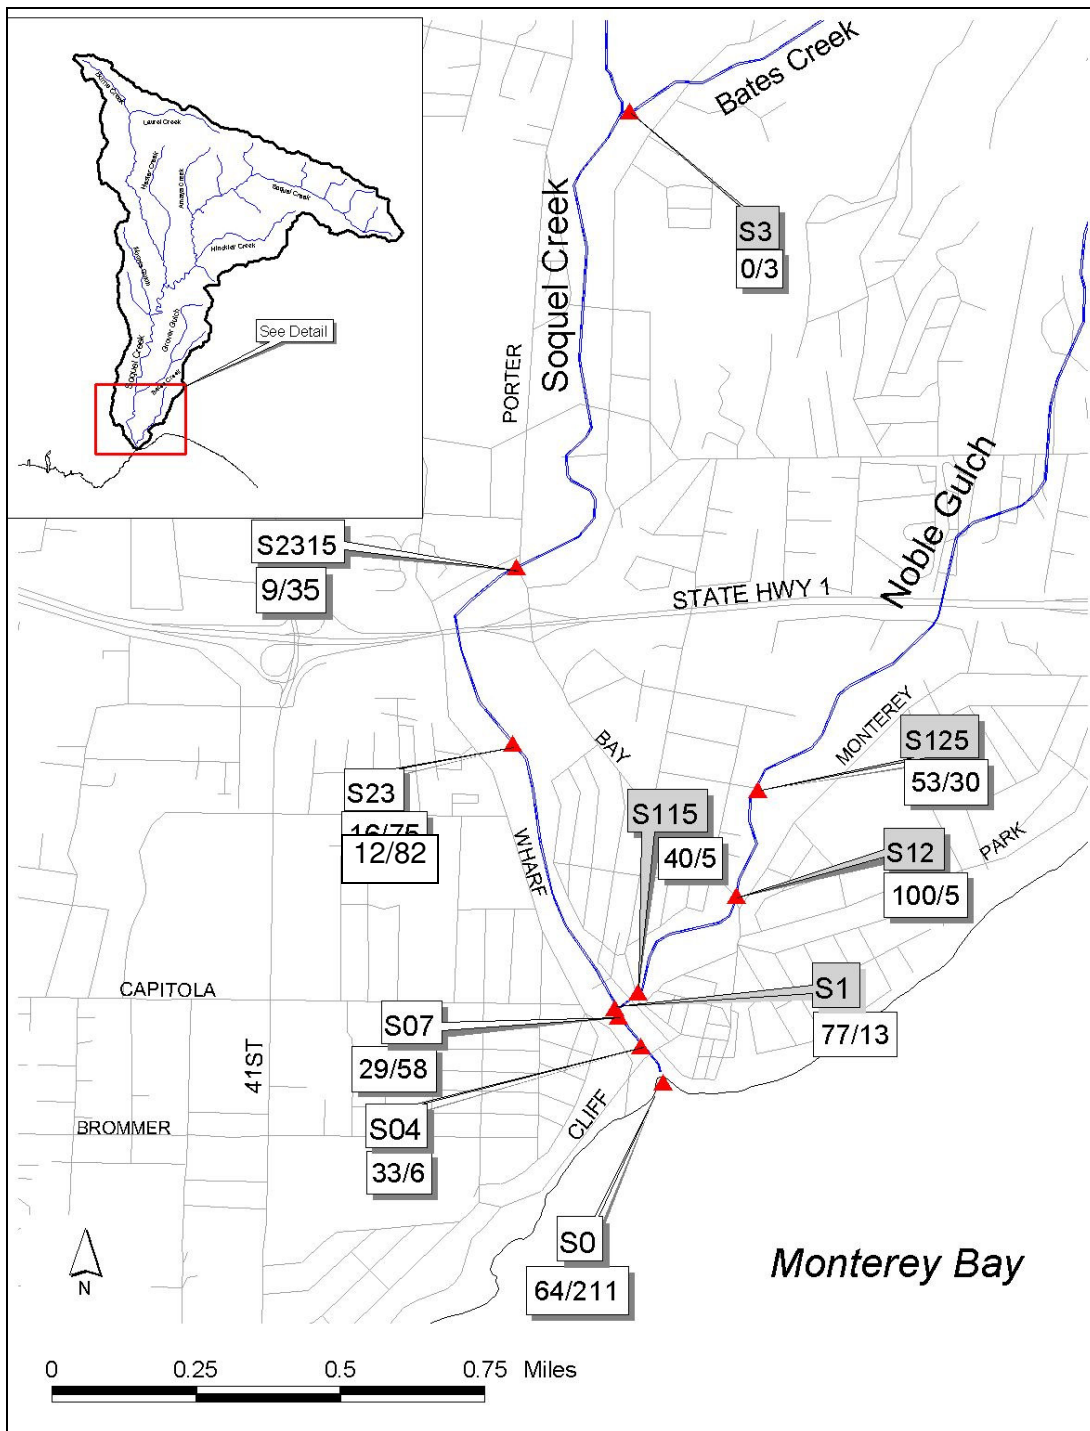
Figure 3-1 and Figure 3-2 illustrate monitoring site locations and proportion of data exceeding water quality objectives.

Figure 3-1. Soquel Creek, Noble Gulch, and Bates Creek Sampling Stations showing station numbers. Below each station number is the percent of data exceeding 400 MPN over the number of samples since January 1, 2003 (for example, Station S07 exceeded the 400 MPN objective 29 percent of the time based on 58 samples). Noble Gulch and Bates Creek Sampling Stations were shaded to separate them from the Soquel Creek stations.

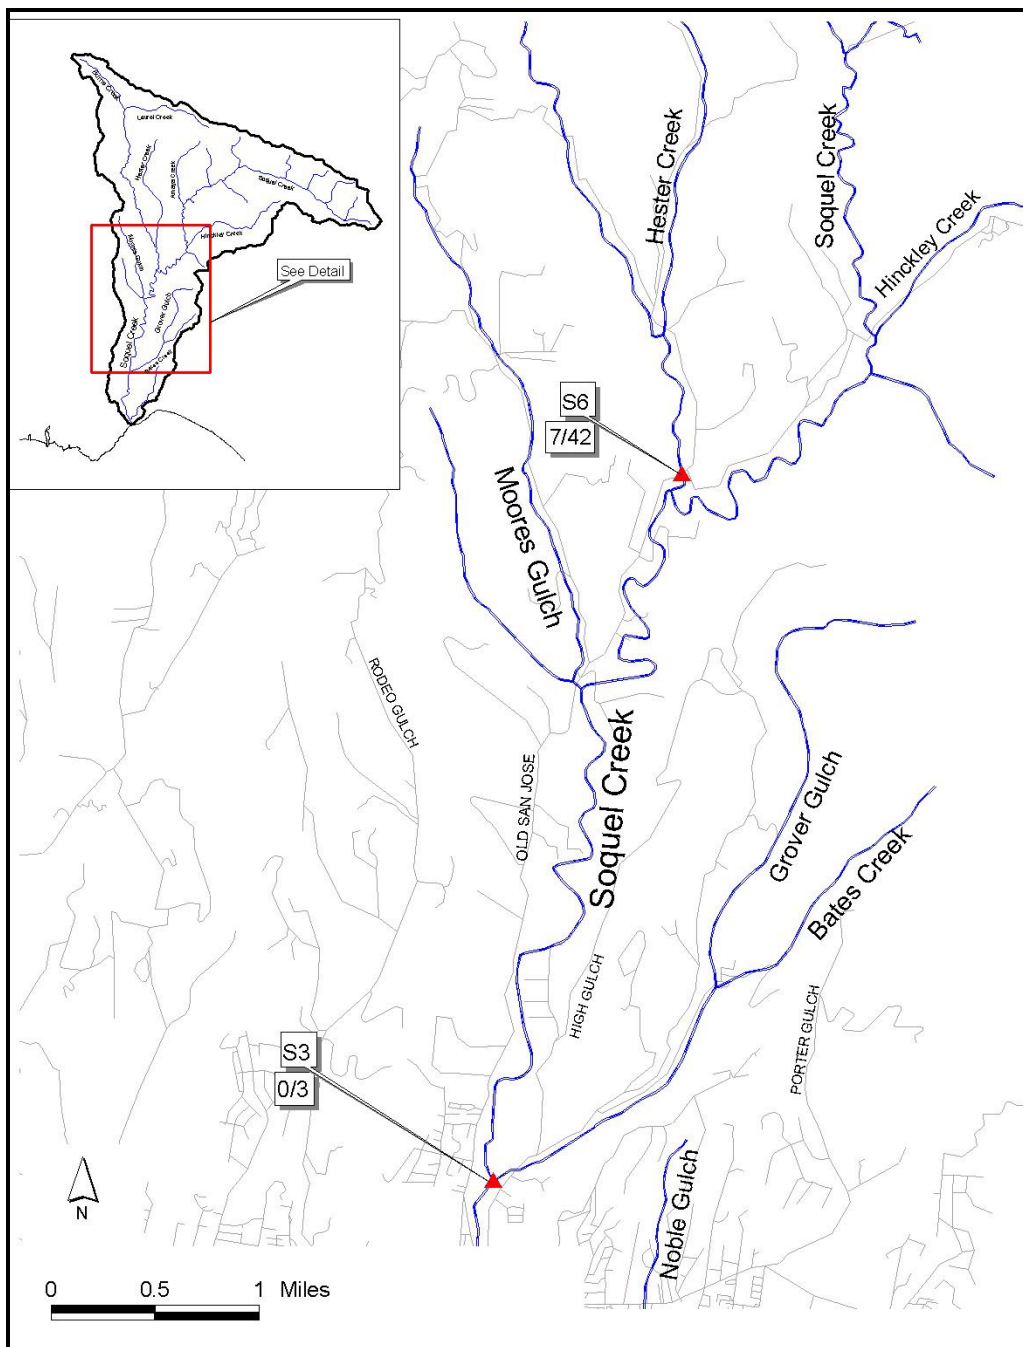
Figure 3-2. West Branch Soquel Creek at San Jose at Olive Springs Road Sampling Station (S6). (This Sampling Station was too far upstream in the Watershed to include on Figure 3-1). The Bates Creek Sampling Station (S3) from Figure 3-1 was included for reference. Both stations show percent exceedance over number of samples since January 1, 2003.)

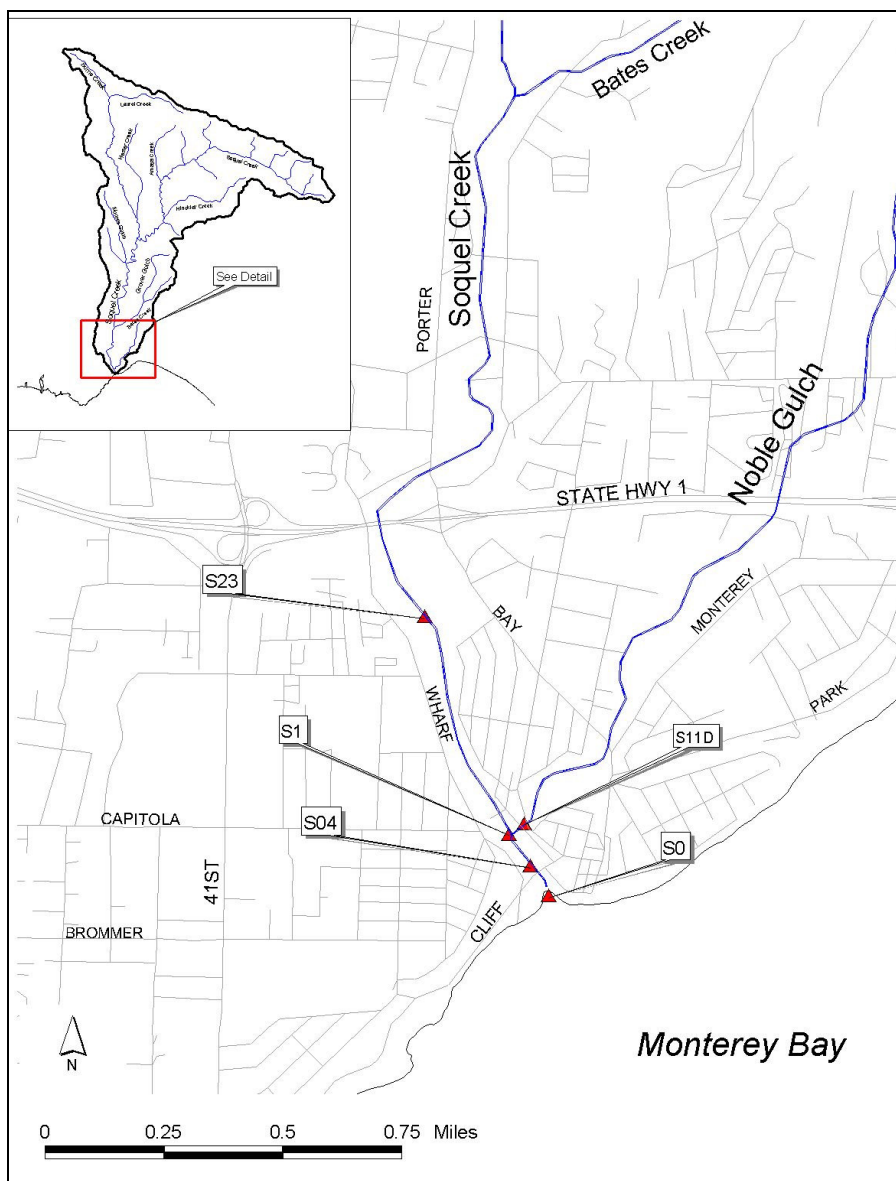
Figure 3-2. Soquel Creek and Noble Gulch Ribotyping Data Collection Stations

Santa Cruz County personnel collected *E. coli* samples for ribotyping analysis from three of the sampling stations on Soquel Creek (S0, S04, and S23), one of the sampling stations on Noble Gulch (S1), and an additional station on Noble Gulch (S11D) that was originally thought to be a storm drain (Noble Gulch is piped underground for its last approximately 0.4 mile prior to entering Soquel Creek). The sampling stations are shown in Figure 4-1.

Ribotyping samples were collected between January 13, 2004 and March 17, 2005. Percent source contributions from samples collected during both wet and dry seasons combined are presented in Table 3-8. Table 3-9 contains the percent source contributions separated into wet and dry seasons.

Based on this combined wet and dry season study, birds were the largest contributing source of *E. coli* at 36 percent or more from all five sampling stations. Other sources, wildlife (raccoon, deer, and opossum), dog, and rodent were present at all five stations and contributed a significant percentage of the fecal coliform. We also observed a four to six percent human contribution to fecal coliform at all but one of the sampling stations, Soquel Creek above Stockton Bridge East. However, this station was downstream of another station that did have a human source. Horse was identified as contributing one percent of the fecal coliform isolates in both Soquel Creek and Noble Gulch.

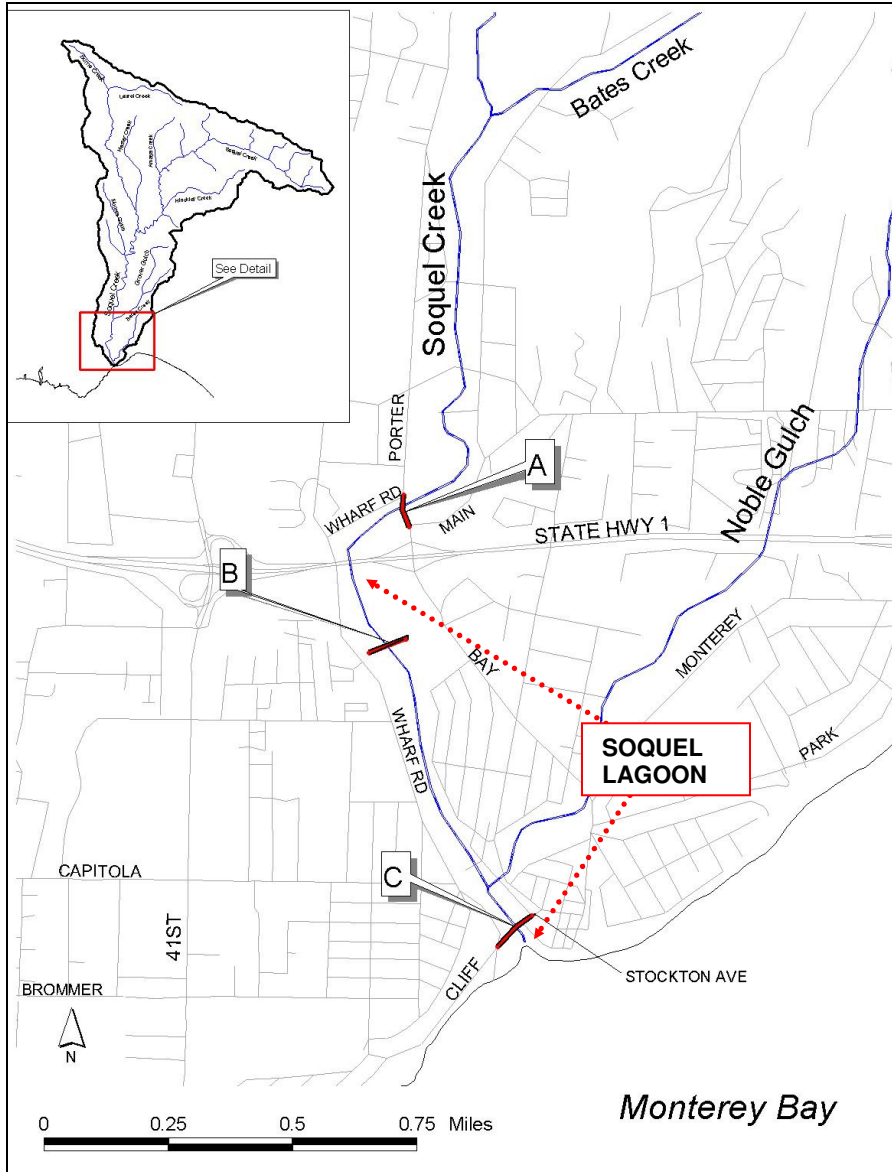
The report indicated that the sewer main in the worst condition was along Cherry and San Jose Avenues located in the Esplanade section of Capitola, which is east of and adjacent to the Lagoon. Several sections were cracked and lateral connections extended into the sewer main with slime build up below. Many as-built plans were missing and the mapping of the sewer lines was incomplete. Some of the manholes in the Capitola village area showed inlet piping that may or may not be abandoned. Occasionally, sewer mains that were considered abandoned were determined functional and connected to residences. Furthermore, some of the manholes were constructed of brick. Water in the rainy season can leak around the bricks and into the sewer system causing overflows (or spills).

Figure 4-1. Locations where the sewer main crosses under Soquel Creek (A: Porter Street between Soquel Wharf Road and Main Street, B: Near Nob Hill at Soquel Creek sampling station toward Soquel Wharf Road, and C: Stockton Avenue Bridge)

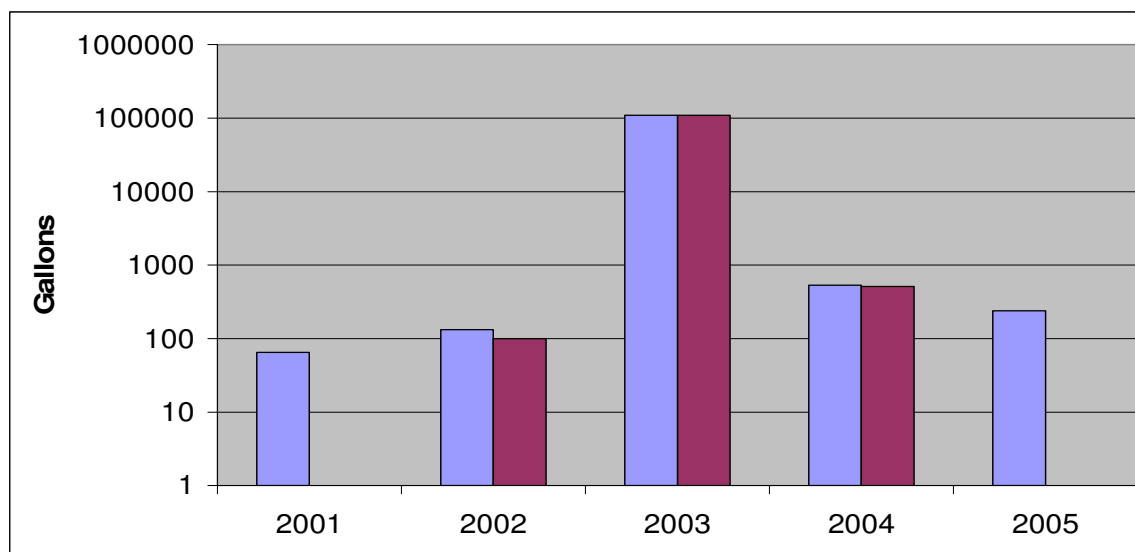
The sewers' problems were not just leaks, but also blocks and spills. Sewer main blocks that did not require clean up action, in addition to blocks that resulted in spills were partially due to the faultiness of the collection system as described above. Staff concluded that blocks and spills were also due to obstructions such as grease, wood, rags, and hair. Spill data was compiled into the following graph in Figure 4-2.

Figure 4-2. Total Domestic Sewage Spilled into Soquel Creek/Lagoon and Storm Drain System from 2001 to 2005. Blue bars represent total spills to Soquel Creek/Lagoon and Storm Drains. Red bars represent total spills only to Soquel Creek/Lagoon.

From 2001 through 2005, 22 spills were reported that were a result of SCCSD collection system failure within the Soquel Watershed. The largest spill volume occurred in 2003 amounting to 109,205 gallons, of which 109,000 gallons reached Soquel Creek. Two spills that occurred that year were relatively large with one measuring 100,000 gallons and the other measuring 9,000 gallons. The 9,000-gallon spill also entered Noble Gulch. The total volume of spills in each of the other four years was 535 gallons or less. Spills did not reach the Soquel Lagoon in 2001 and 2005.
