CLEANUP AND ABATEMENT ORDER R5-2015-0740

SOPER FAMILY 2004 TRUST
LAKE COUNTY

Inspection Report

INSPECTION DATE:	24 August 2015
LOCATION & COUNTY:	7405 Soda Bay Road, Kelseyville, Lake County (Clear Lake Watershed) APN 009-019-05, 009-019-06, and 009-020-13
SITE TYPE:	Private land
INSPECTED BY:	Rajmir Rai, Holly Grover, Michelle Wood, and Terry Bechtel Central Valley Water Board
REPORT DATE:	10 September 2015
PREPARED BY:	Rajmir Rai

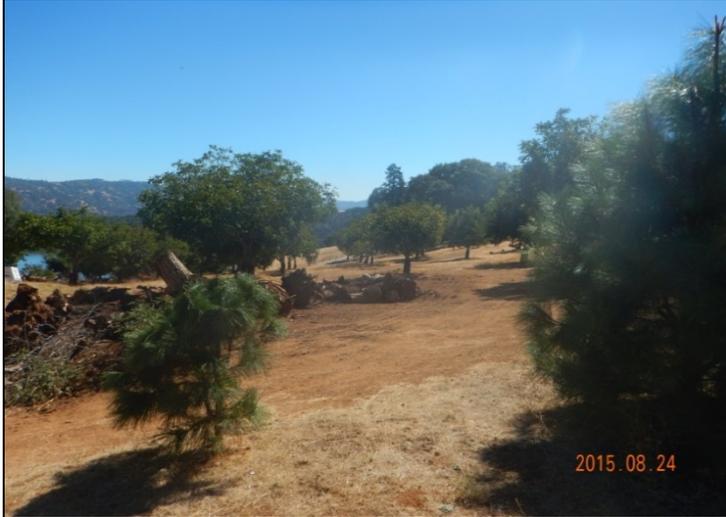
Photo 1. View of the Soper Property from Marina View Drive on 24 August 2015. This view depicts the southwestern side of the property, which is the portion of the property furthest from Clear Lake.

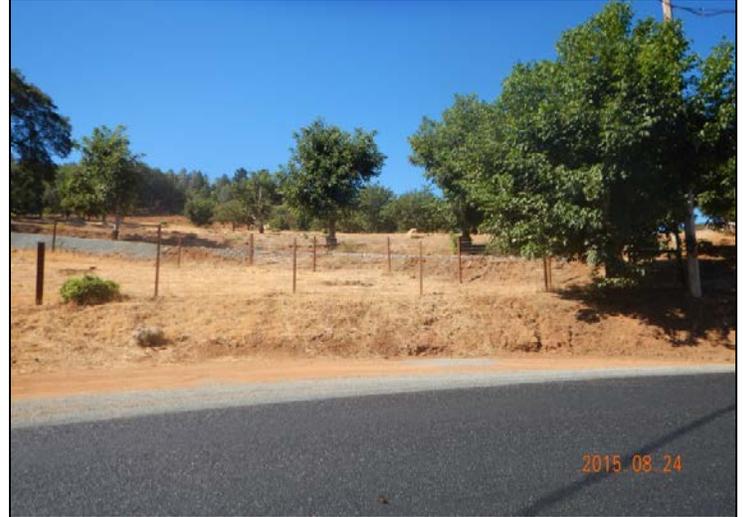
Photo 2. Alternate view of the Soper Property south (uphill) of Soda Bay Road. This view from Soda Bay Road depicts a portion of the property closer to Clear Lake (and depicts an opposite view of Photo 1).

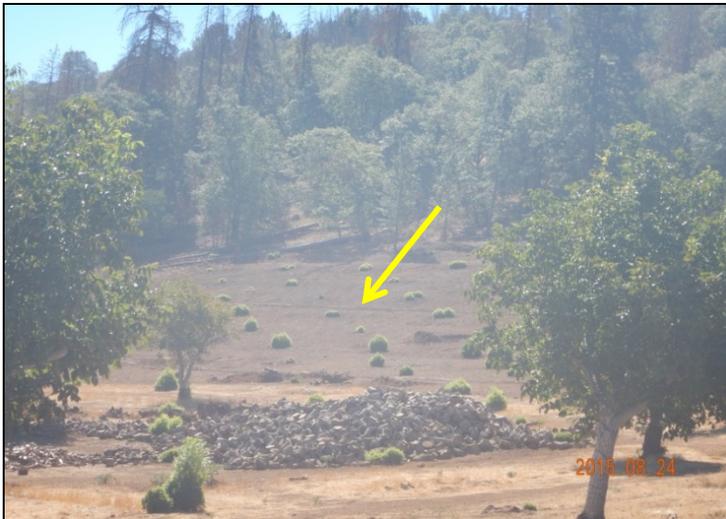
Photo 3. Another view of the southwestern portion of the Soper Property. This photo indicates that a portion of the property has been cleared and graded.

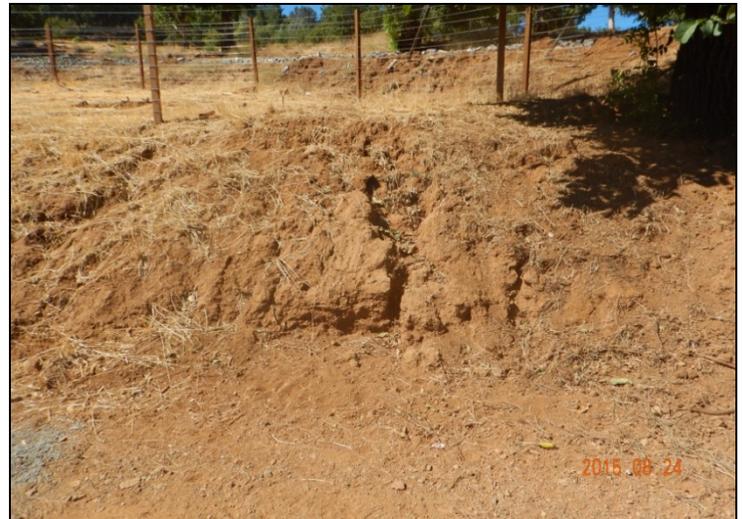
Staff did not observe any stormwater runoff originating from the Soper Property at the time of inspection; this finding is not unexpected given no rain occurred on 24 August 2015 or preceding days. However, Staff observed evidence of soil erosion from prior runoff. In addition, Staff observed inadequate and ineffective BMPs in place to prevent potential stormwater runoff and soil erosion associated with walnut orchard removal activities. Based on this inspection, Staff recommends contacting the property owners to request improved BMP installation and/or installation of additional BMPs to prevent further soil erosion. Staff also recommends having a discussion with Central Valley Water Board management to determine if enforcement should result from this inspection.

Photo 4. View of soil erosion features on the Soper Property uphill (south) of Soda Bay Road.

- (a) The Discharger shall immediately begin implementing best management practices for soil stabilization and erosion control.
 - (b) By **31 October 2015**, the Discharger shall submit a ***Sediment and Erosion Control Plan*** to the Central Valley Water Board for approval by the Assistant Executive Officer.

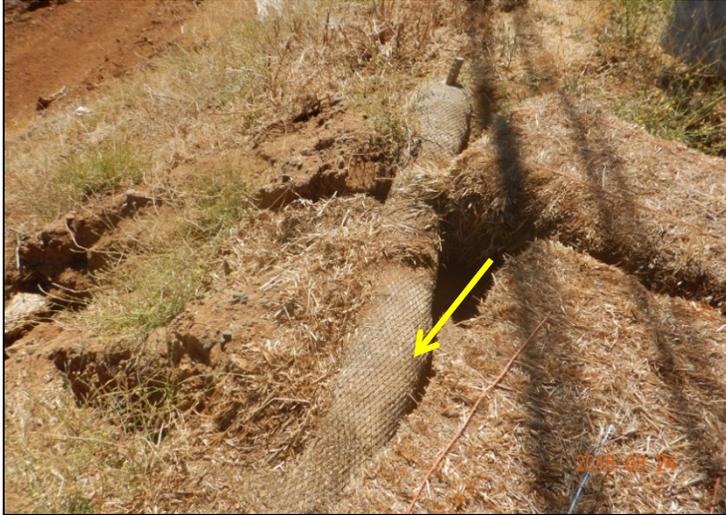
Photo 5. View of a straw wattle (indicated by yellow arrow), hay bales, and soil erosion features on the northeastern portion of the Soper Property downhill (north) of Soda Bay Road.

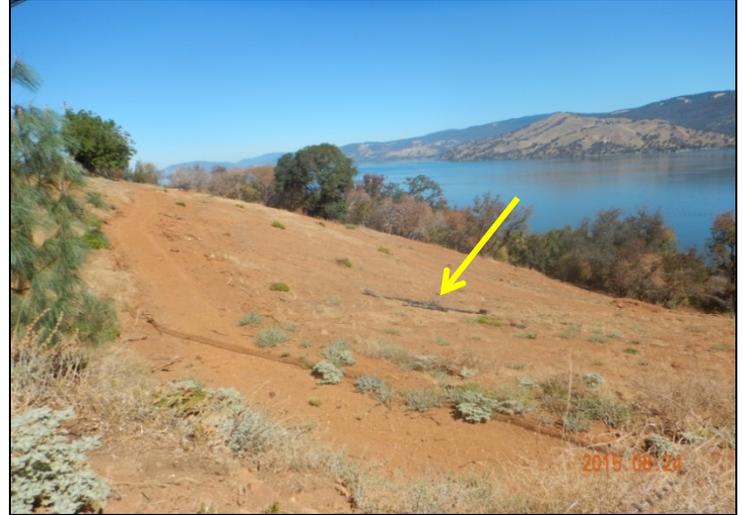
Photo 6. View of Clear Lake from Soda Bay Road. The yellow arrow indicates a failed silt fence on the Soper Property.

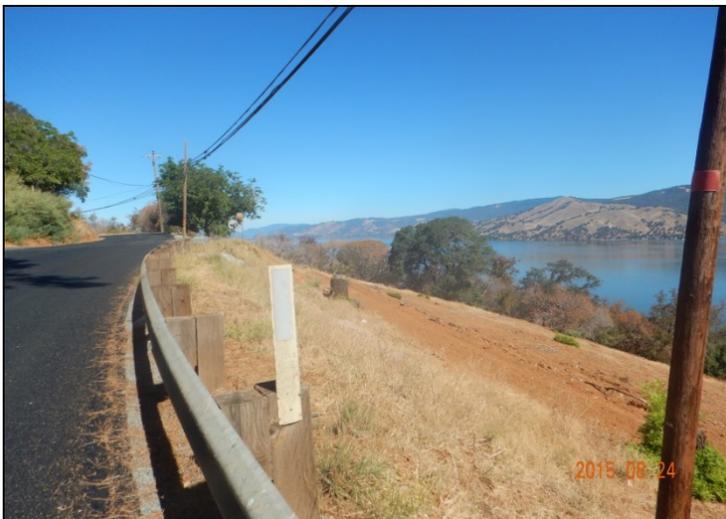
Photo 7. A view of Soda Bay Road on the left and the Soper Property on the right, downhill (north) of Soda Bay Road.

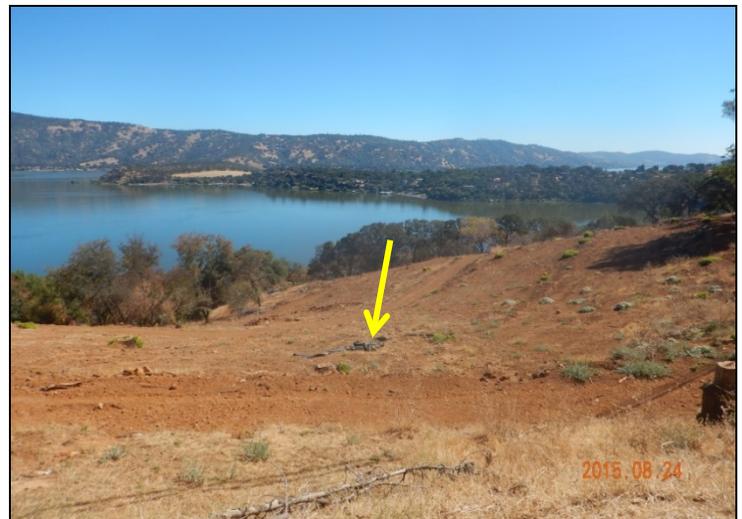
Photo 8. View of another failed silt fence on the northeastern portion of the Soper Property. This picture is taken from Soda Bay Road.
