Map Grid Index

Groundwater Cr(VI) concentrations in monitoring wells:

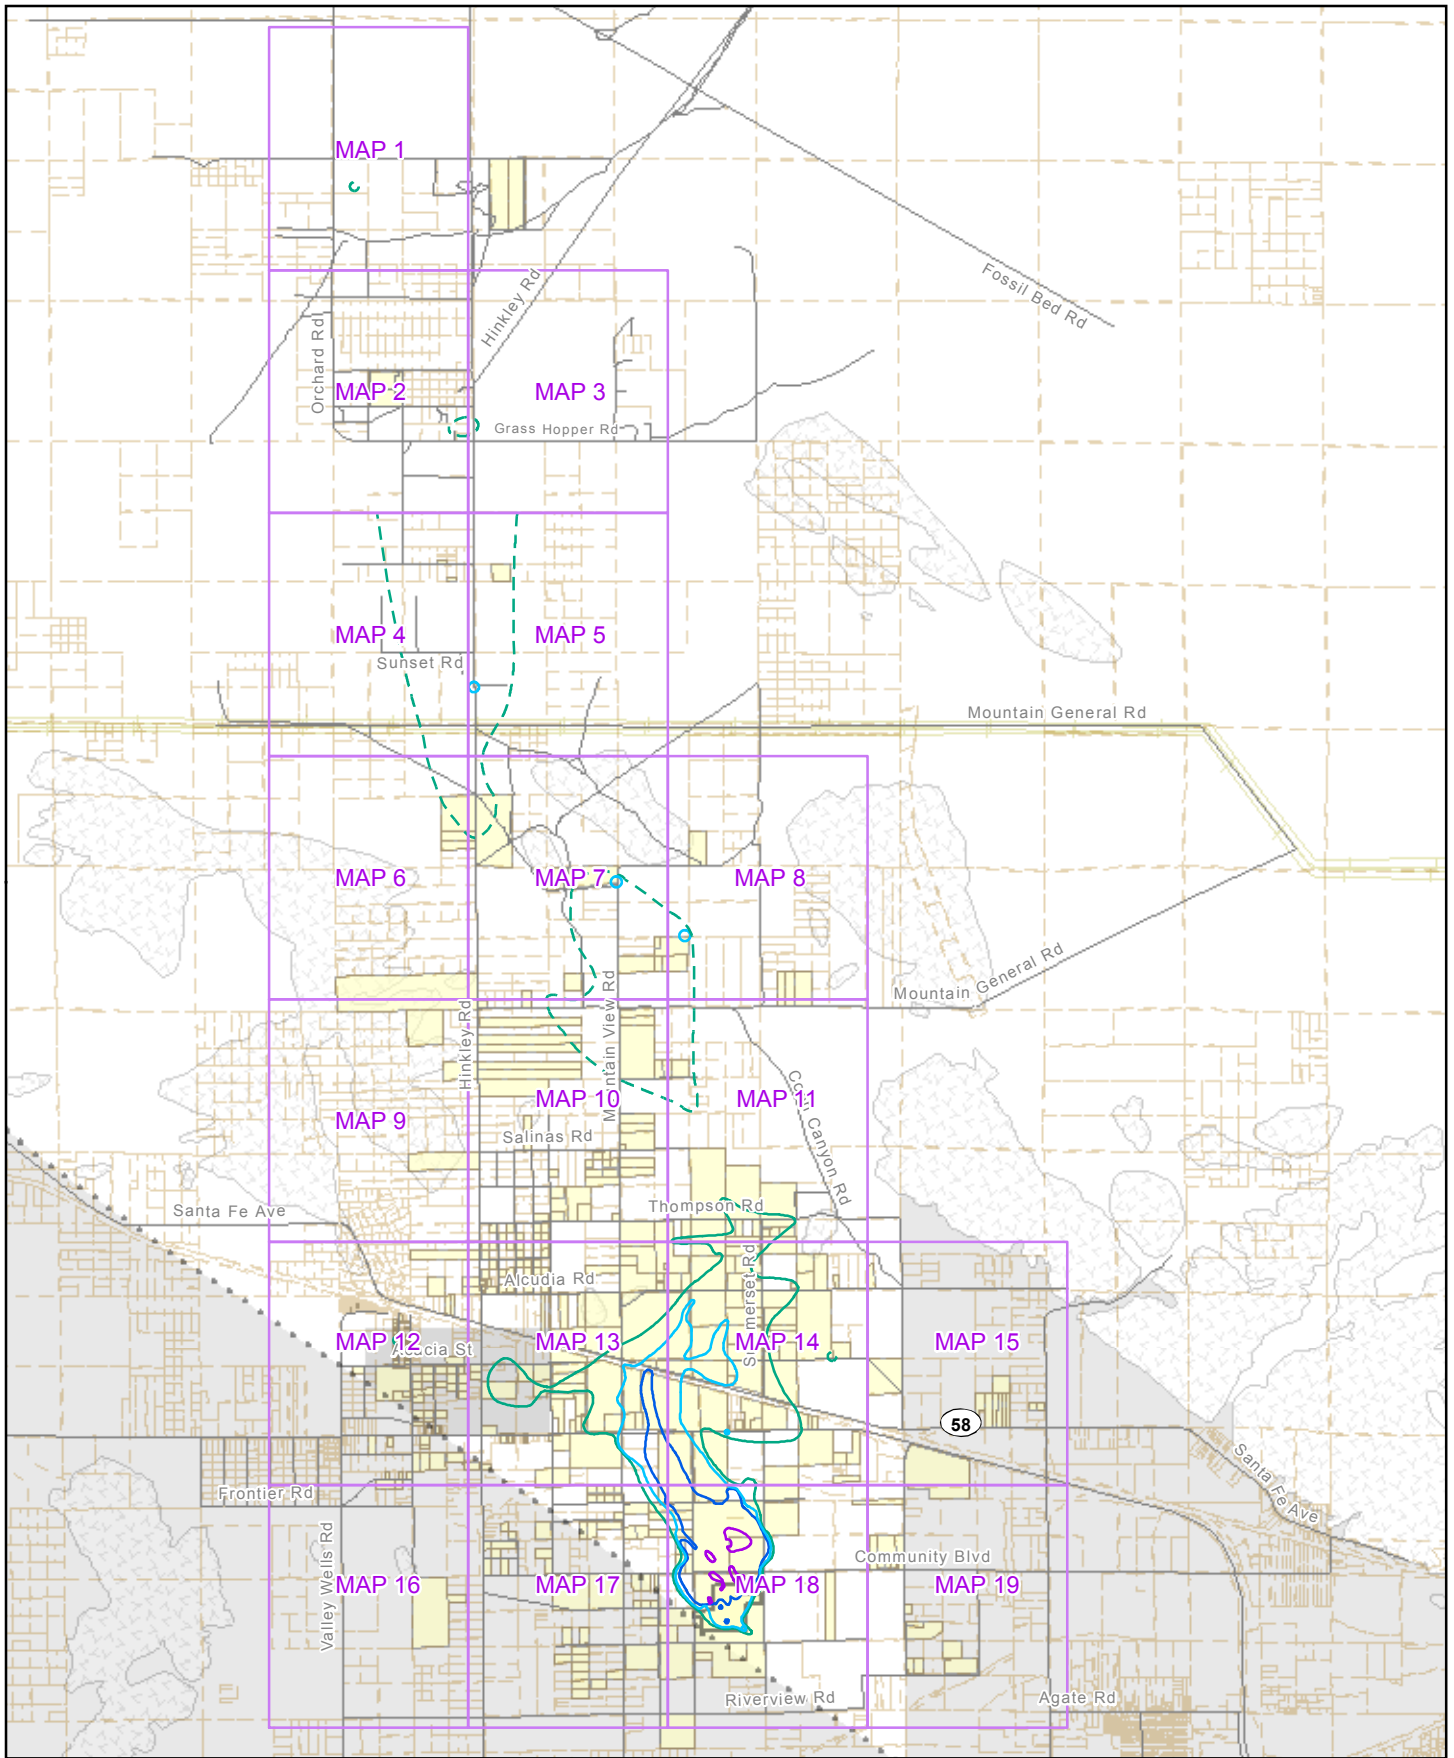
1. Chromium results are shown for site-wide Groundwater Monitoring Program and domestic wells sampled in the Third Quarter (July through September) 2015 monitoring period. For wells sampled multiple times during the reporting period, the most recent results are shown.

2. The concentration contours are based on Third Quarter 2015 chromium results for the groundwater monitoring and extraction wells that are completed in the shallow zone and deep zone of the Upper Aquifer as noted on Figures 5-1 and 5-2. Results for domestic wells (brown-colored labels) were not used for chromium plume contouring except for those located north of Grasshopper Road, pursuant to the Lahontan Regional Water Quality Control Board's Letter Conditional Acceptance of Northern Areas Investigation Proposal dated February 26, 2014.

3. Pursuant to the Lahontan Regional Water Quality Control Board's letter *Review of Chromium Plume Maps, Third Quarter 2013 Groundwater Monitoring Report and Agreement with Northern Investigation Concept* dated December 12, 2013, groundwater monitoring wells are not used for chromium contouring if they are located in the areas southwest of the Lockhart Fault and on or east of Dixie Road.

4. Chromium plume contouring for concentrations of 10, 50 and 1000 µg/L are completed using the more robust dataset presented in the July 15, 2015 Second Quarter 2015 Monitoring Report for the In Situ Reactive Zone and Northwest Freshwater Injection Projects and represent a composite of the shallow and deep zone contours presented therein. Select wells from that program are shown here for reference.
