Simi Valley

Waterbody: Bus Canyon Drain (tributary to Arroyo Simi)

Location: North of intersection at 5th St. and Los Angeles Ave. (34°16′18.59"N, 118°47′1.51"W) **Pros:** Likely well-defined rating table, located

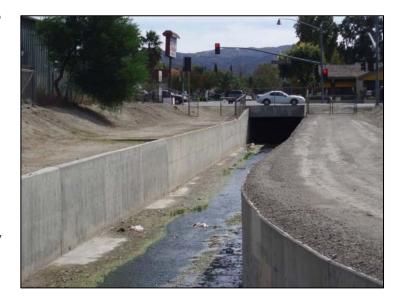
behind VCWPD gate

Cons: Pedestrian traffic on levee nearby
