ENHANCED WATERSHED MANAGEMENT PROGRAM (EWMP) FOR NORTH SANTA MONICA BAY COASTAL WATERSHEDS

Submitted to:
Los Angeles Regional Water Quality Control Board

Submitted by:
North Santa Monica Bay Coastal Watersheds EWMP Group

March 2016

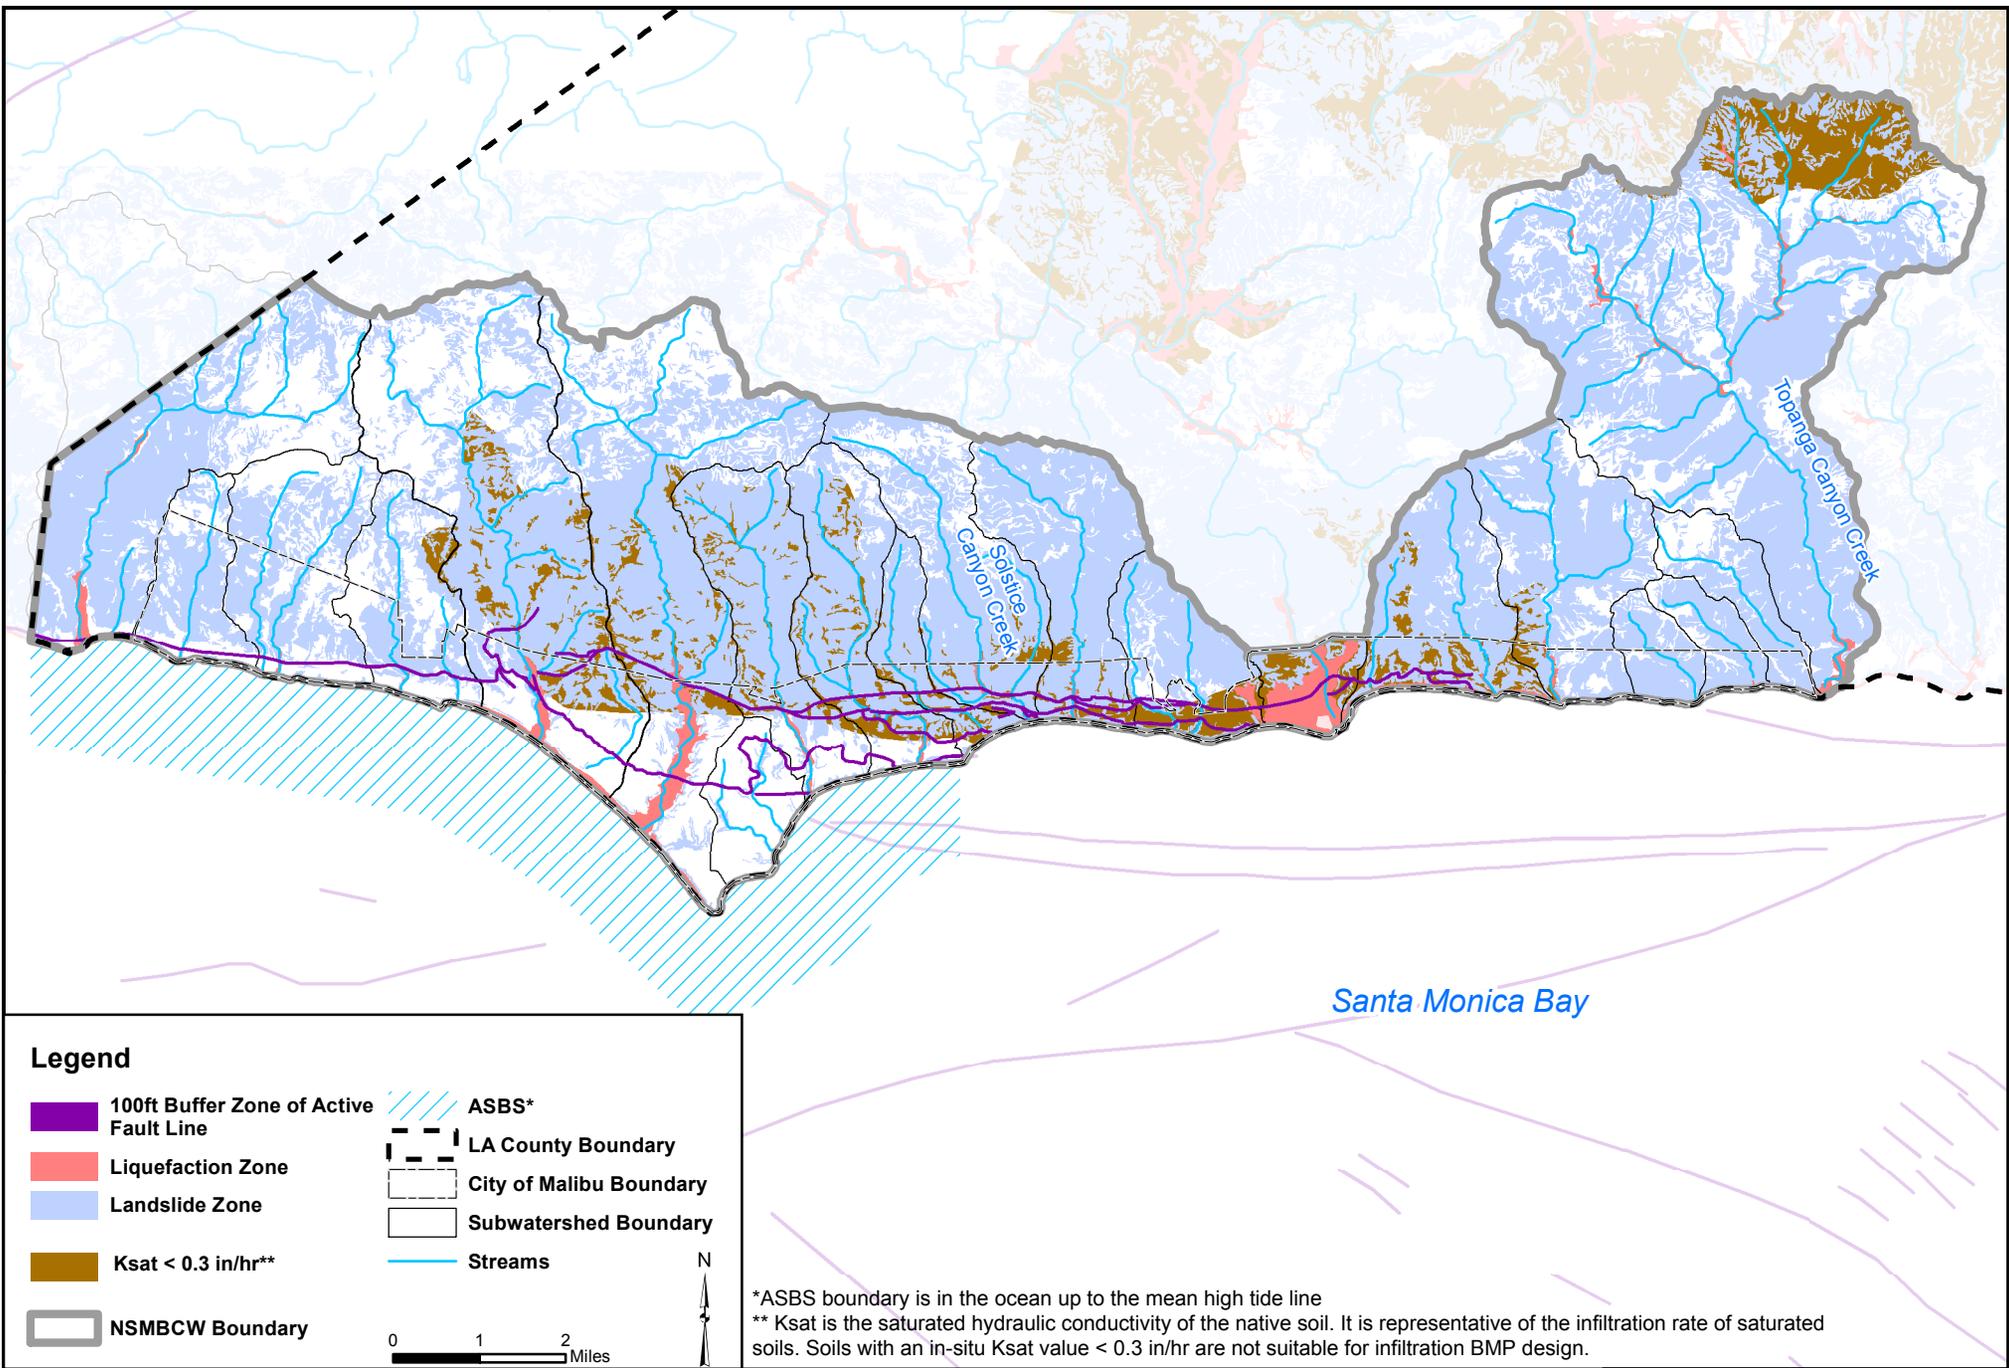
**Figure 2. NSMBCW Geologic Conditions
NSMBCW EWMP**

Based on the SBPAT geodatabase, **Figure 2** presents a general overview of soil conditions and geologic hazards that serve as an impedance to large-scale infiltration within the NSMBCW EWMP Area. When coupled with developed conditions near the ocean and lack of undeveloped, publicly owned parcels near storm drains, the opportunity for implementation of infiltration projects within the EWMP Area becomes severely limited. Additional discussion of this conclusion is provided in Section 5.2.1.

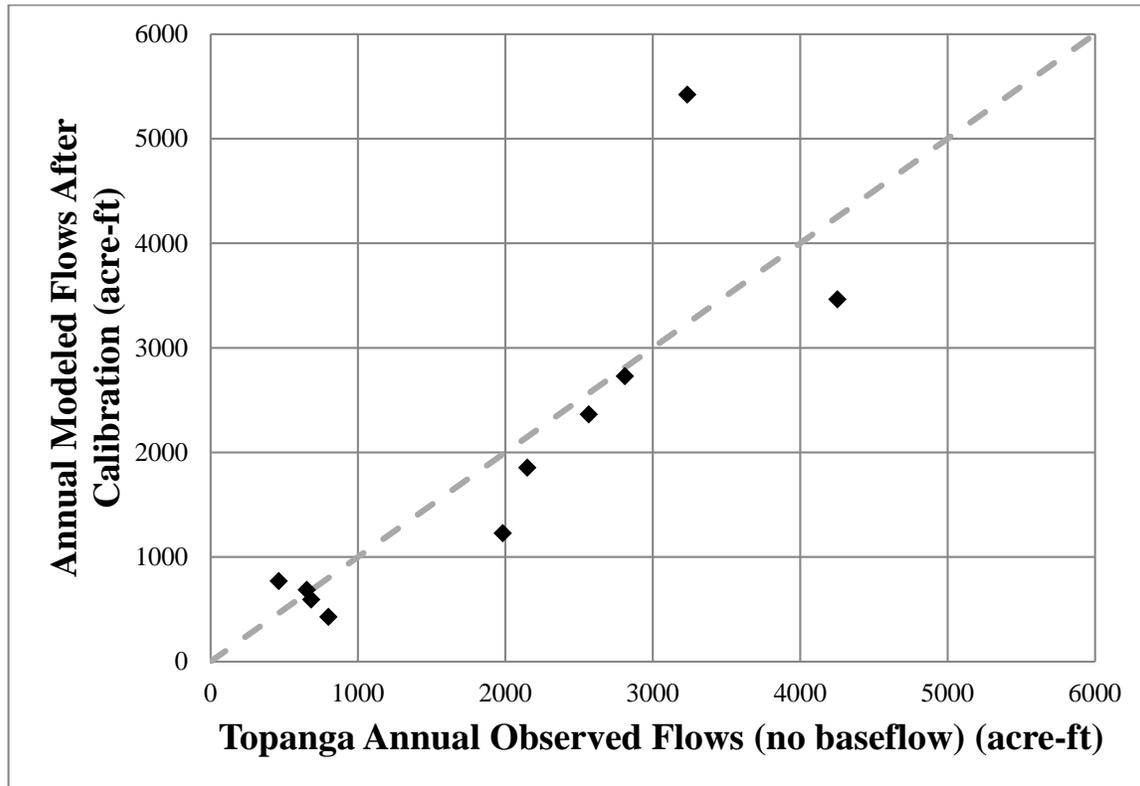
Figure 11. Annual Runoff Volumes for Topanga Subwatershed: Modeled vs. Observed, 2001-2012

results.²¹ These calibrated input parameter values were used throughout all SMB watersheds in the wet weather RAAs. Figure 12 presents these same results in a flow duration curve format, which compares the distribution of annual discharge volume magnitudes throughout the period analyzed between the modeled and observed data.

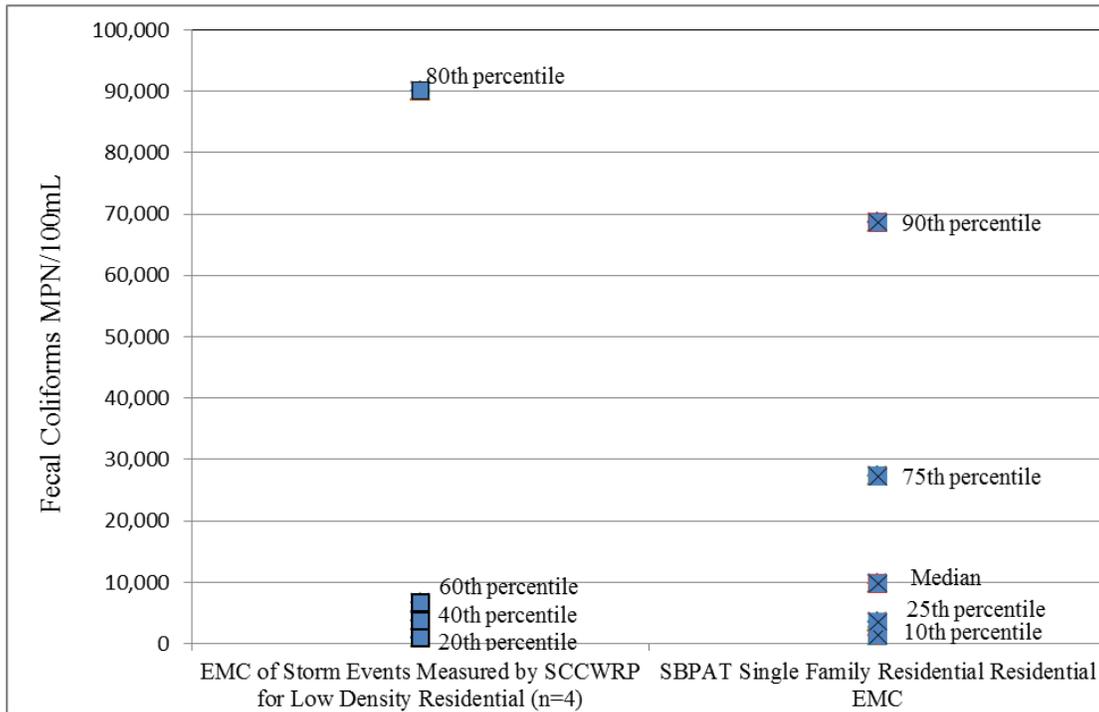
found for each modeled pollutant in **Appendix C**. Modeled EMC values are consistent with the recommended values for land use-specific loading in Table 3.3 of the RAA Guidelines.²² In the future, as new local monitoring data become available, EMCs may be reevaluated as part of the EWMP adaptive management process.

Figure 13. Comparison of Fecal Coliform Low Density Residential EMC Values Between SCCWRP Measurements (n=4) and SBPAT Modeled Values (a full log distribution is used by the model, but non-parametric summary statistics are shown for comparison)

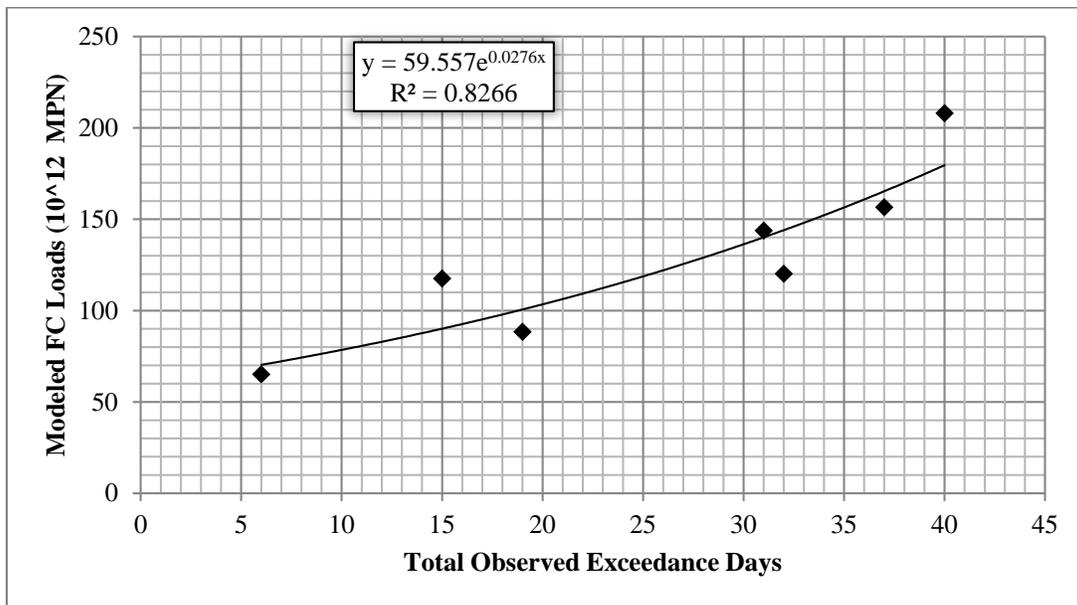
A second methodology validation step was performed to demonstrate that modeled annual fecal coliform loads are indeed predictive of the compliance metric, or annual exceedance days for all fecal indicator bacteria. For bacteria modeling, verifying the linkage between modeled *fecal coliform loads* (i.e., discharged from the hypothetical subwatershed outlets) and total observed wet weather *exceedance days* (in the receiving water, based on REC1 daily maximum water quality objectives) is critical to establish reasonable assurance that compliance monitoring locations will be in compliance with the Permit limits. To establish this linkage, an analysis was conducted using shoreline monitoring data at Topanga Canyon²⁵ (SMB 1-18) between 2005 and 2013. **Figure 14** illustrates a reasonable correlation between total modeled annual fecal coliform loads and total annual observed wet weather exceedance days. Each point shown represents one single Model Year.

Figure 14. Correlation between Modeled Fecal Coliform Loads and Observed Exceedance Days, 2005-2013

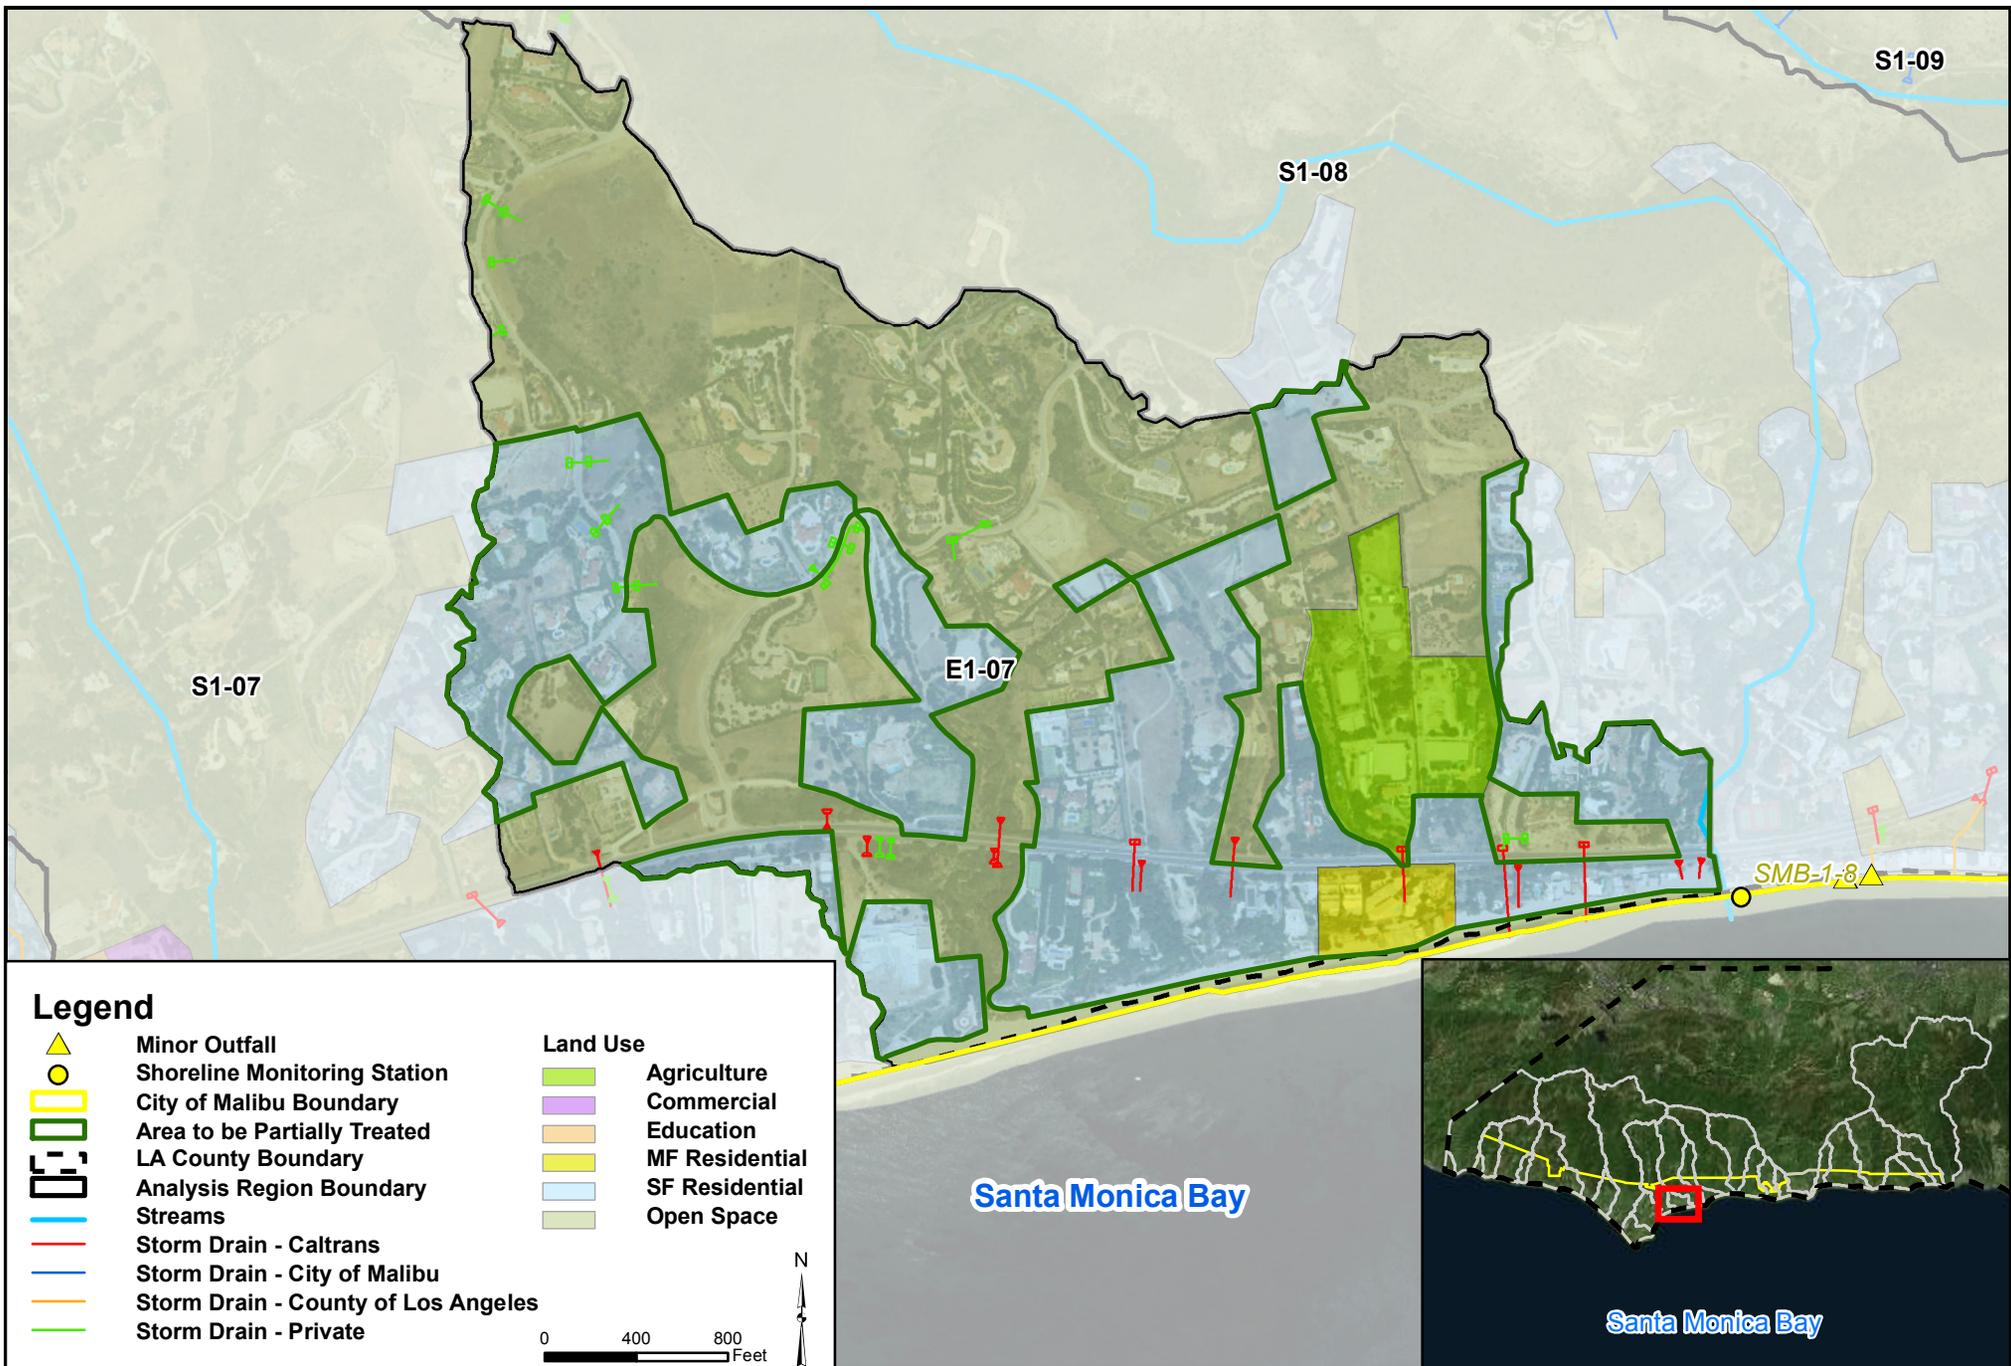
**Figure 16. East of Ramirez Creek at Paradise Cove (Analysis Region E1-07)
Area to be Treated by Distributed BMPs (35% of Area Outlined in Green)
NSMBCW EWMP**

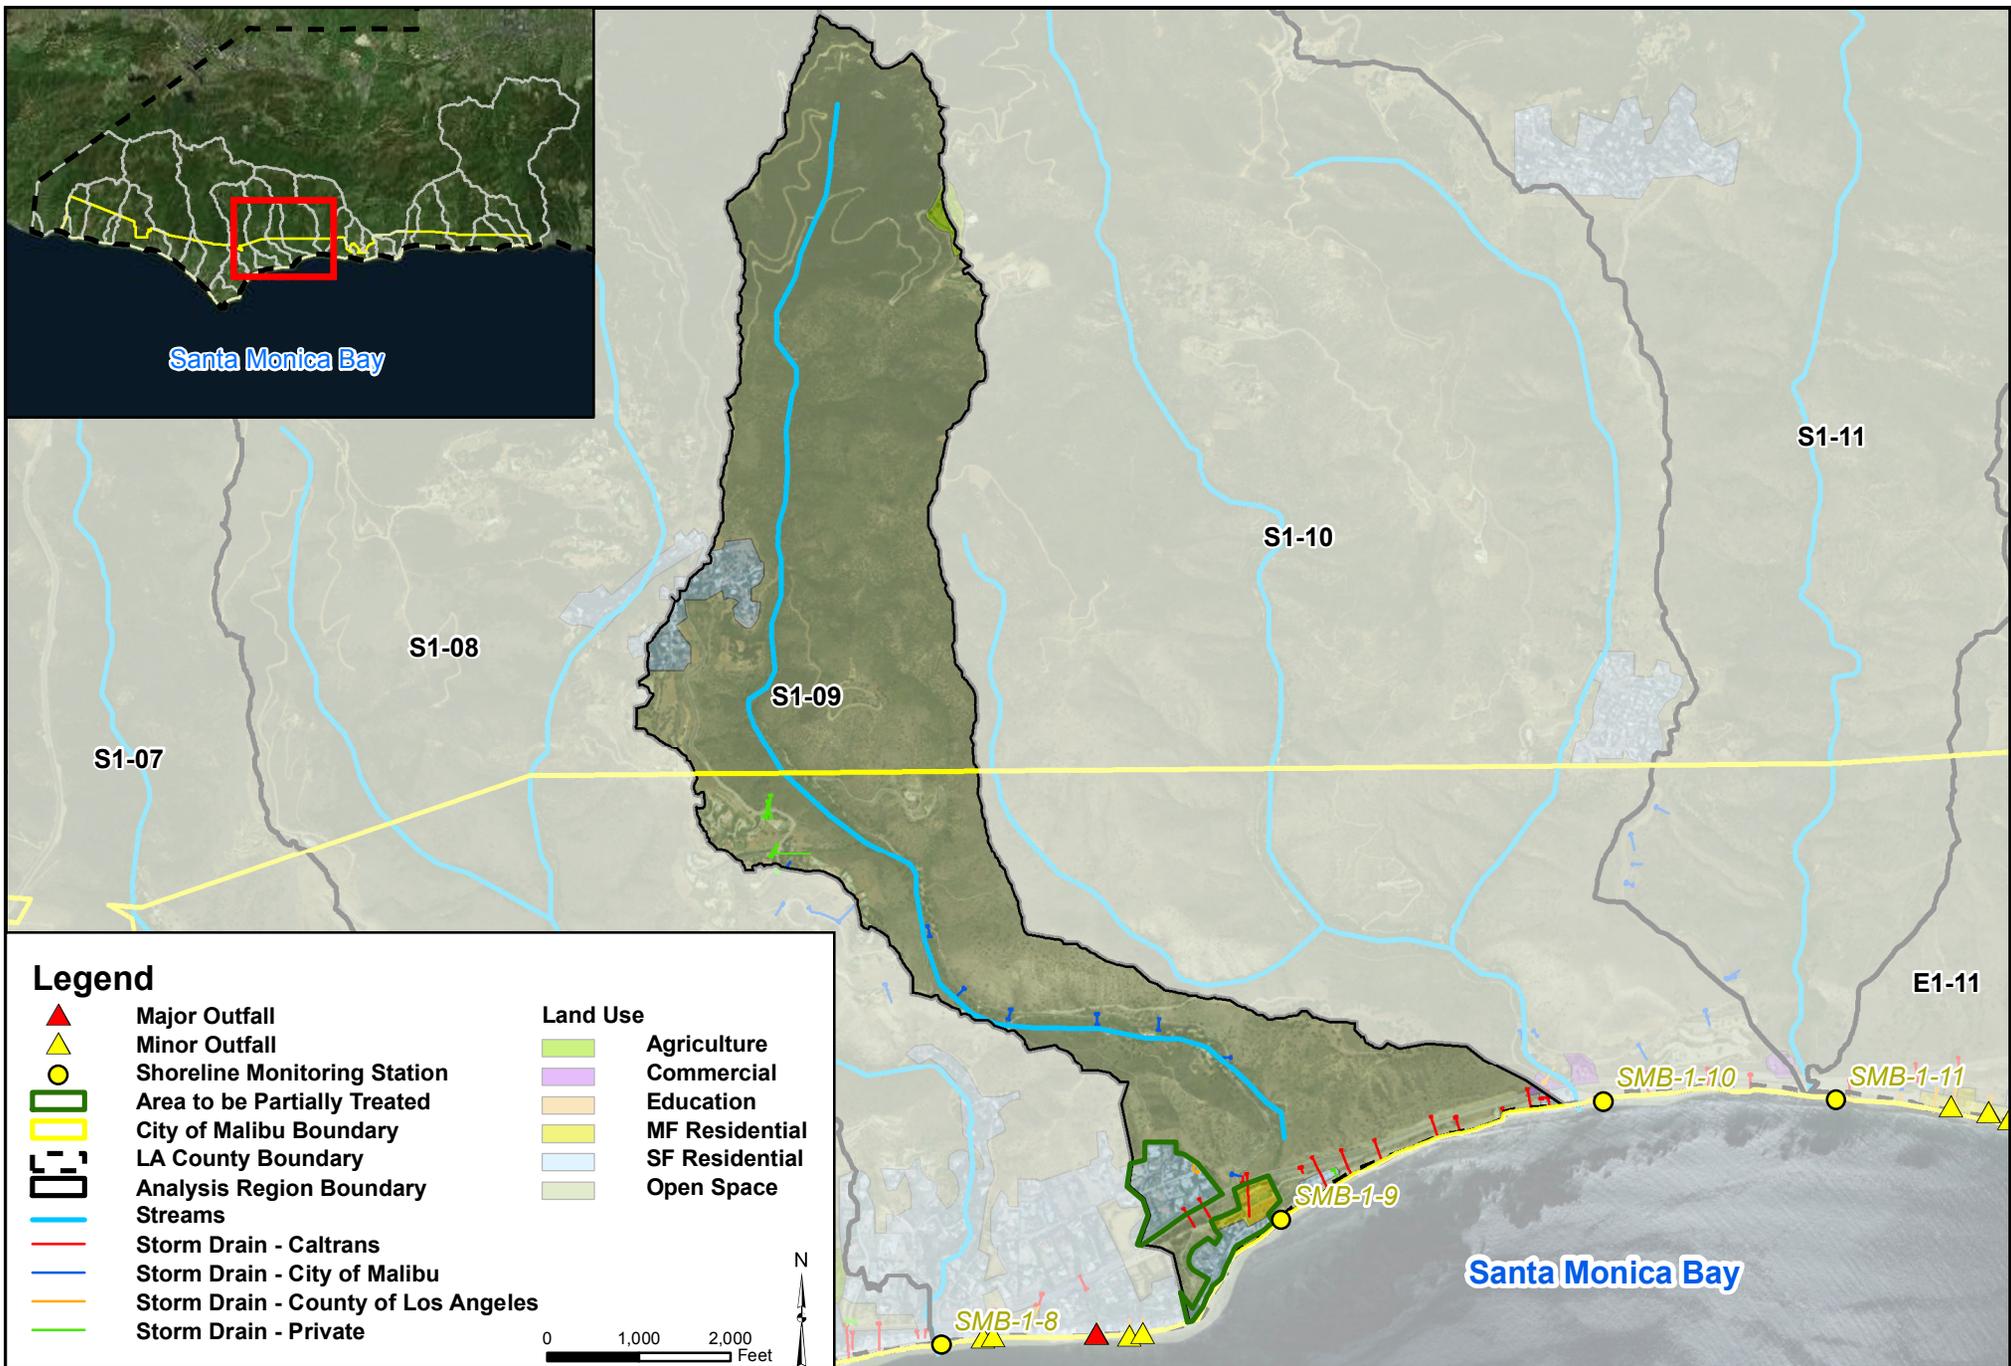
Figure 17. Latigo Canyon (Analysis Region S1-09)
Area to be Treated by Distributed BMPs (15% of Area Outlined in Green)
NSMBCW EWMP

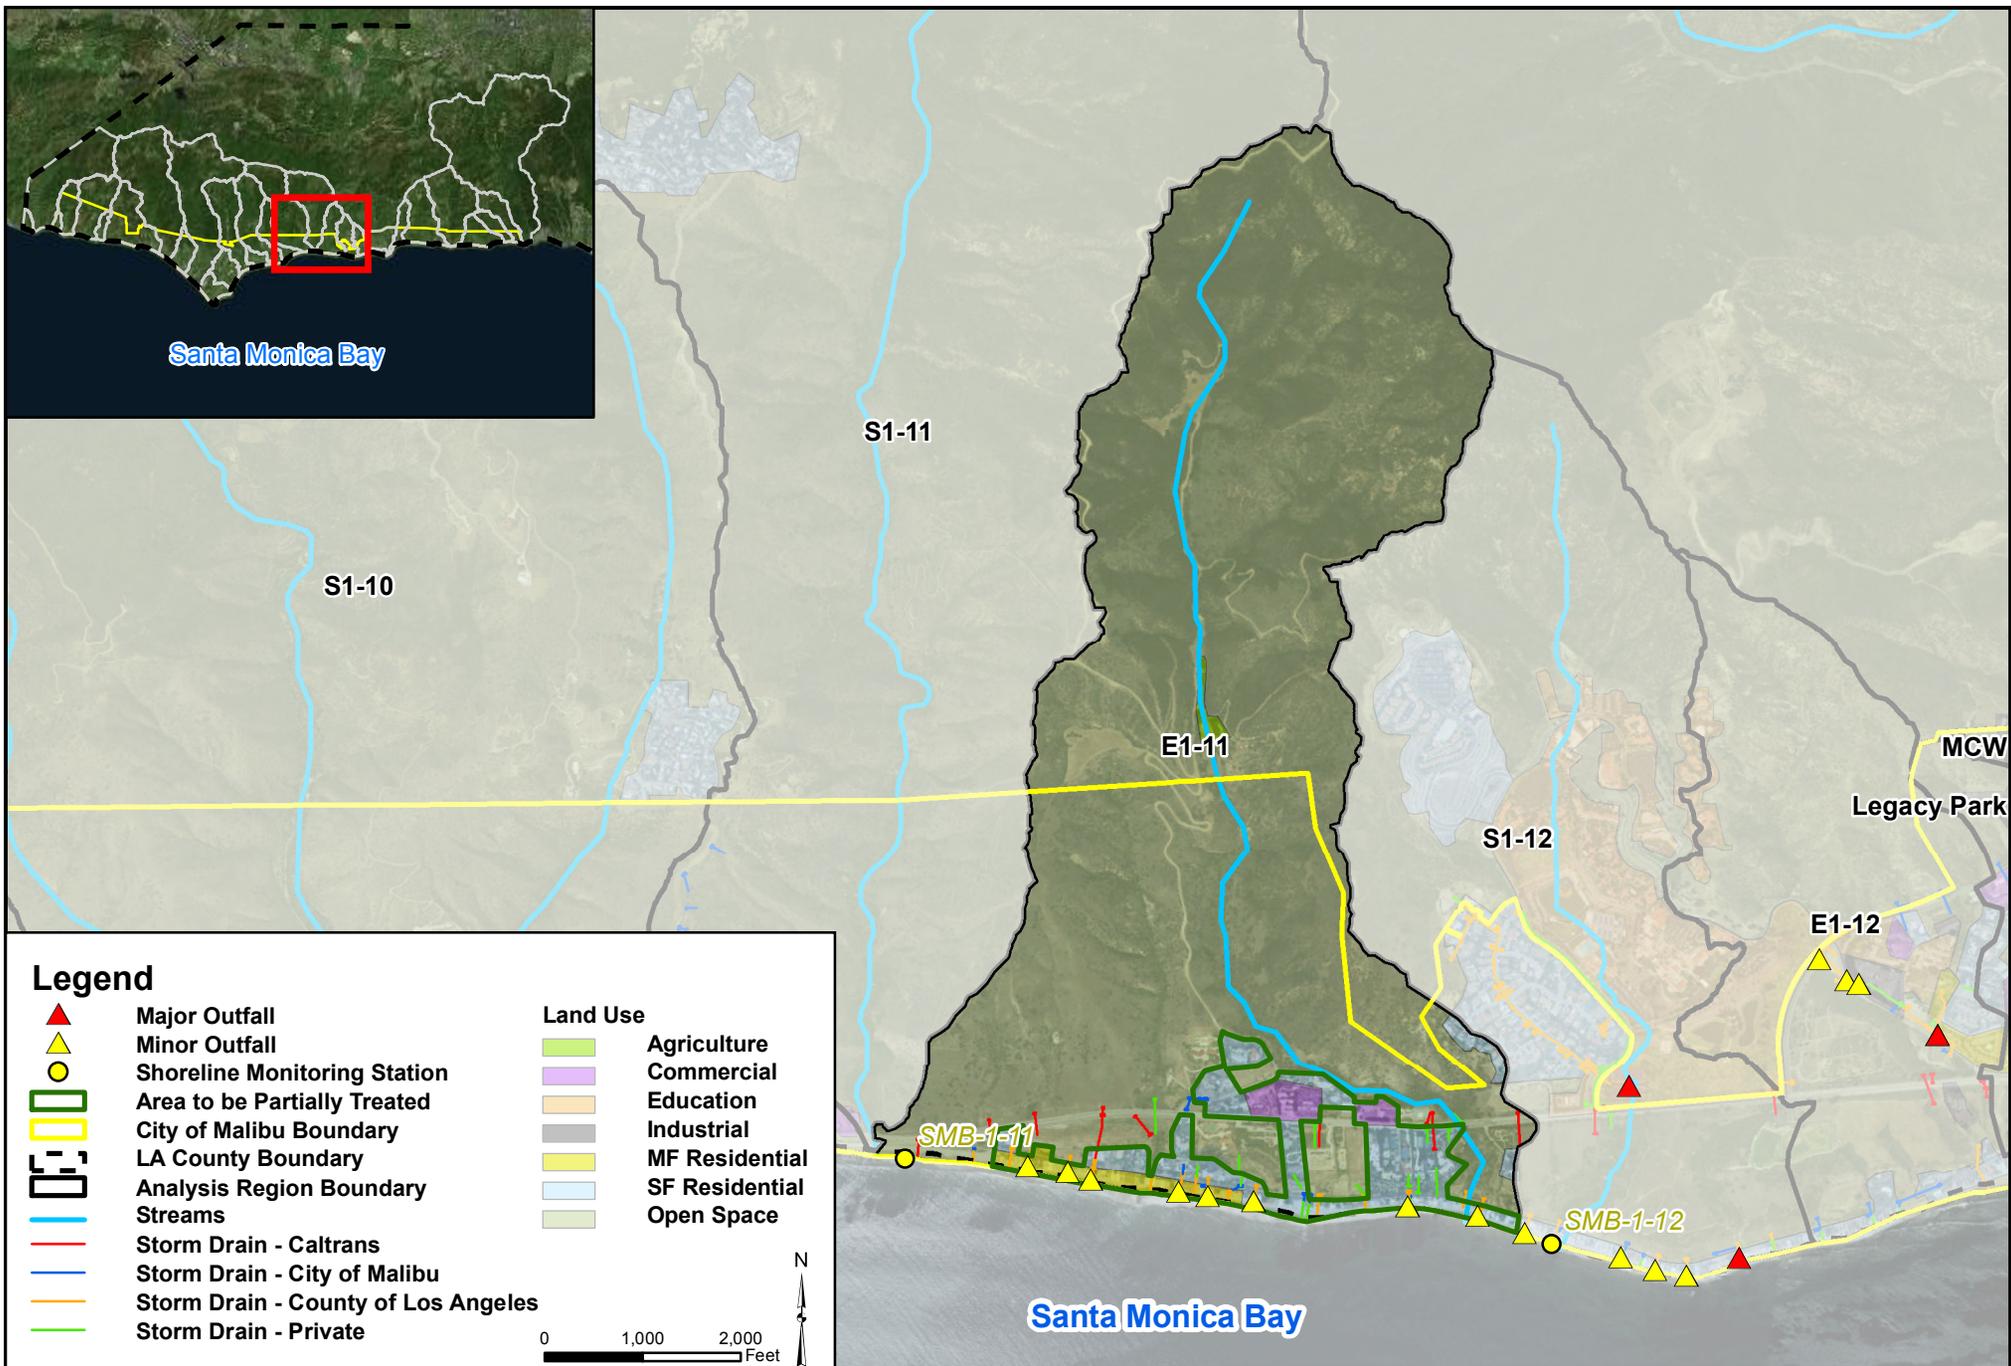
**Figure 18. East of Corral Canyon Creek (Analysis Region E1-11)
Area to be Treated by Distributed BMPs (20% of Area Outlined in Green)
NSMBCW EWMP**

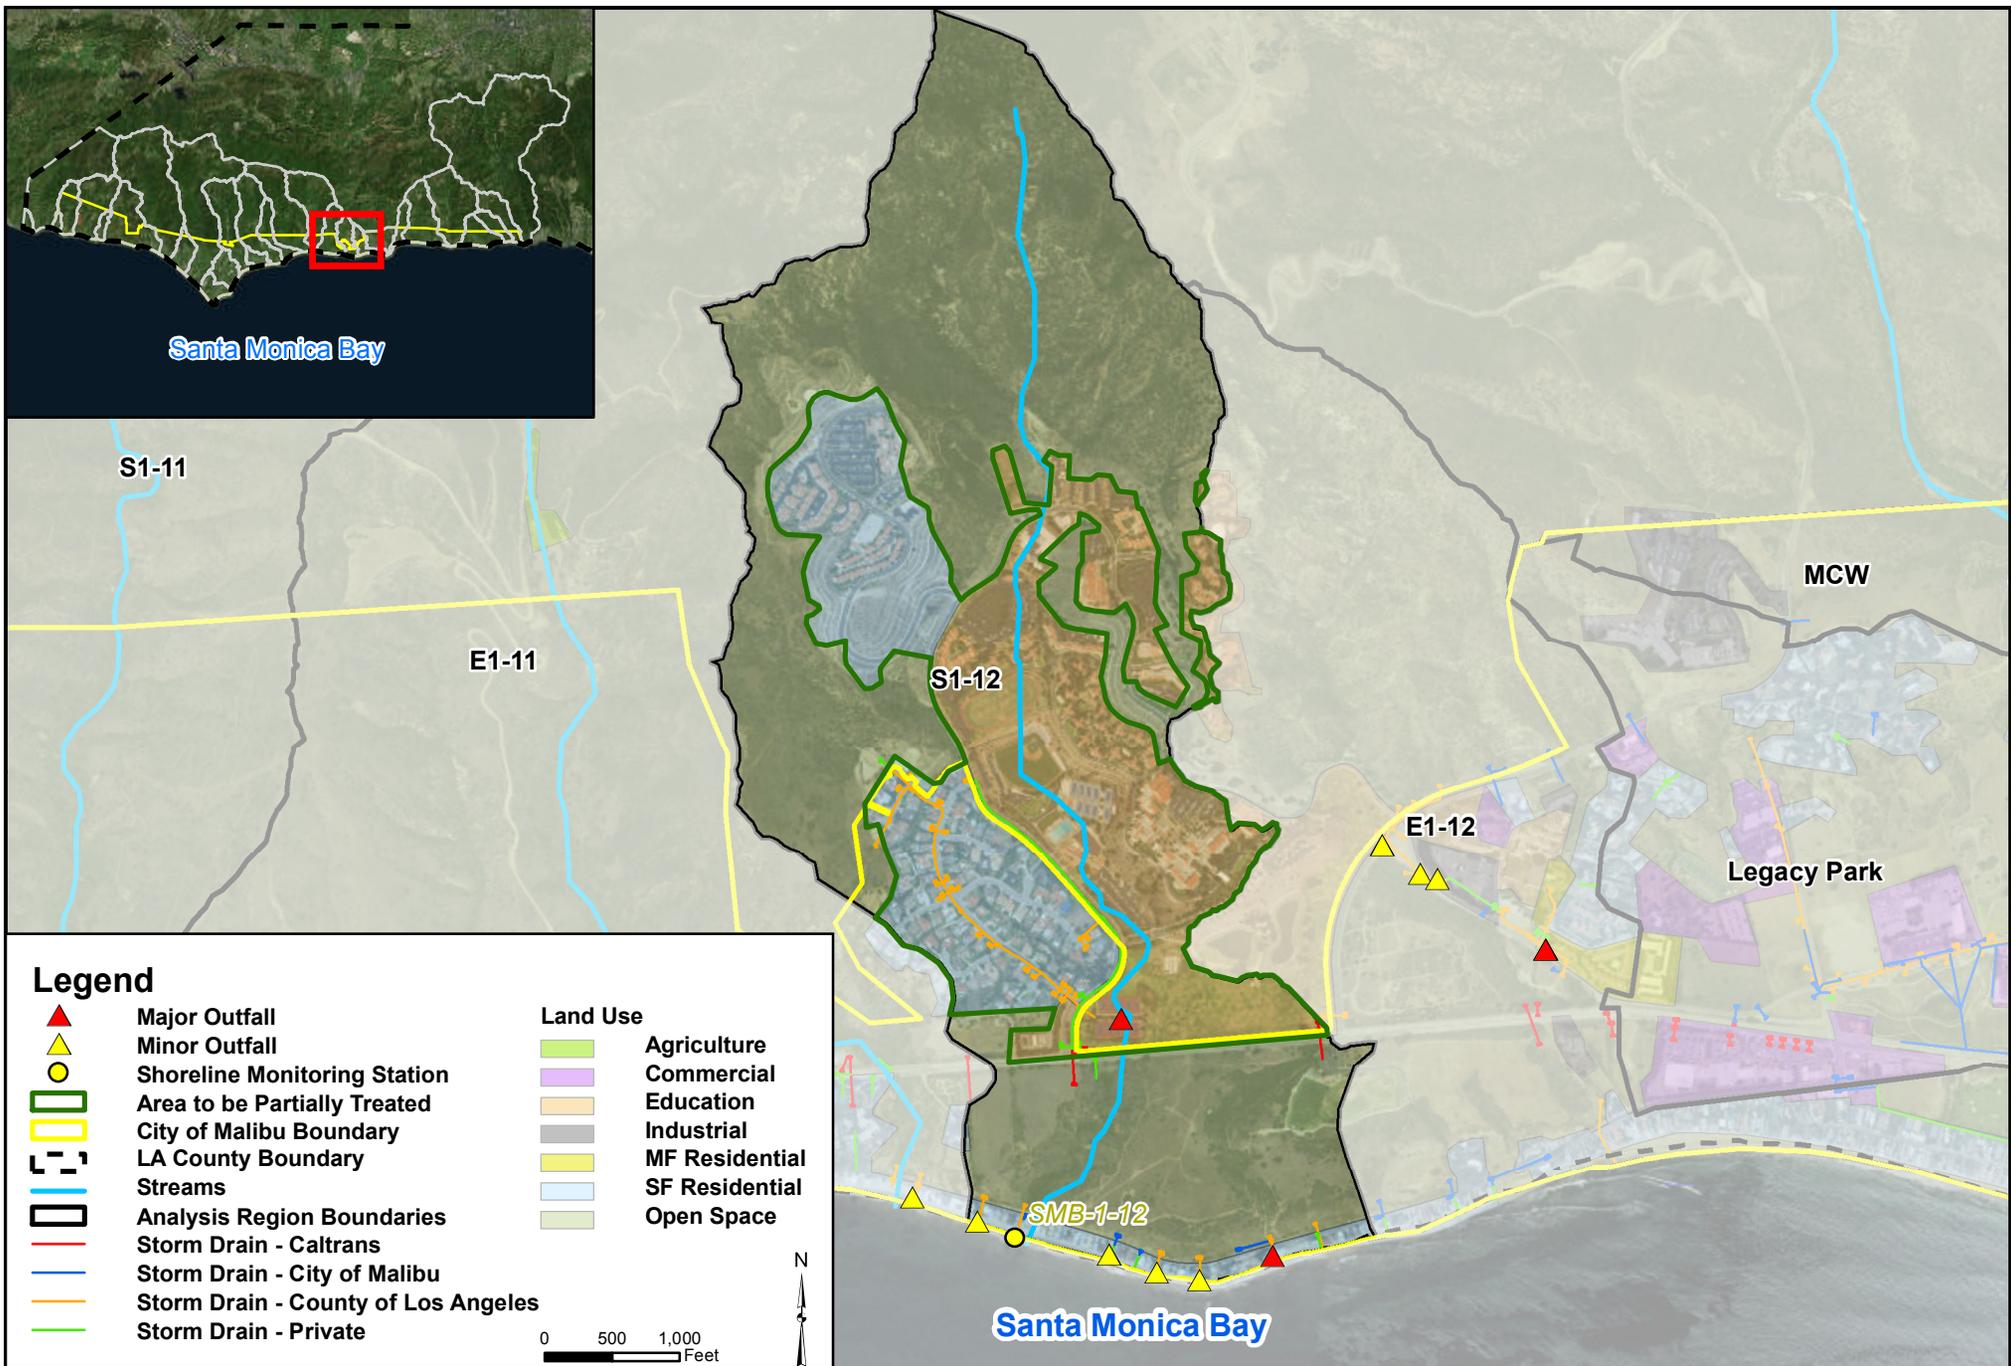
**Figure 19. Marie Canyon at Puerco Beach (Analysis Region S1-12)
Area to be Treated by Distributed BMPs (55% of Area Outlined in Green)
NSMBCW EWMP**

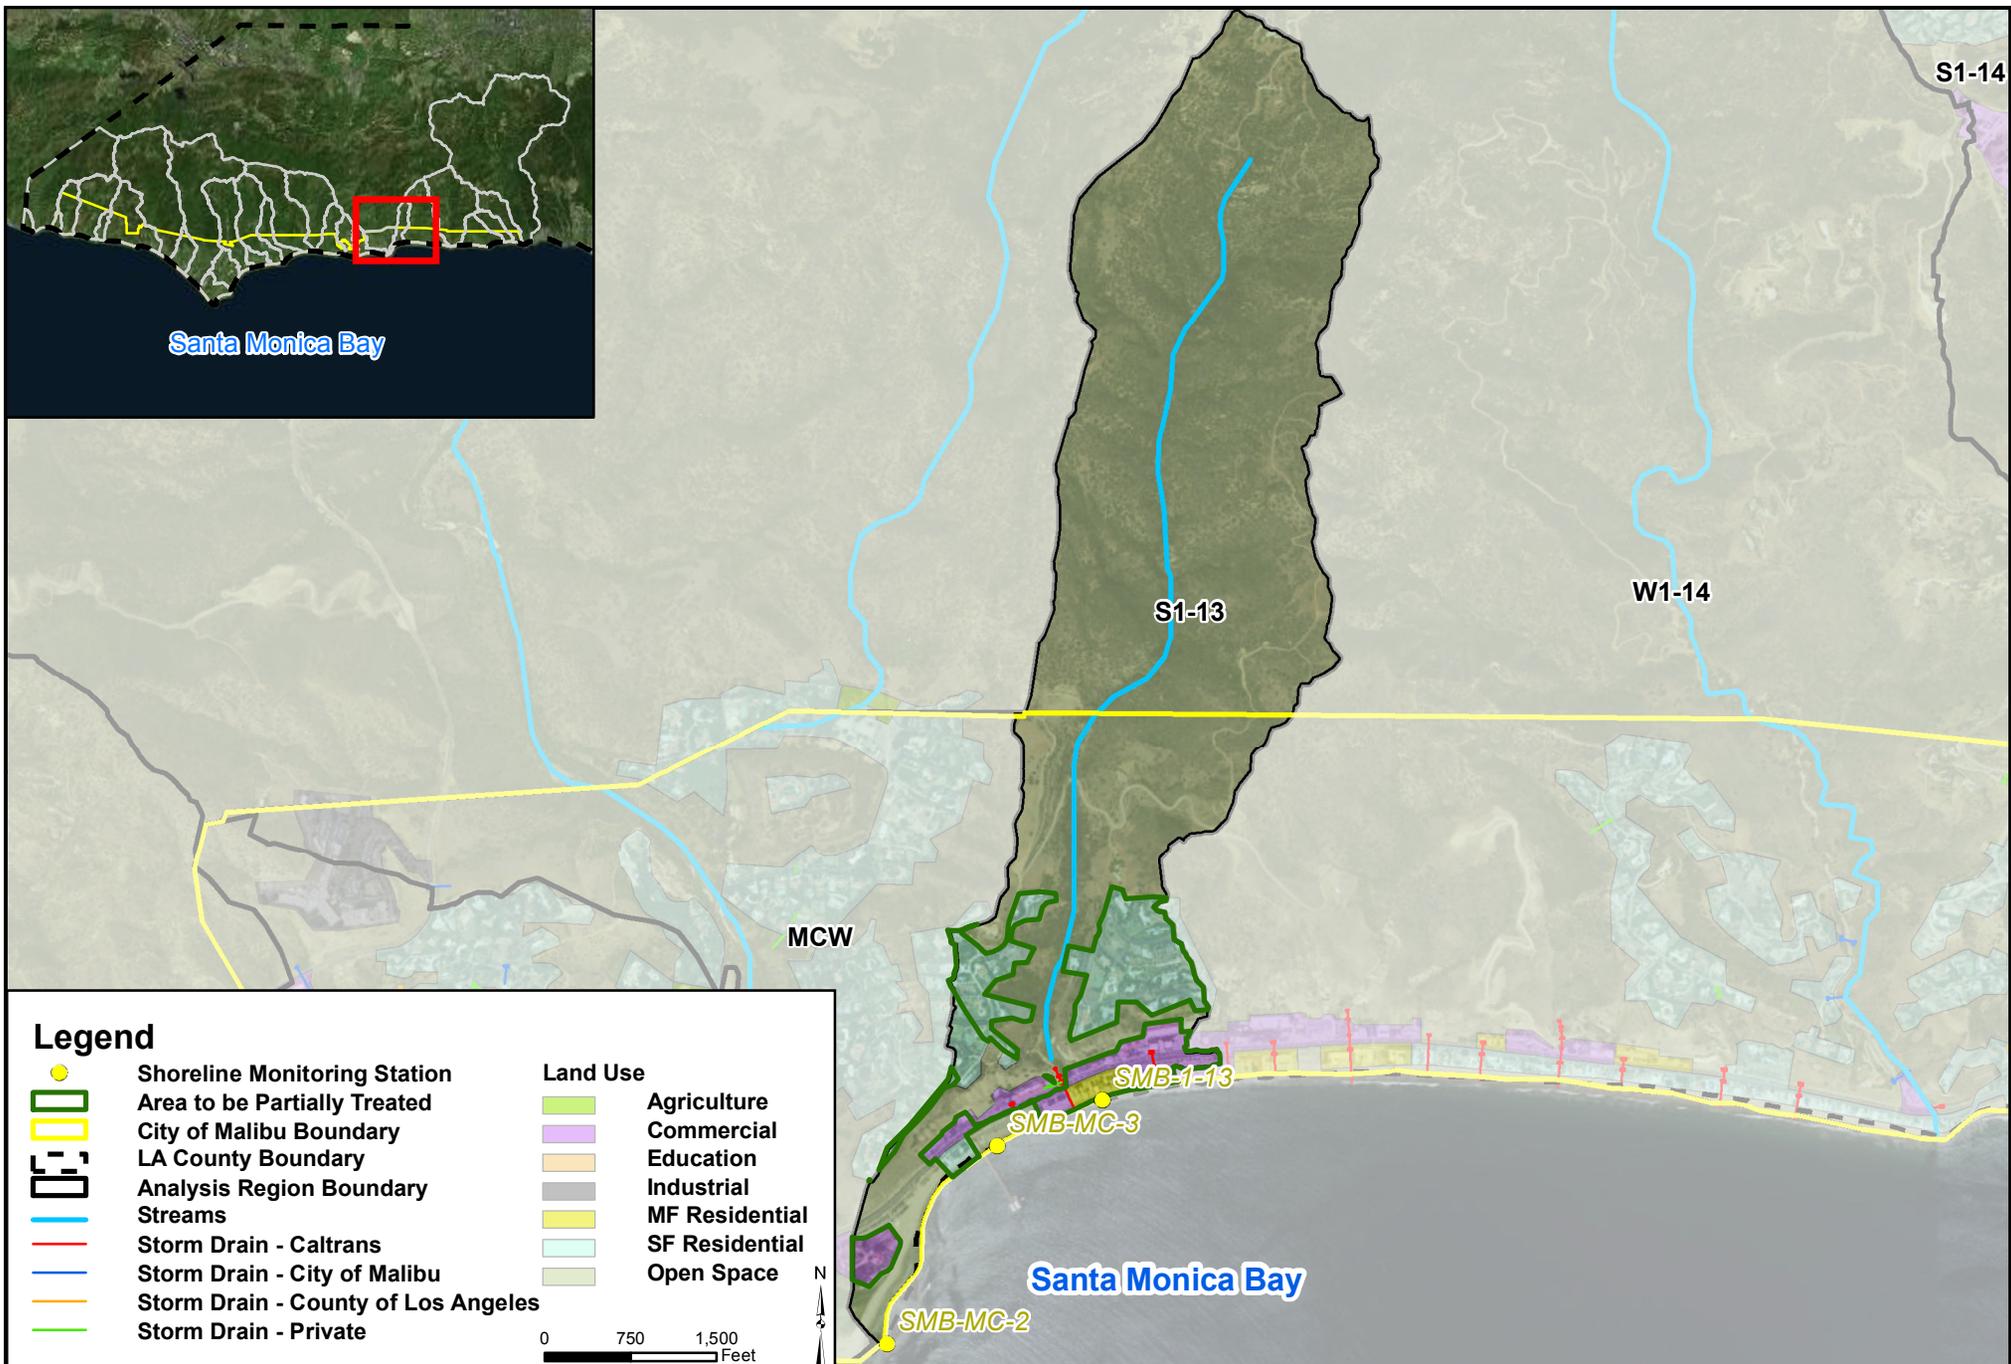
**Figure 21. Sweetwater Creek at Carbon Beach (Analysis Region S1-13)
 Area to be Treated by Distributed BMPs (10% of Area Outlined in Green)
 NSMBCW EWMP**

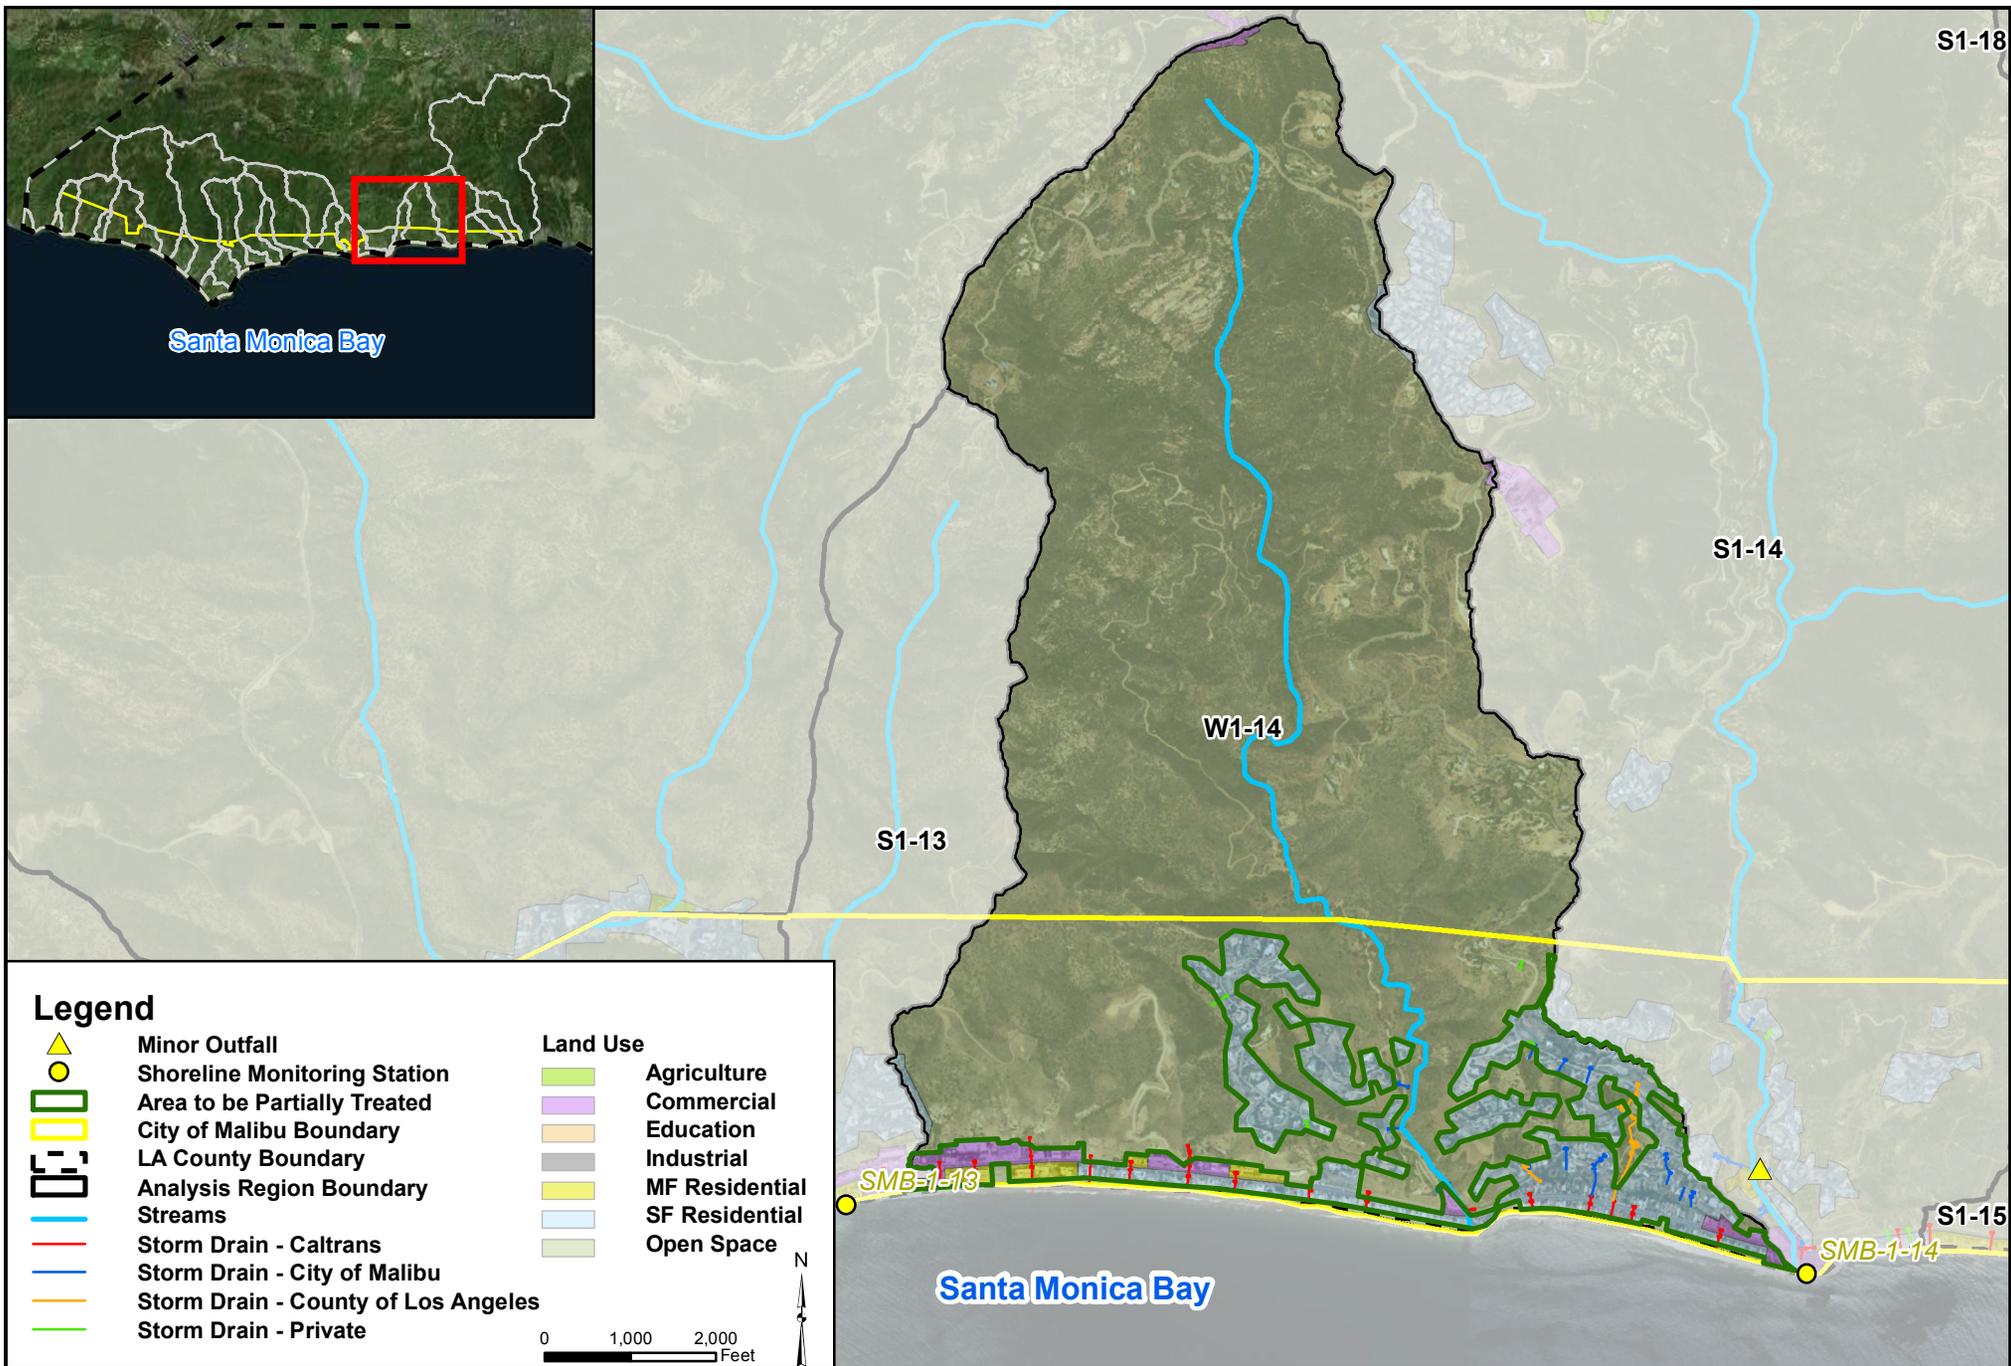
**Figure 22. West of Las Flores Creek (Analysis Region W1-14)
Area to be Treated by Distributed BMPs (15% of Area Outlined in Green)
NSMBCW EWMP**
