ENHANCED WATERSHED MANAGEMENT PROGRAM (EWMP) FOR NORTH SANTA MONICA BAY COASTAL WATERSHEDS

Submitted to:
Los Angeles Regional Water Quality Control Board

Submitted by:
North Santa Monica Bay Coastal Watersheds EWMP Group

March 2016

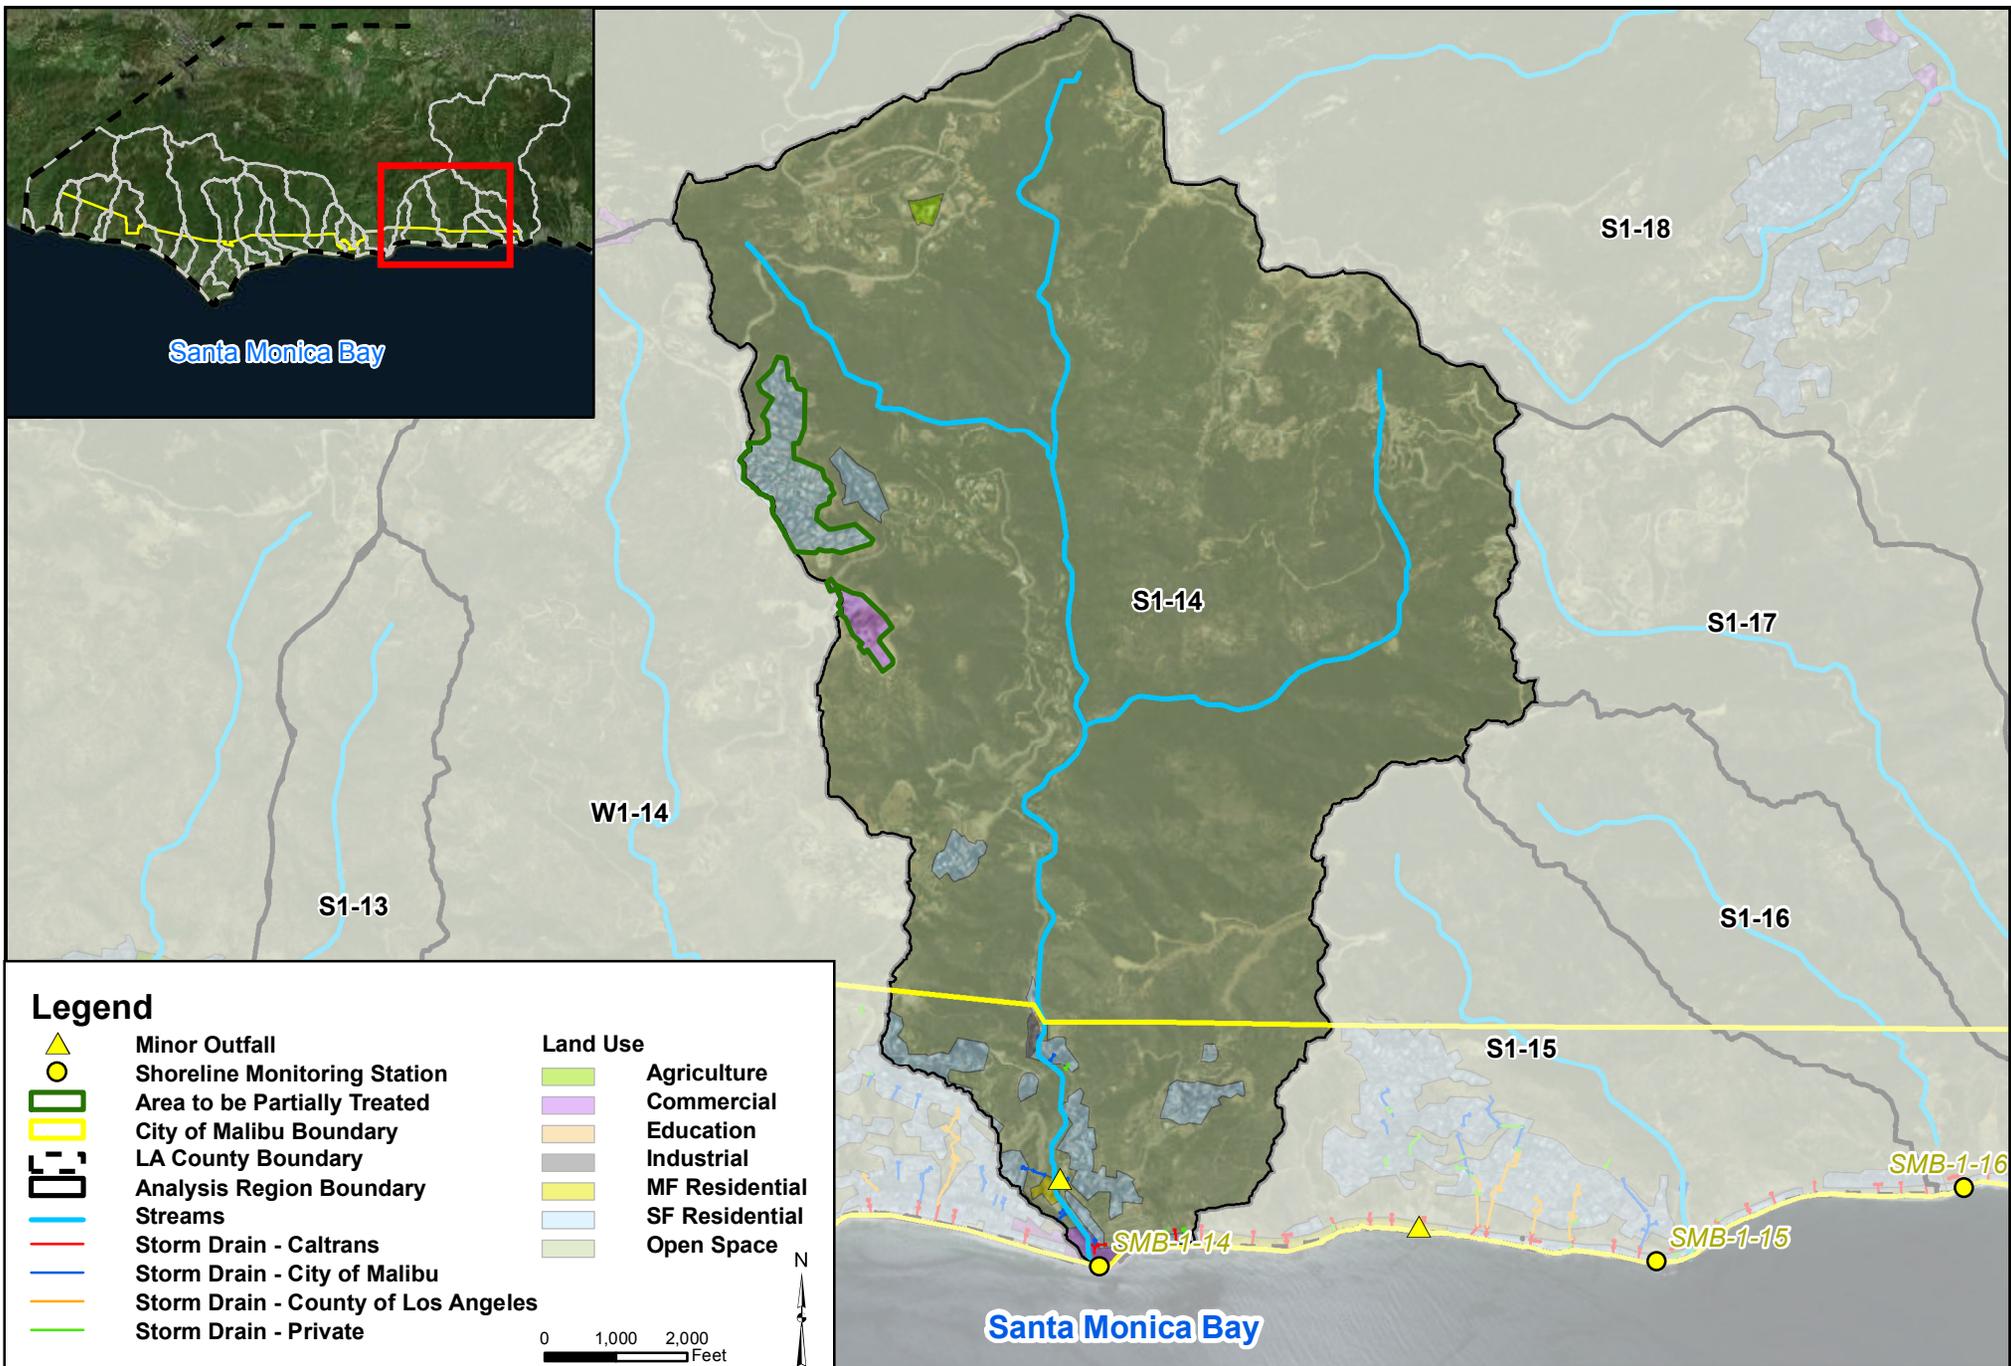
Figure 23. Las Flores Creek (Analysis Region S1-14)
Area to be Treated by Distributed BMPs (10% of Are Outlined in Green)
NSMBCW EWMP

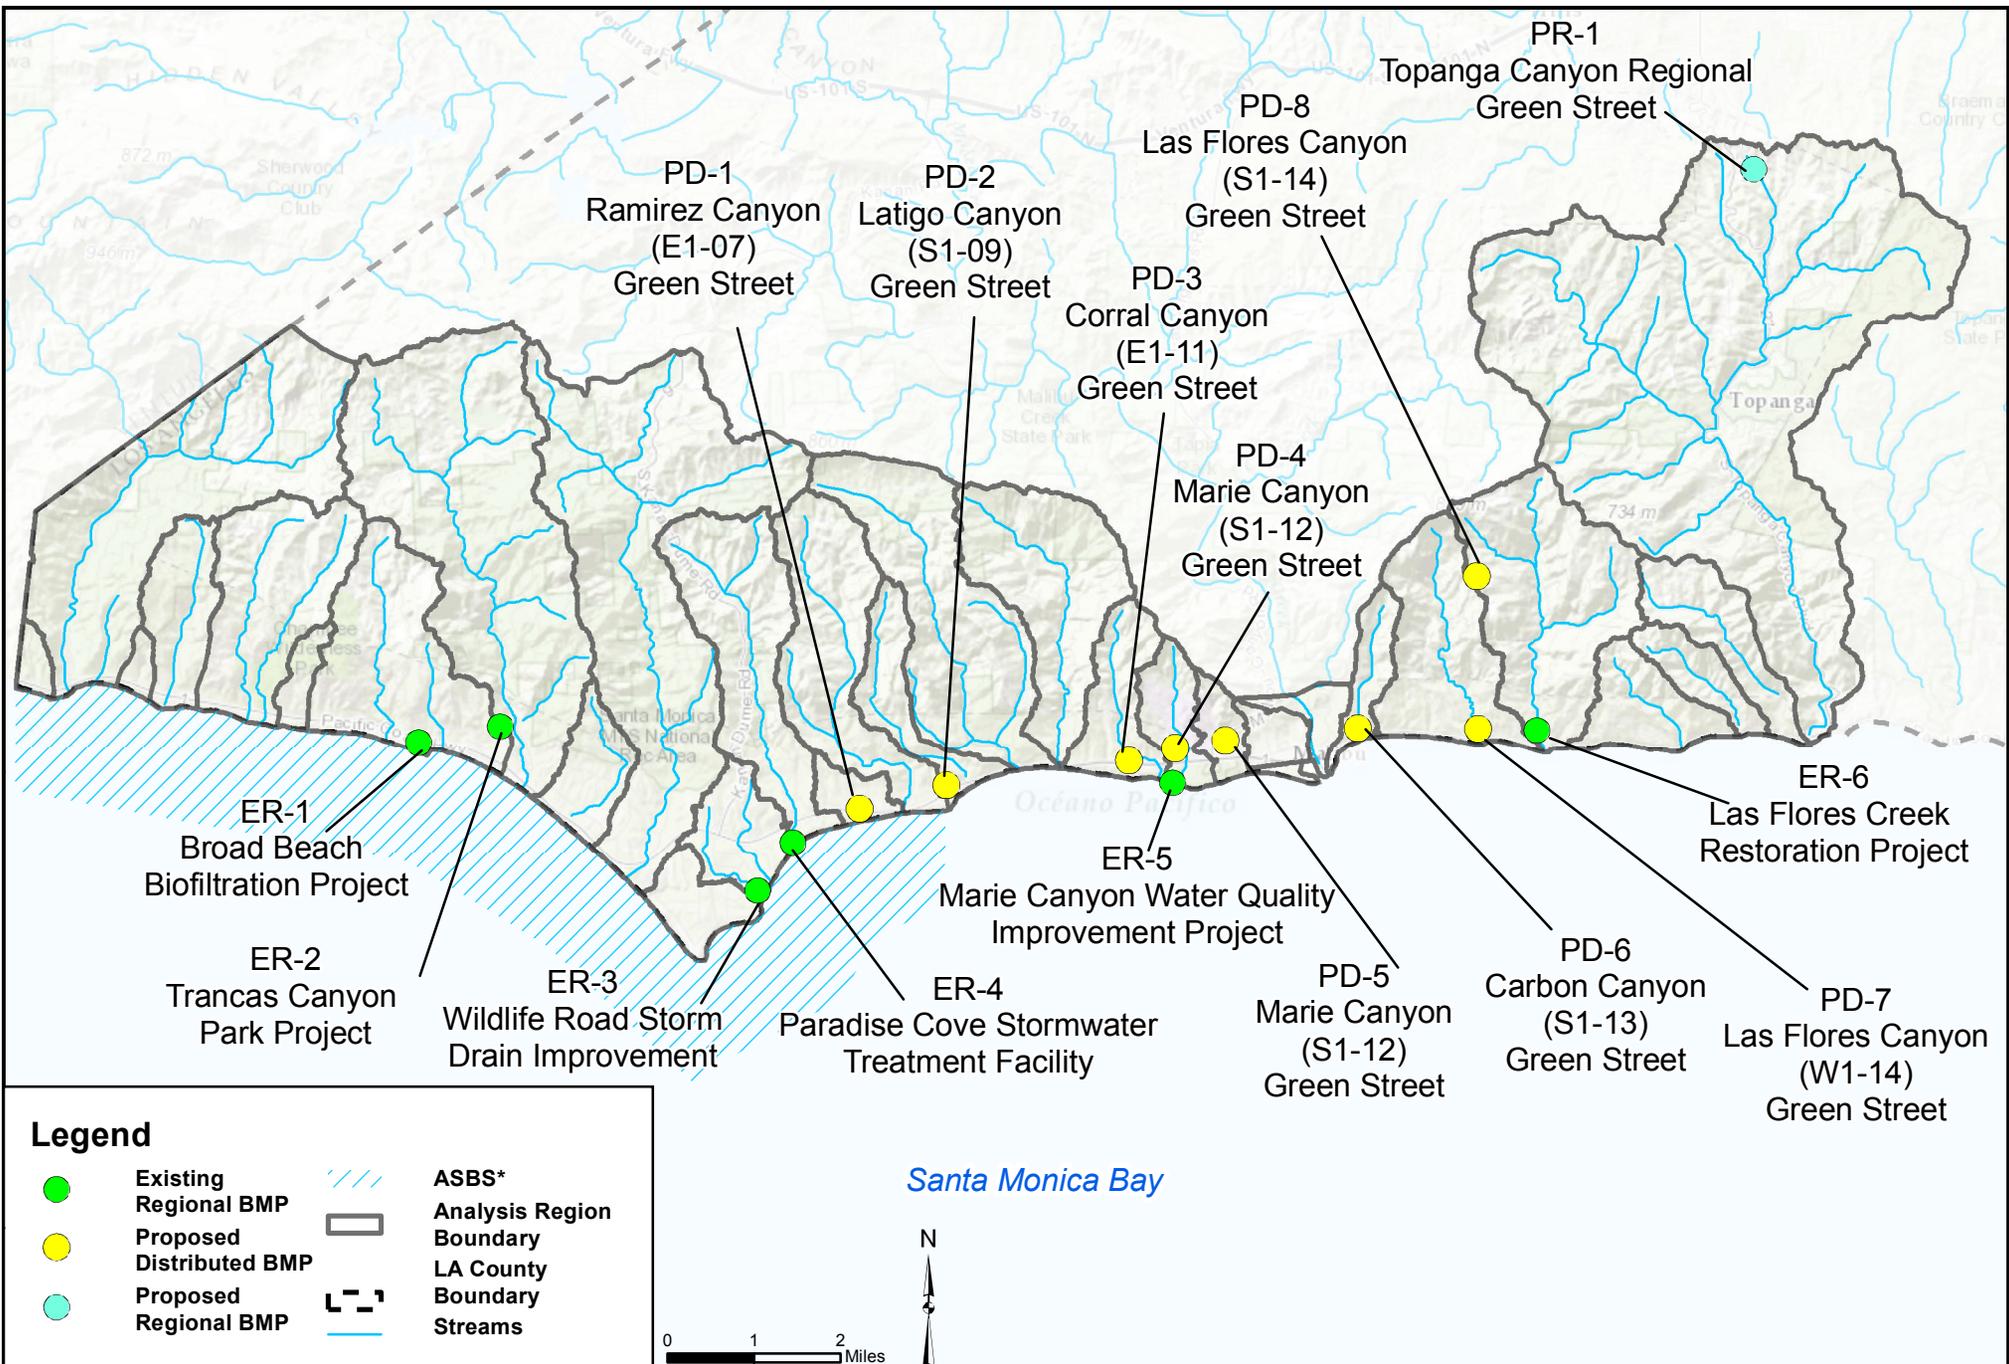
Figure 24 shows an overview of all existing and proposed structural BMPs within the SMB portion of the NSMBCW EWMP Area.

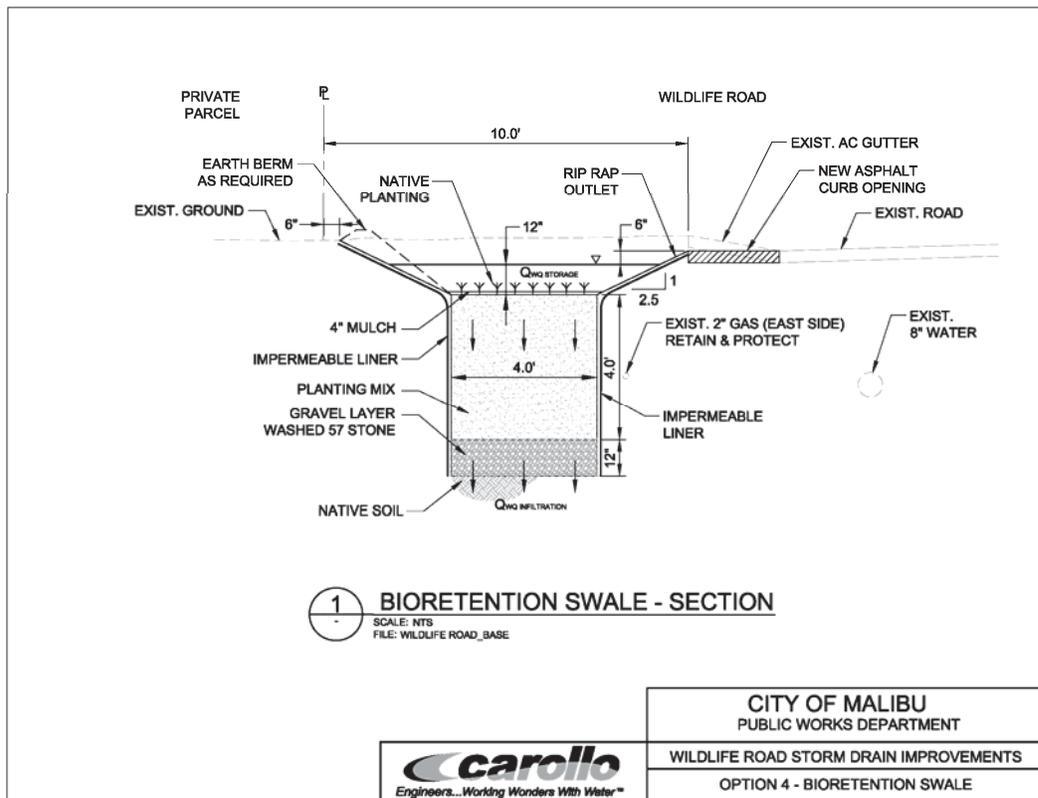
Figure 6. Typical Bioretention Swale

- Small foot print biofilters such as the Filterra™ or Bacterra™ systems, which incorporate flow-based design, smaller right of way requirements, and higher treatment capacity. A schematic of the Filterra system is provided as Figure 3.
- Bioretention swales will be constructed adjacent to the existing roadway without significant impact to the existing infrastructure (driveways, hardscape and landscaping). The bioretention swales are vegetated shallow depressions that provide above ground storage, evapotranspiration, infiltration, and hydro-modification of stormwater runoff. Runoff from the roadway will enter into the bioretention swales where the proposed vegetation will assist in removing the pollutants through plant uptake. The remaining stormwater runoff is infiltrated through the bottom of the swale into the native soils.

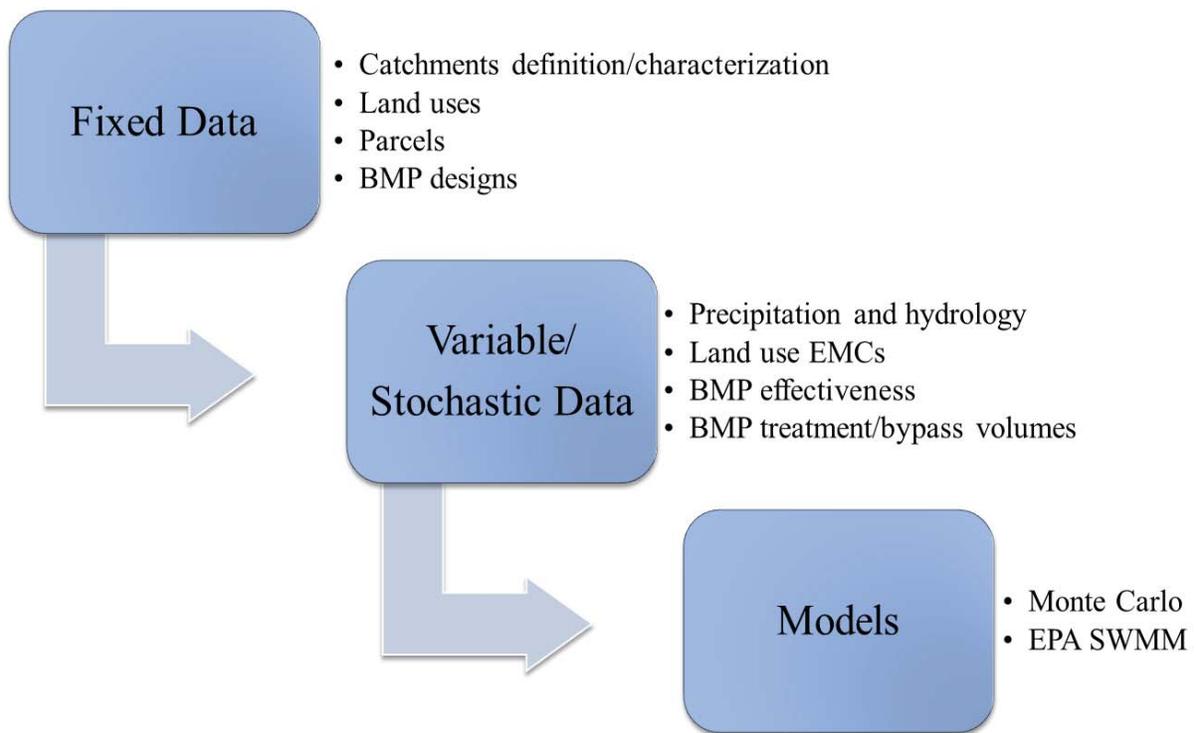
Figure 6. SBPAT Model Data Flow

Data used for the quantification/analysis module include both fixed and stochastic parameters. The model utilizes land use based EMCs, USEPA SWMM, USEPA/American Society of Civil Engineers/Water Environment Research Foundation (USEPA/ASCE/WERF) International BMP Database (IBD) water quality concentrations, watershed/GIS data, and a Monte Carlo approach to quantify water quality benefits and uncertainties. Model data flow is provided below in Figure 6.

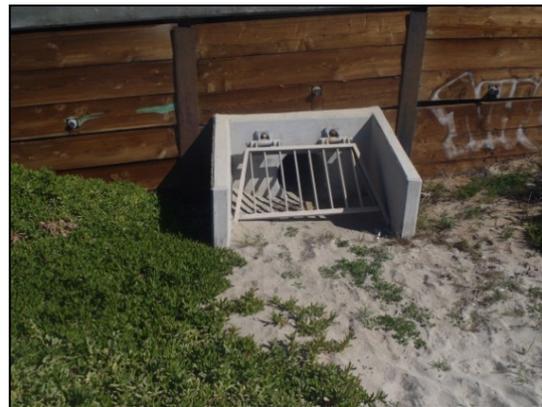
Figure 2-16. ASBS-031 Outfall

ASBS-031 is a 22-inch outfall located in the middle portion of Nicholas Beach, at the base of Nicholas Beach Road (Figure 2-16). This outfall is accessible during all tides; however, no flow was observed during either of the monitored storm events. The watershed draining to ASBS-031 is 30.1 acres in size and the surrounding landscape at ASBS-031 consists of a gradually sloping, broad sandy beach.

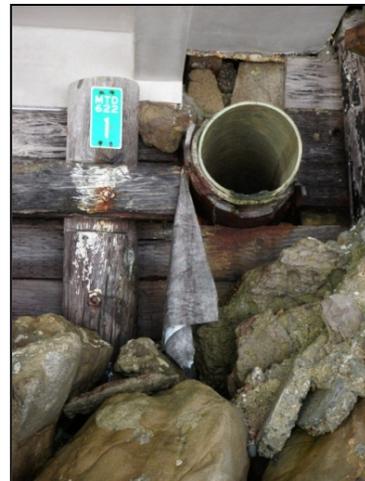
Figure 2-32. ASBS-025 Outfall

ASBS-025 is an 18-inch outfall located at the southern end of Escondido Beach, south of the Malibu Cove Colony Drive entrance off PCH (Figure 2-32). The outfall is integrated with the foundation of a residence and discharges directly onto the sand between two residences. This outfall is inaccessible during high tide but was successfully sampled during three monitored storm events (February 19 and March 8, 2013, and February 28, 2014). The watershed draining to ASBS-025 is 0.8 acres in size and the landscape surrounding the outfall is composed of a steep, sandy beach.

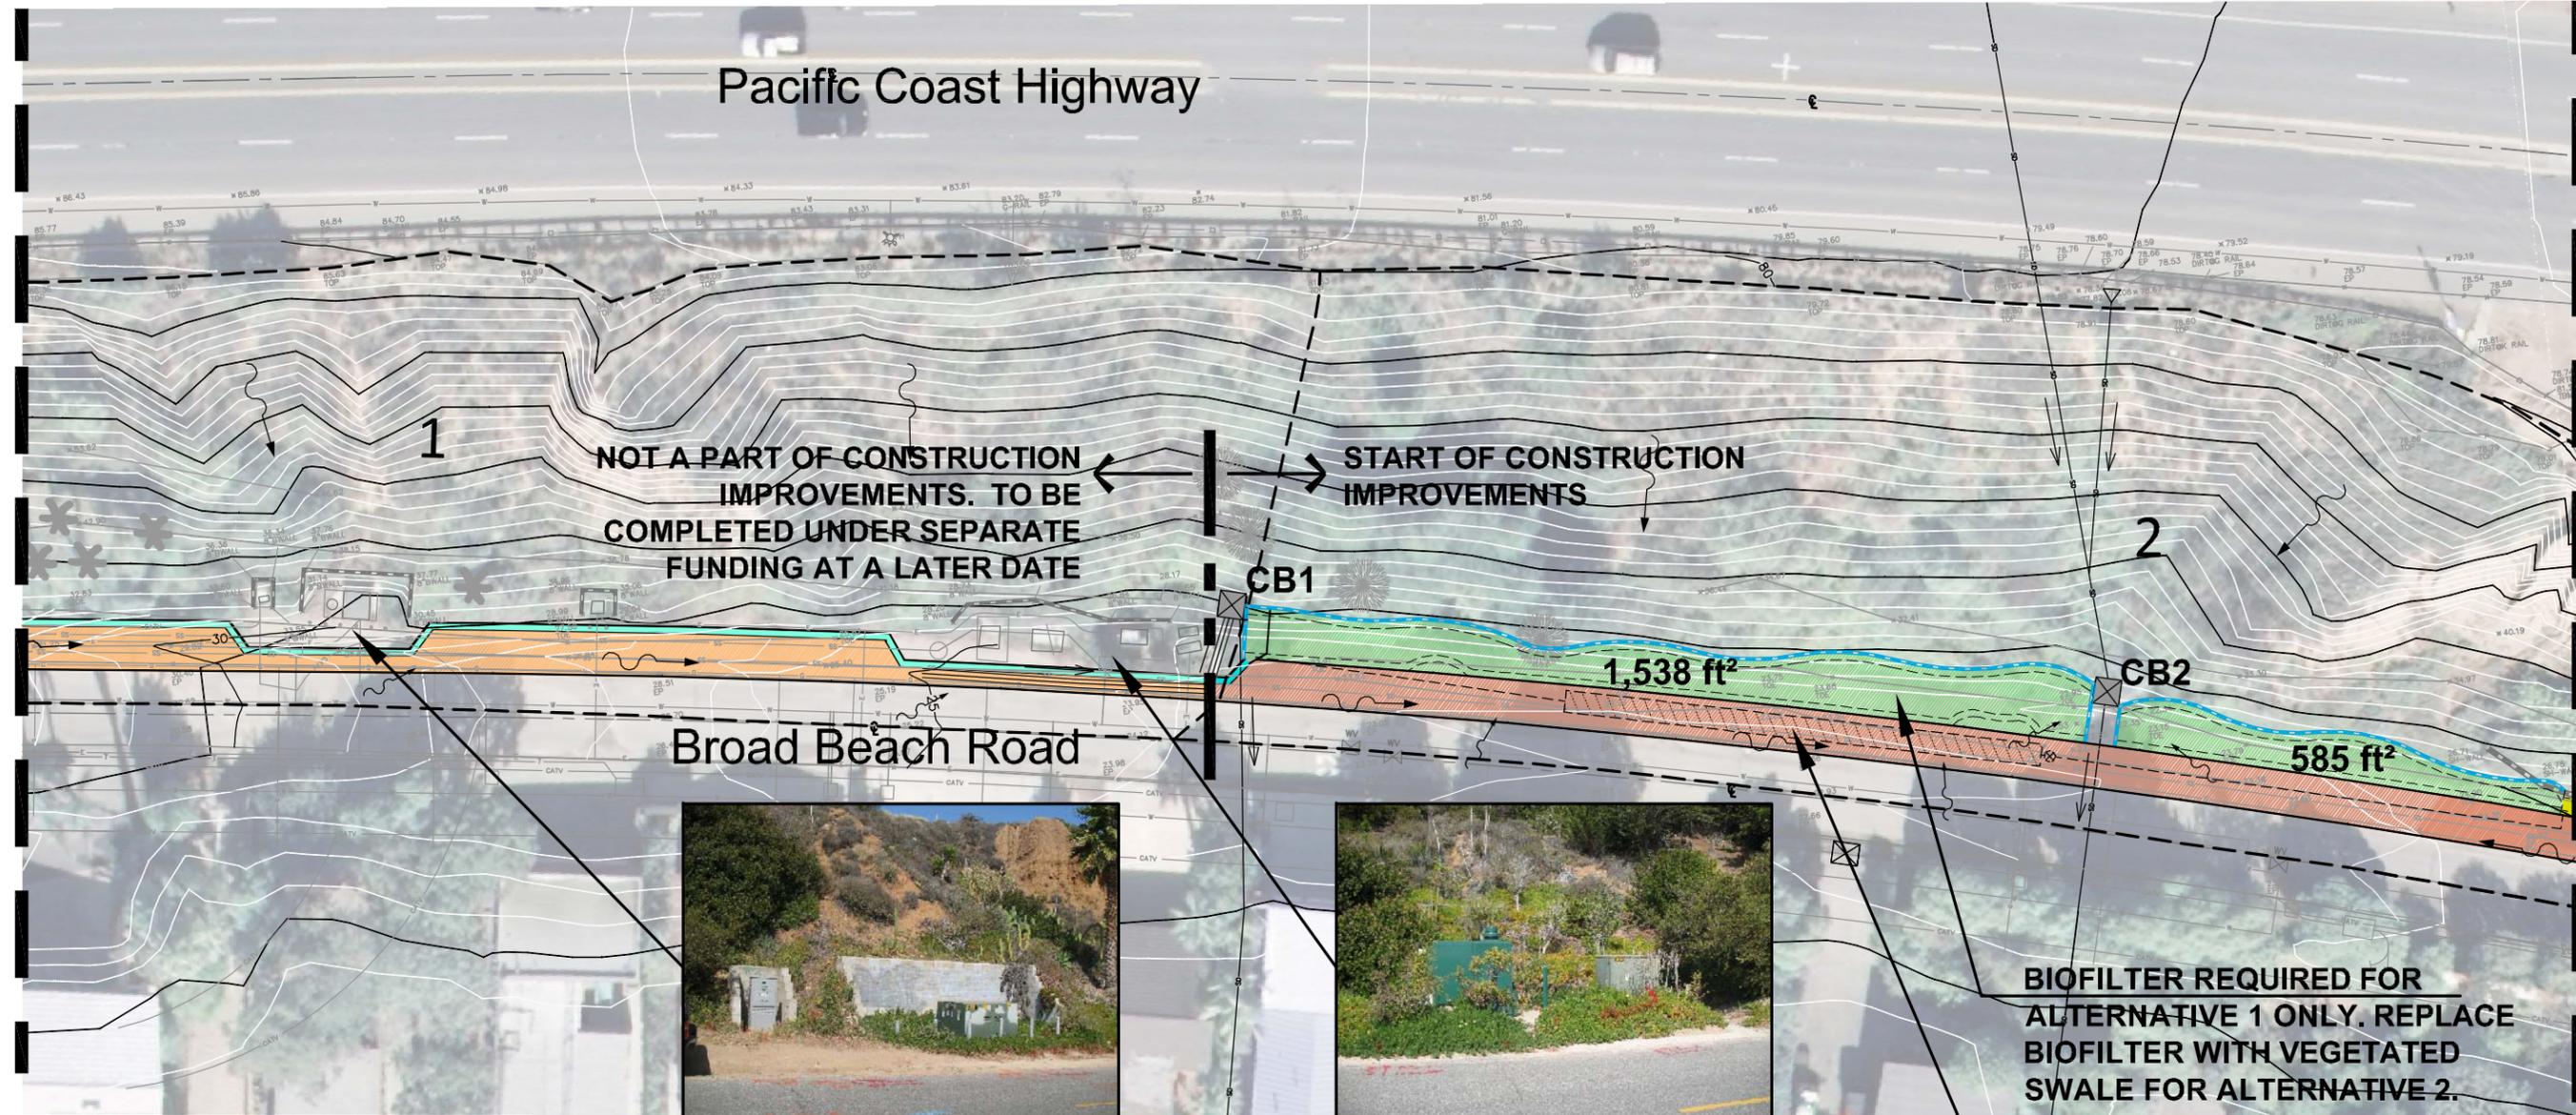
BIOFILTER REQUIRED FOR ALTERNATIVE 1 ONLY. REPLACE BIOFILTER WITH VEGETATED SWALE FOR ALTERNATIVE 2.
