Mattole Basin Assessment Implementation Summary

Downie, Scott T., C.W. Davenport, E. Dudik, F. Yee, and J. Clements (multi-disciplinary Mattole assessment team leads). 2003. Mattole Basin Assessment Implementation Summary. CDFG Coastal Planning and Assessment Program, p. 67. California Department of Fish and Game, Sacramento, California.

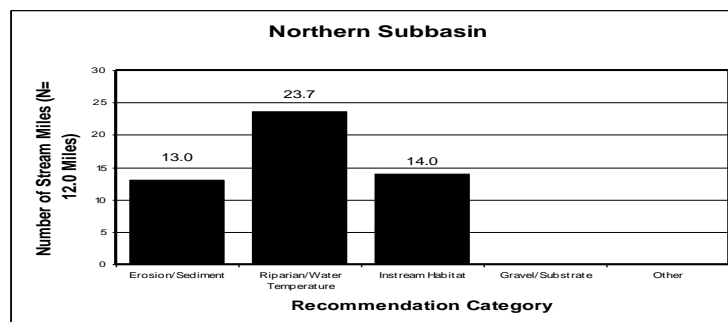
However, comparing recommendation categories in the Northern Subbasin by number of tributaries could be confounded by the differences in the number of stream miles surveyed on each tributary. Therefore, the number of stream miles in each subbasin assigned to various recommendation categories was calculated (Figure 5). When examining recommendation categories by number of stream miles, the most important recommendation categories in the Northern Subbasin are Riparian/Water Temp, Instream Habitat, and Erosion/Sediment. These comprise the top tier of recommended improvement activity focus areas.

Figure 5. Recommendation categories by stream miles in the Northern Subbasin.

The high number of Riparian/Water Temperature, Instream Habitat, and Erosion/Sediment Recommendations across the Northern Subbasin indicates that high priority should be given to restoration projects emphasizing riparian replanting, pools, cover, and sediment reduction.

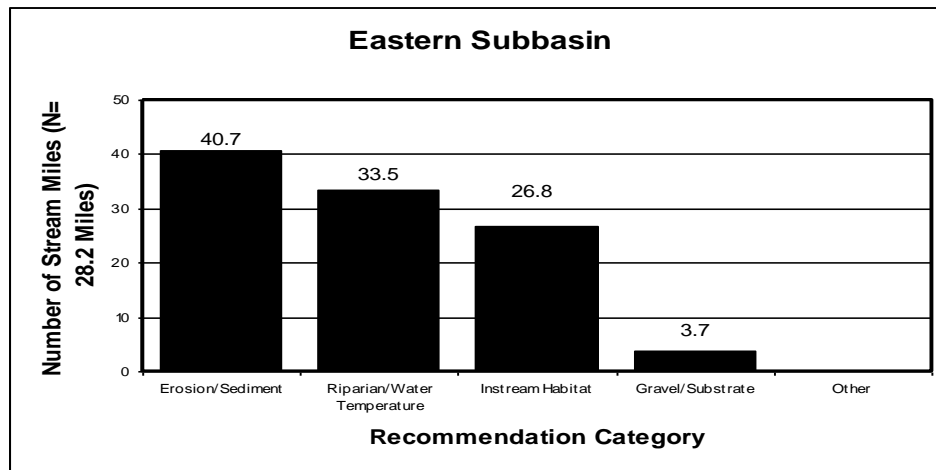
However, comparing recommendation categories in the Eastern Subbasin by number of tributaries could be confounded by the differences in the number stream miles surveyed on each tributary. Therefore, the number of stream miles in each subbasin assigned to the various recommendation categories was calculated (Figure 7). When examining recommendation categories by number of stream miles, the most important recommendation categories in the Eastern Subbasin are Erosion/Sediment, Riparian/Water Temp, and Instream Habitat.

Figure 7. Recommendation categories by stream miles in the Eastern Subbasin.

The high number of Erosion/Sediment, Riparian/Water Temp, and Instream Habitat Recommendations across the Eastern Subbasin indicates that high priority should be given to restoration projects emphasizing sediment reduction, riparian replanting, pools, and cover.

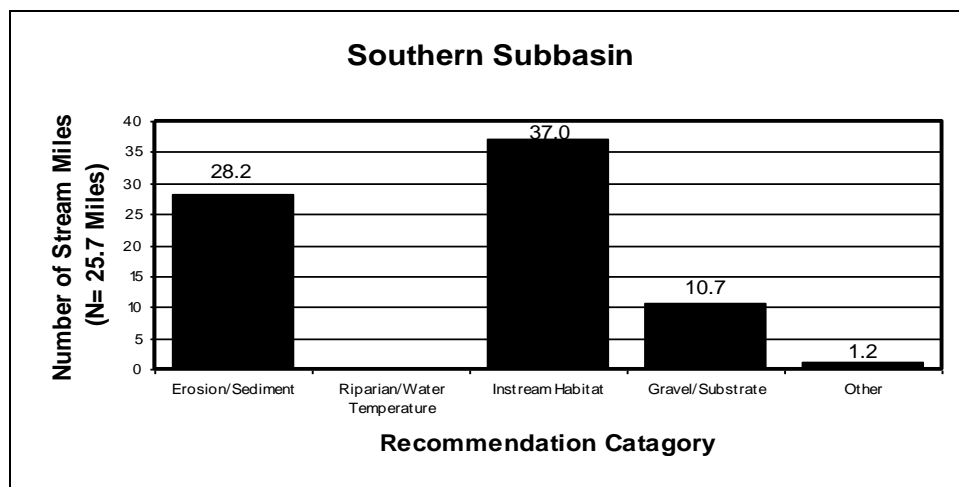
However, comparing recommendation categories in the Southern Subbasin by number of tributaries could be confounded by the differences in the number stream miles surveyed on each tributary. Therefore, the number of stream miles in each subbasin assigned to the various recommendation categories was calculated (Figure 9). When examining recommendation categories by number of stream miles, the most important recommendation categories in the Southern Subbasin are Instream Habitat, Erosion/Sediment, and Gravel/Substrate.

Figure 9. Recommendation categories by stream miles in the Southern Subbasin.

The high number of Instream Habitat, Erosion/Sediment, and Gravel/Substrate Recommendations across the Southern Subbasin indicates that high priority should be given to restoration projects emphasizing pools, cover, and sediment reduction.

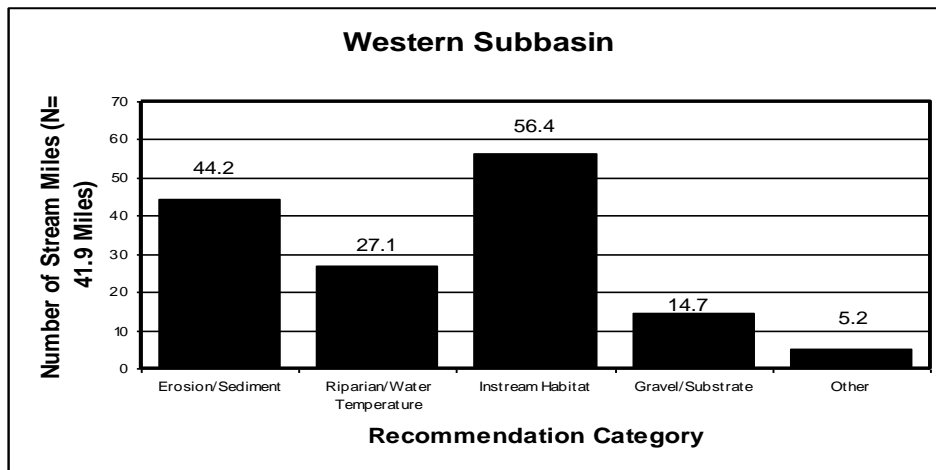
However, comparing recommendation categories in the Western Subbasin by number of tributaries could be confounded by the differences in the number of stream miles surveyed on each tributary. Therefore, the number of stream miles in each subbasin assigned to the various recommendation categories was calculated (Figure 11). When examining recommendation categories by number of stream miles, the most important recommendation categories in the Western Subbasin are Instream Habitat, Erosion/Sediment, and Riparian/Water Temperature.

Figure 11. Recommendation categories by stream miles in the Western Subbasin.

The high number of Instream Habitat, Erosion/Sediment Riparian/Water, and Temp Recommendations across the Western Subbasin indicates that high priority should be given to restoration projects emphasizing pools, cover, sediment reduction, and riparian replanting.
