As required in the Monitoring and Reporting Program (Order No. R5-2008-0005) for Coalition Groups, an Exceedance Report is being submitted to address the following issues: a) the exceedances, b) the follow-up monitoring, and c) any analysis or other actions the Coalition Group may take to address the exceedances.

a.) On December 3, 2012 Normal Monitoring (NM) and Management Plan Monitoring (MPM) occurred at sites in the ESJWQC region. This was considered the second storm event of 2012. Field parameters were measured during sampling. Berenda Slough @ Ave 18 ½ was dry and all other sites were sampled as contiguous waterbodies. Exceedances of receiving water limitations for DO and SC occurred. See attached Table 1 for details of field water quality trigger limit exceedances as well as the calculated discharge from each site. Site pictures taken from each of the monitoring sites during this event are also attached to this email as a pdf. Scanned copies of the field sheets are available upon request.

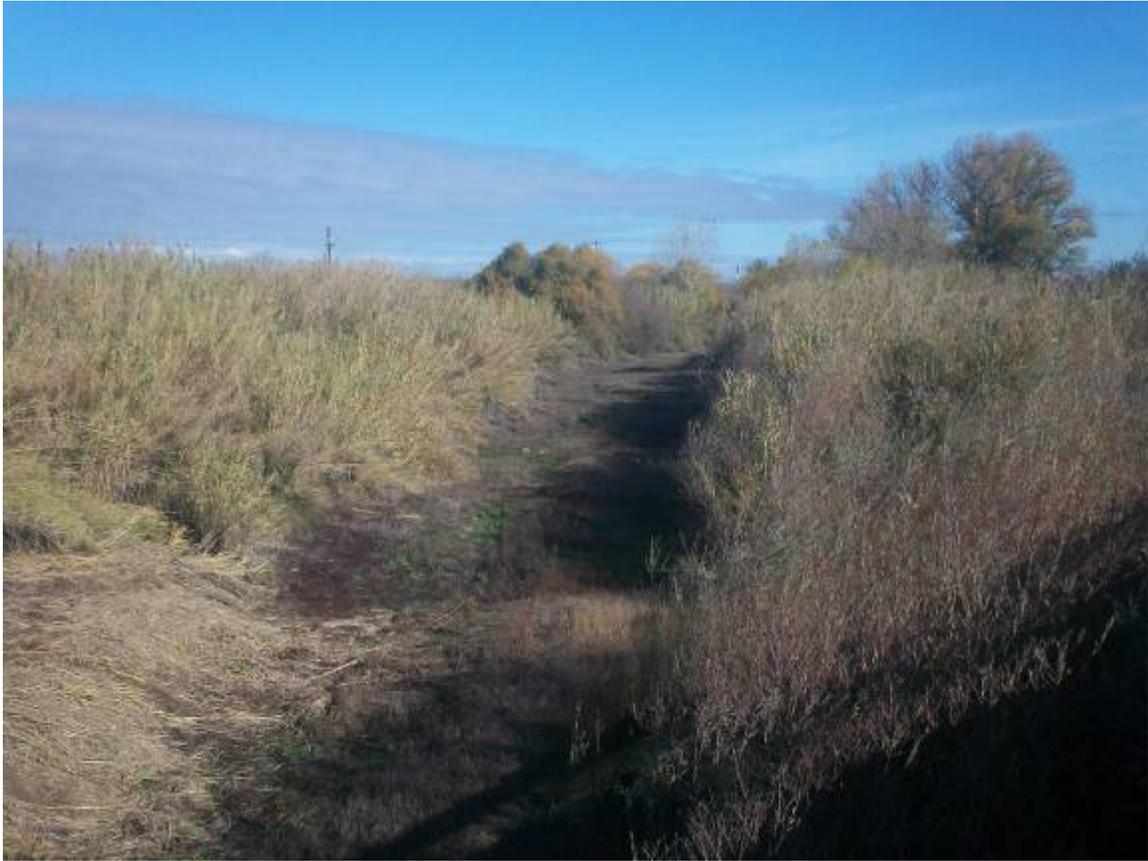
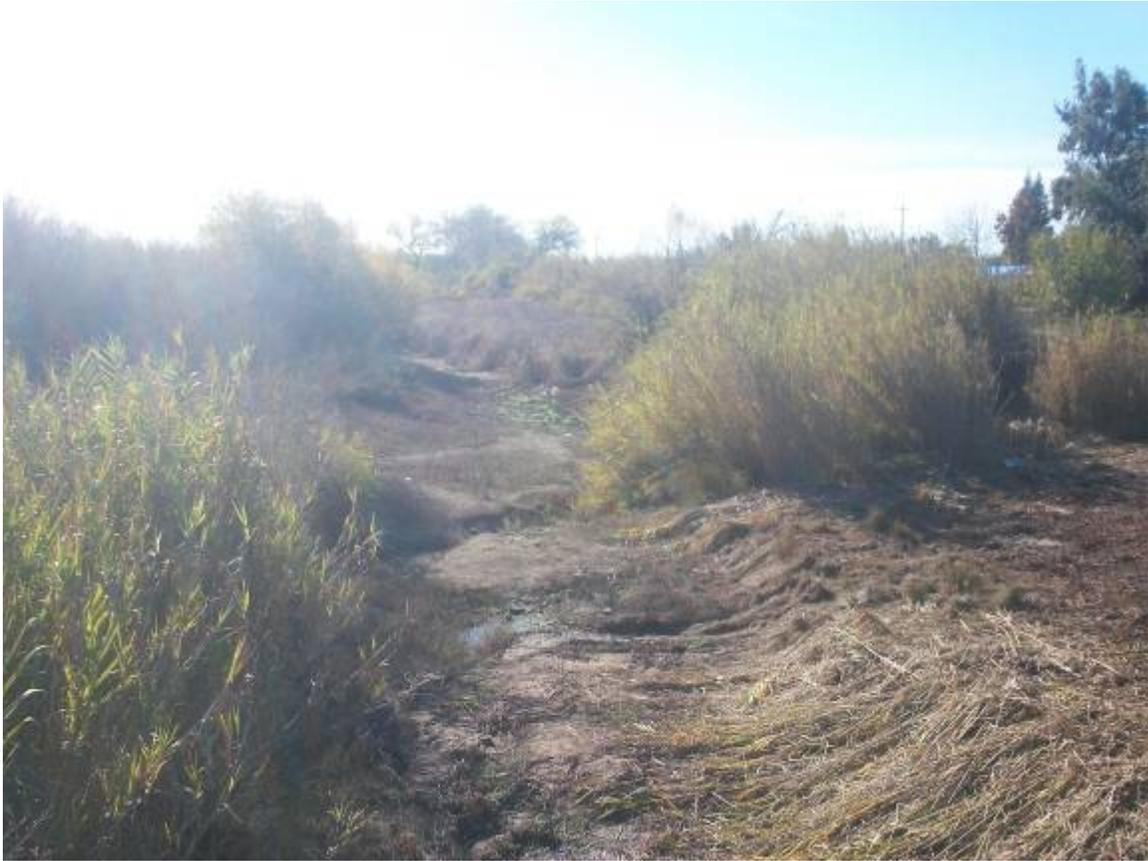
| Station Name | Station Code | Sample Date | Collection Time | Group | Discharge, cfs | DO, 7 mg/L | SC, 700 µS/cm | Comments |
|---|---|---|---|---|---|---|---|---|
| Berenda Slough along Ave 18 1/2 | 545XSAAE | 12/3/2012 | 12:25 | Storm2, Management Plan Monitoring | NA | | | December Management Plan Monitoring for copper. Dry site, no samples collected. |

Berenda Slough @ Avenue 18 ½, 12-03-2012, Facing North (upstream)

Berenda Slough @ Avenue 18 ½, 12-03-2012, Facing South (downstream)

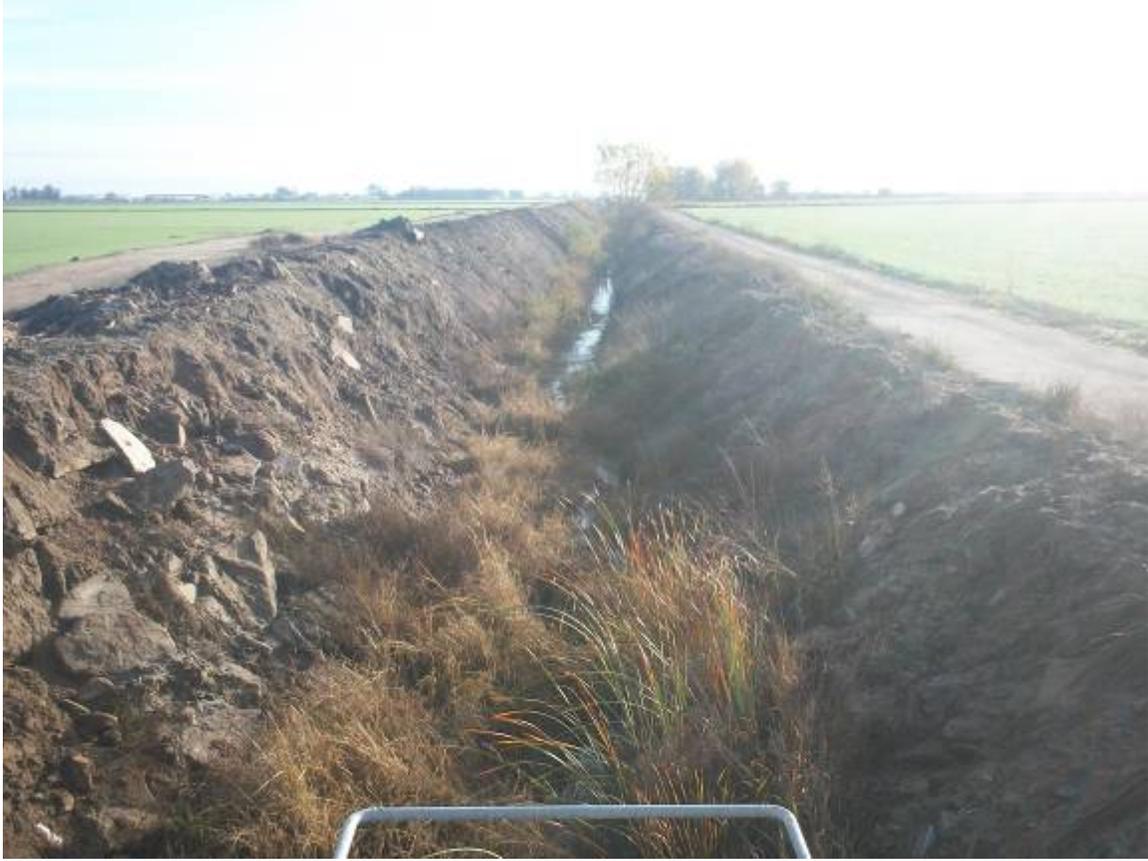
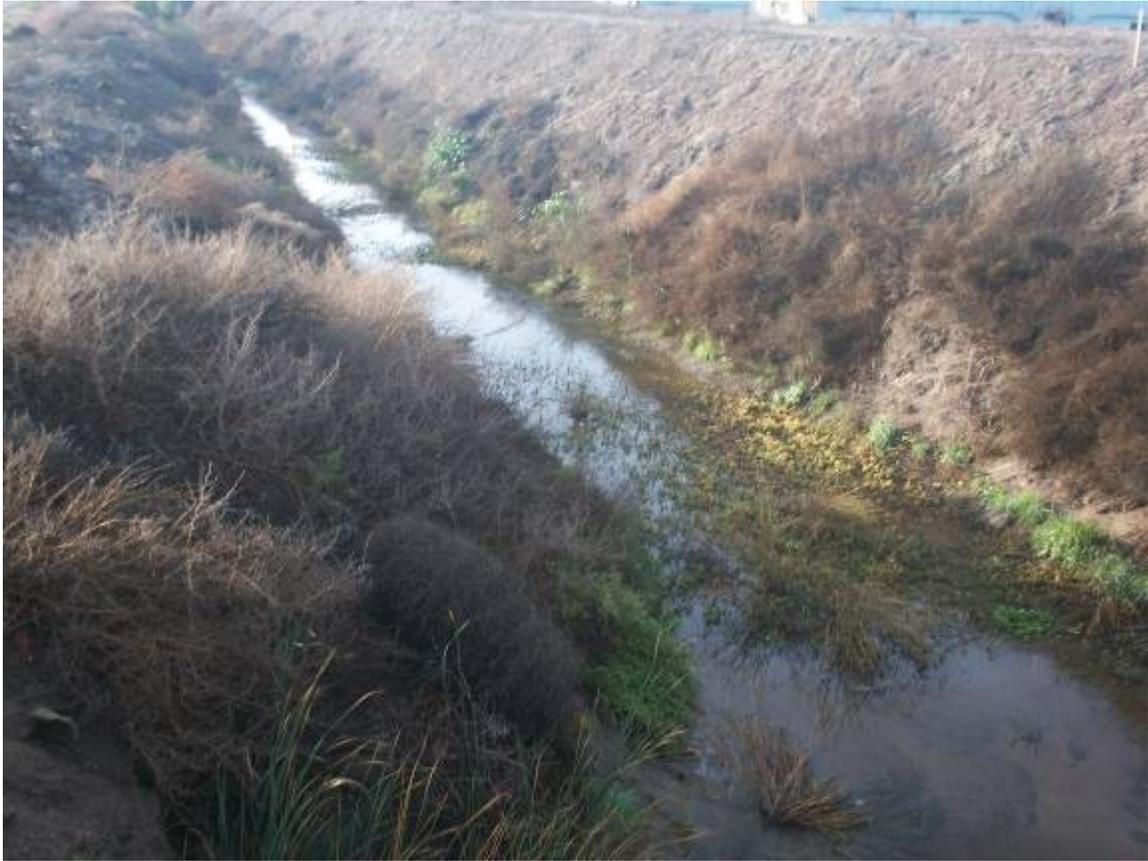
c.) DO exceedances are common in the Coalition region and may be due to low flow and/or high levels of biological oxygen demand in the test drains (this may not be the case for all samples). Sites sampled in previous events have also experienced frequent DO exceedances, particularly on clear, warm days when water temperatures, due to sun exposure, tend to be higher. Measurements of SC are consistently high at some sites in the ESJWQC region. Potential sources of salts and metals (detected in the field as conductivity) include upstream surface water, ground water or drain water from irrigated agricultural lands. All new exceedances requiring Management Plans as well as Management Plan Monitoring results will be evaluated in the ESJWQC annual Management Plan Update Report due April 1, 2013.

| Station Name | Station Code | Sample Date | Collection Time | Group | Discharge, cfs | DO, 7 mg/L | SC, 700 µS/cm | Comments |
|---|---|---|---|---|---|---|---|---|
| Levee Drain @ Carpenter Rd | 535XLDACR | 12/3/2012 | 9:30 | Storm2 | 0.29 | 5.22 | | |

Levee Drain @ Carpenter Rd, 12-03-2012, Facing East (upstream)

Levee Drain @ Carpenter Rd, 12-03-2012, Facing South (downstream)
