Fracture Stereonets  
 All Upper and Lower HSU RI Borings  
 Final Remedial Investigation Report  
 Casmalia Resources Superfund Site  
 Casmalia, California

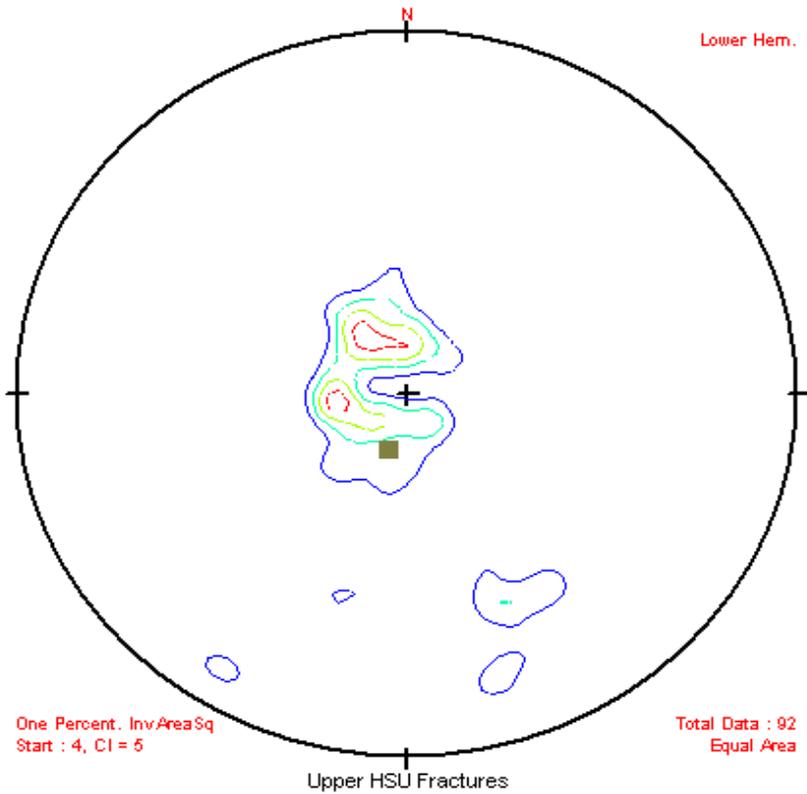
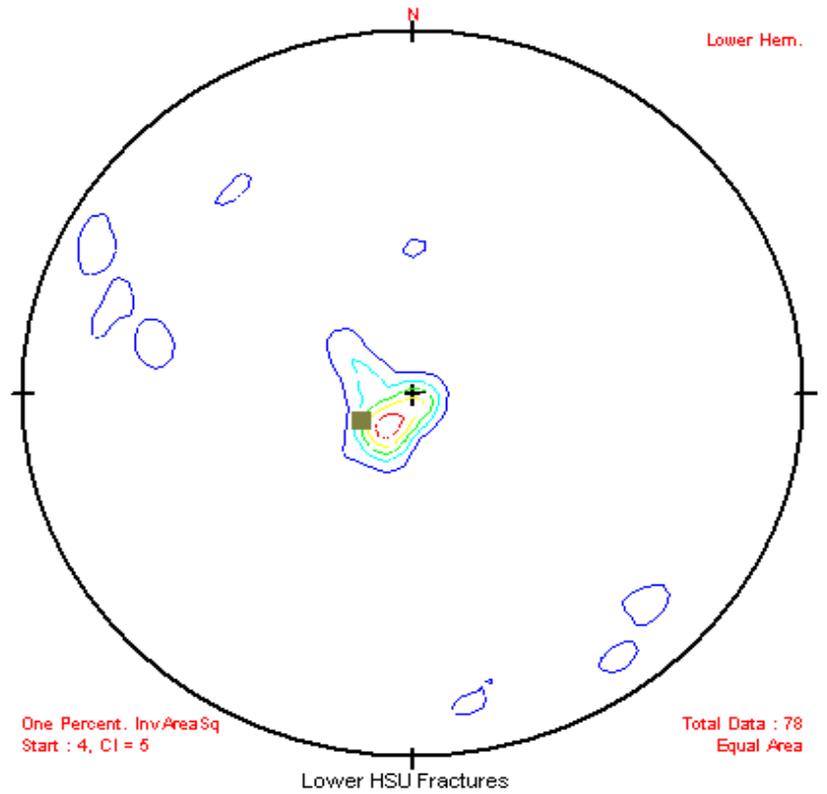
**E-19**

■ Mean Direction (strike,dip): 287,13

■ Mean Direction (strike,dip): 330,12
