East-West Cross Section P/S Landfill - Gallery Well Area
Final Remedial Investigation Report
 Casmalia Resources Superfund Site
 Casmalia, California

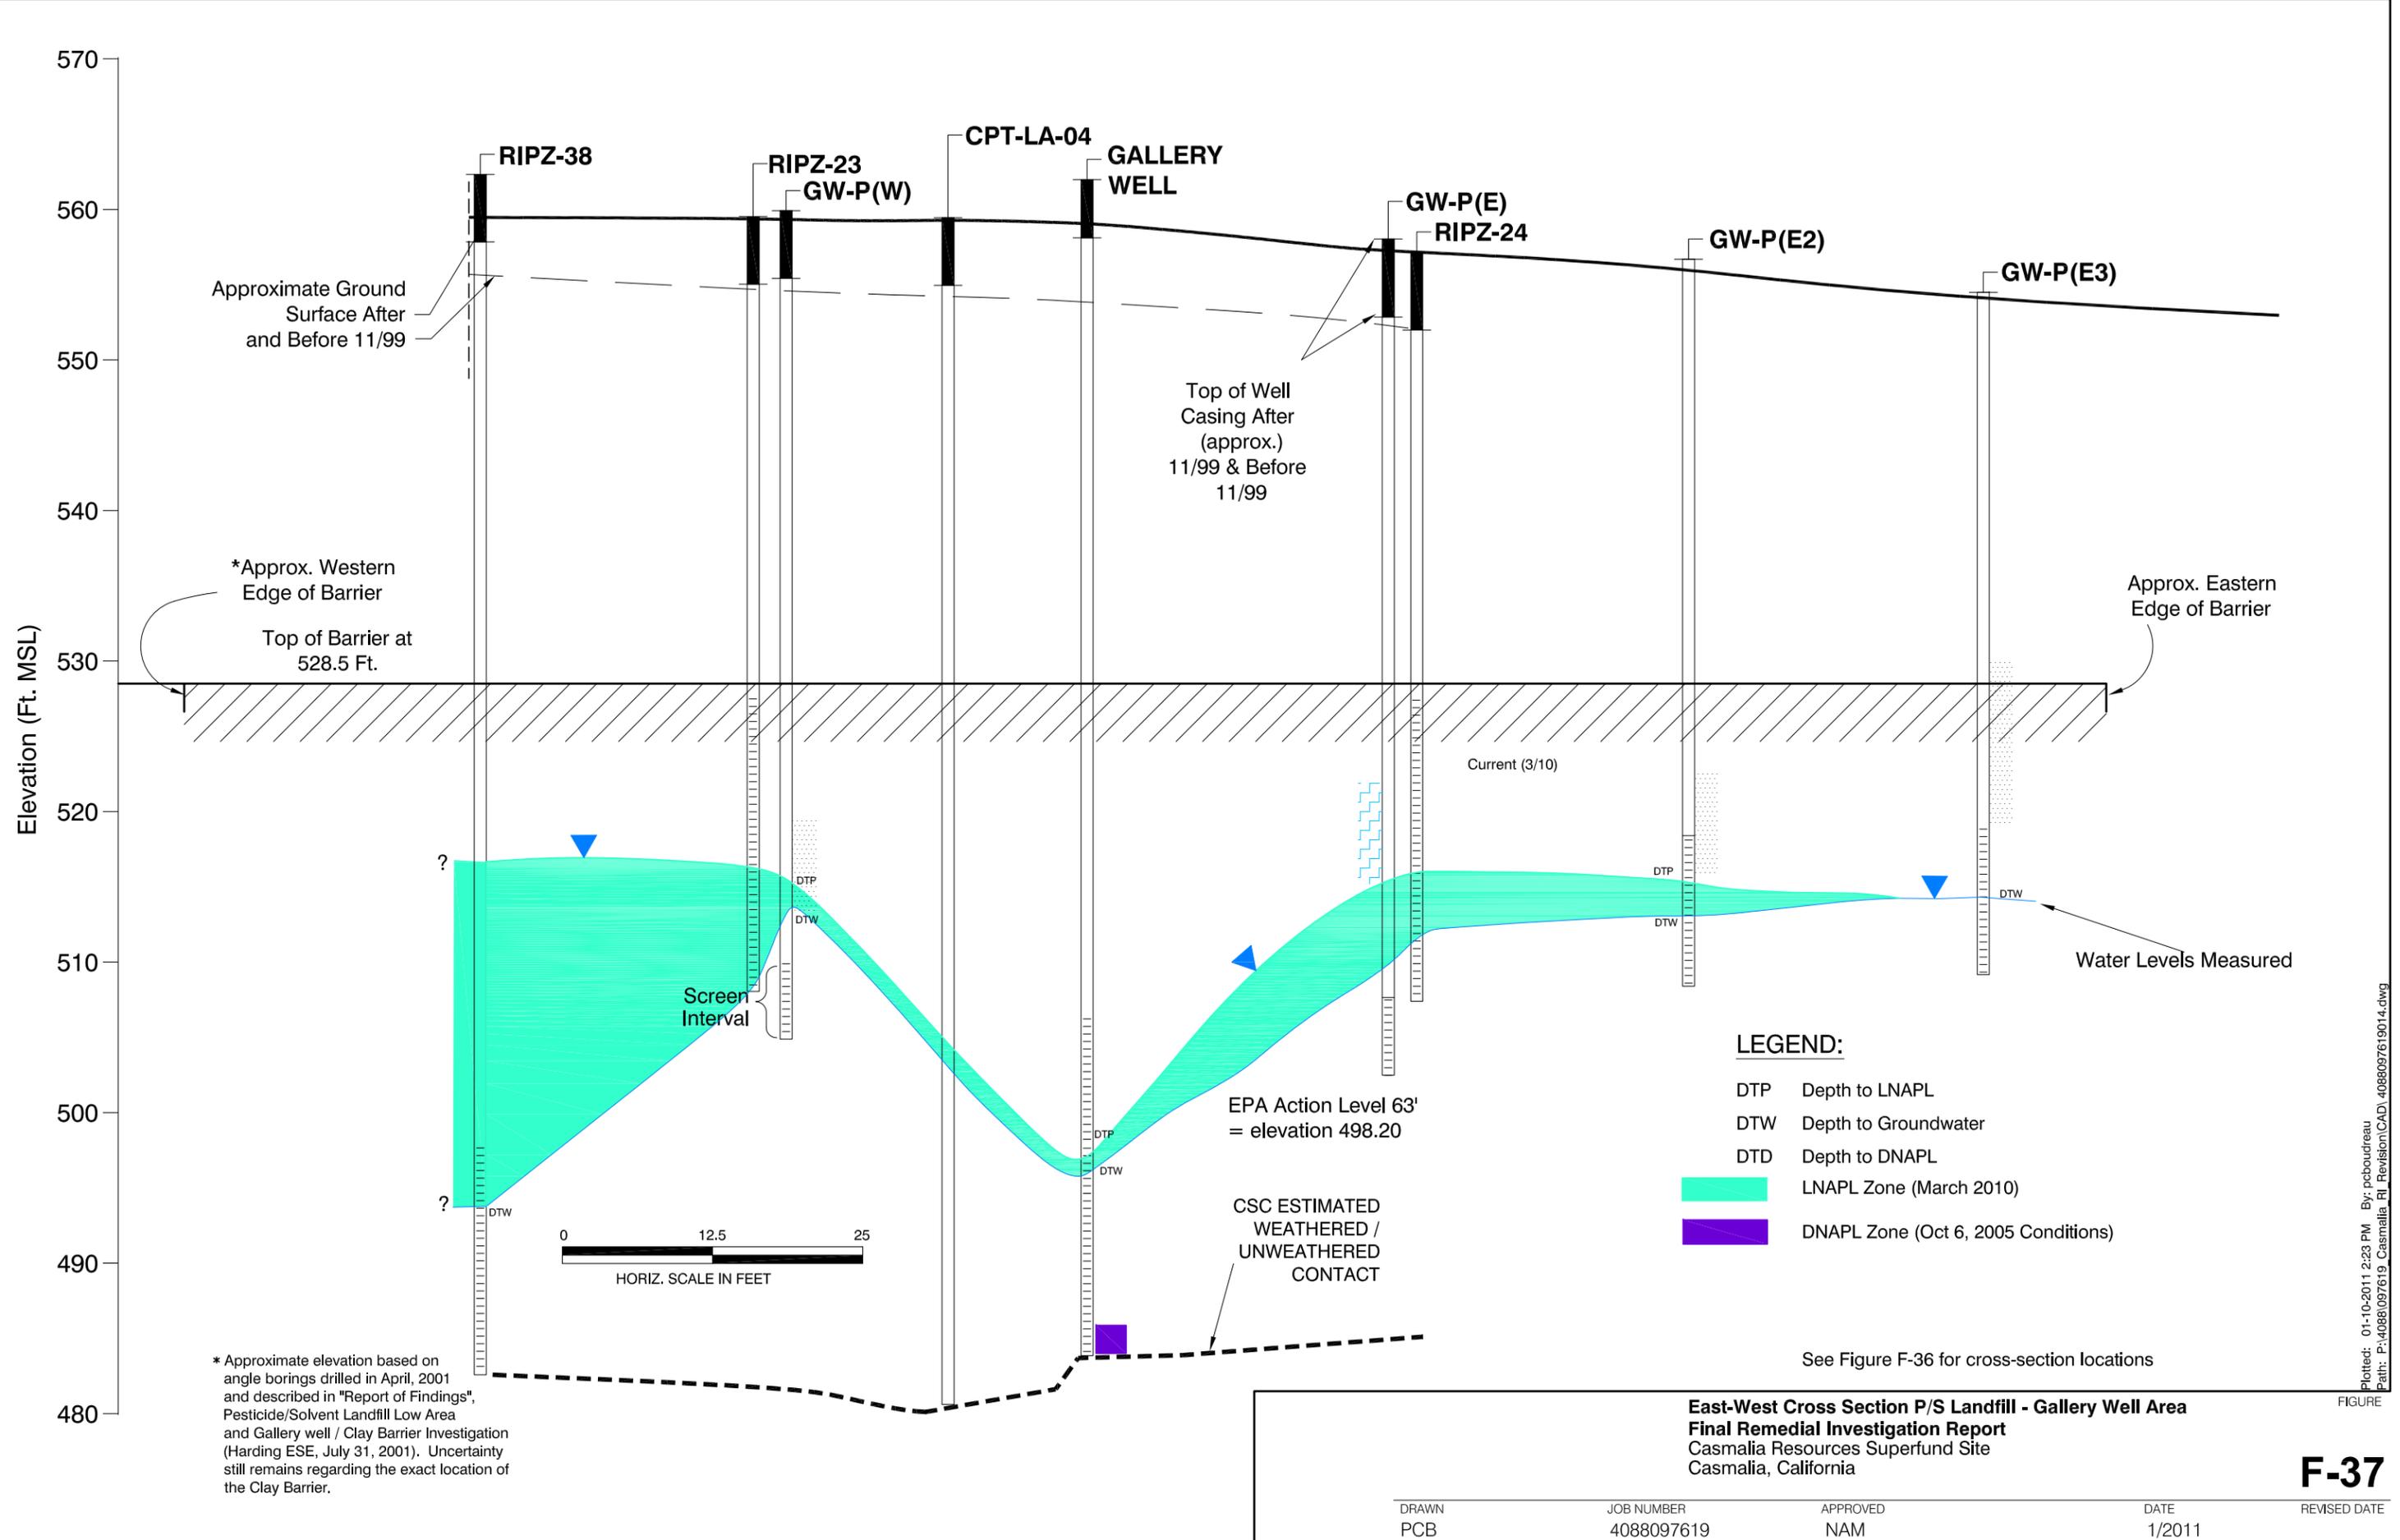
* Approximate elevation based on angle borings drilled in April, 2001 and described in "Report of Findings", Pesticide/Solvent Landfill Low Area and Gallery well / Clay Barrier Investigation (Harding ESE, July 31, 2001). Uncertainty still remains regarding the exact location of the Clay Barrier.

See Figure F-36 for cross-section locations
