Figure 4-9
Site Geologic Map
 Final Remedial Investigation Report
 Casamalia Resources Superfund Site
 January 2011

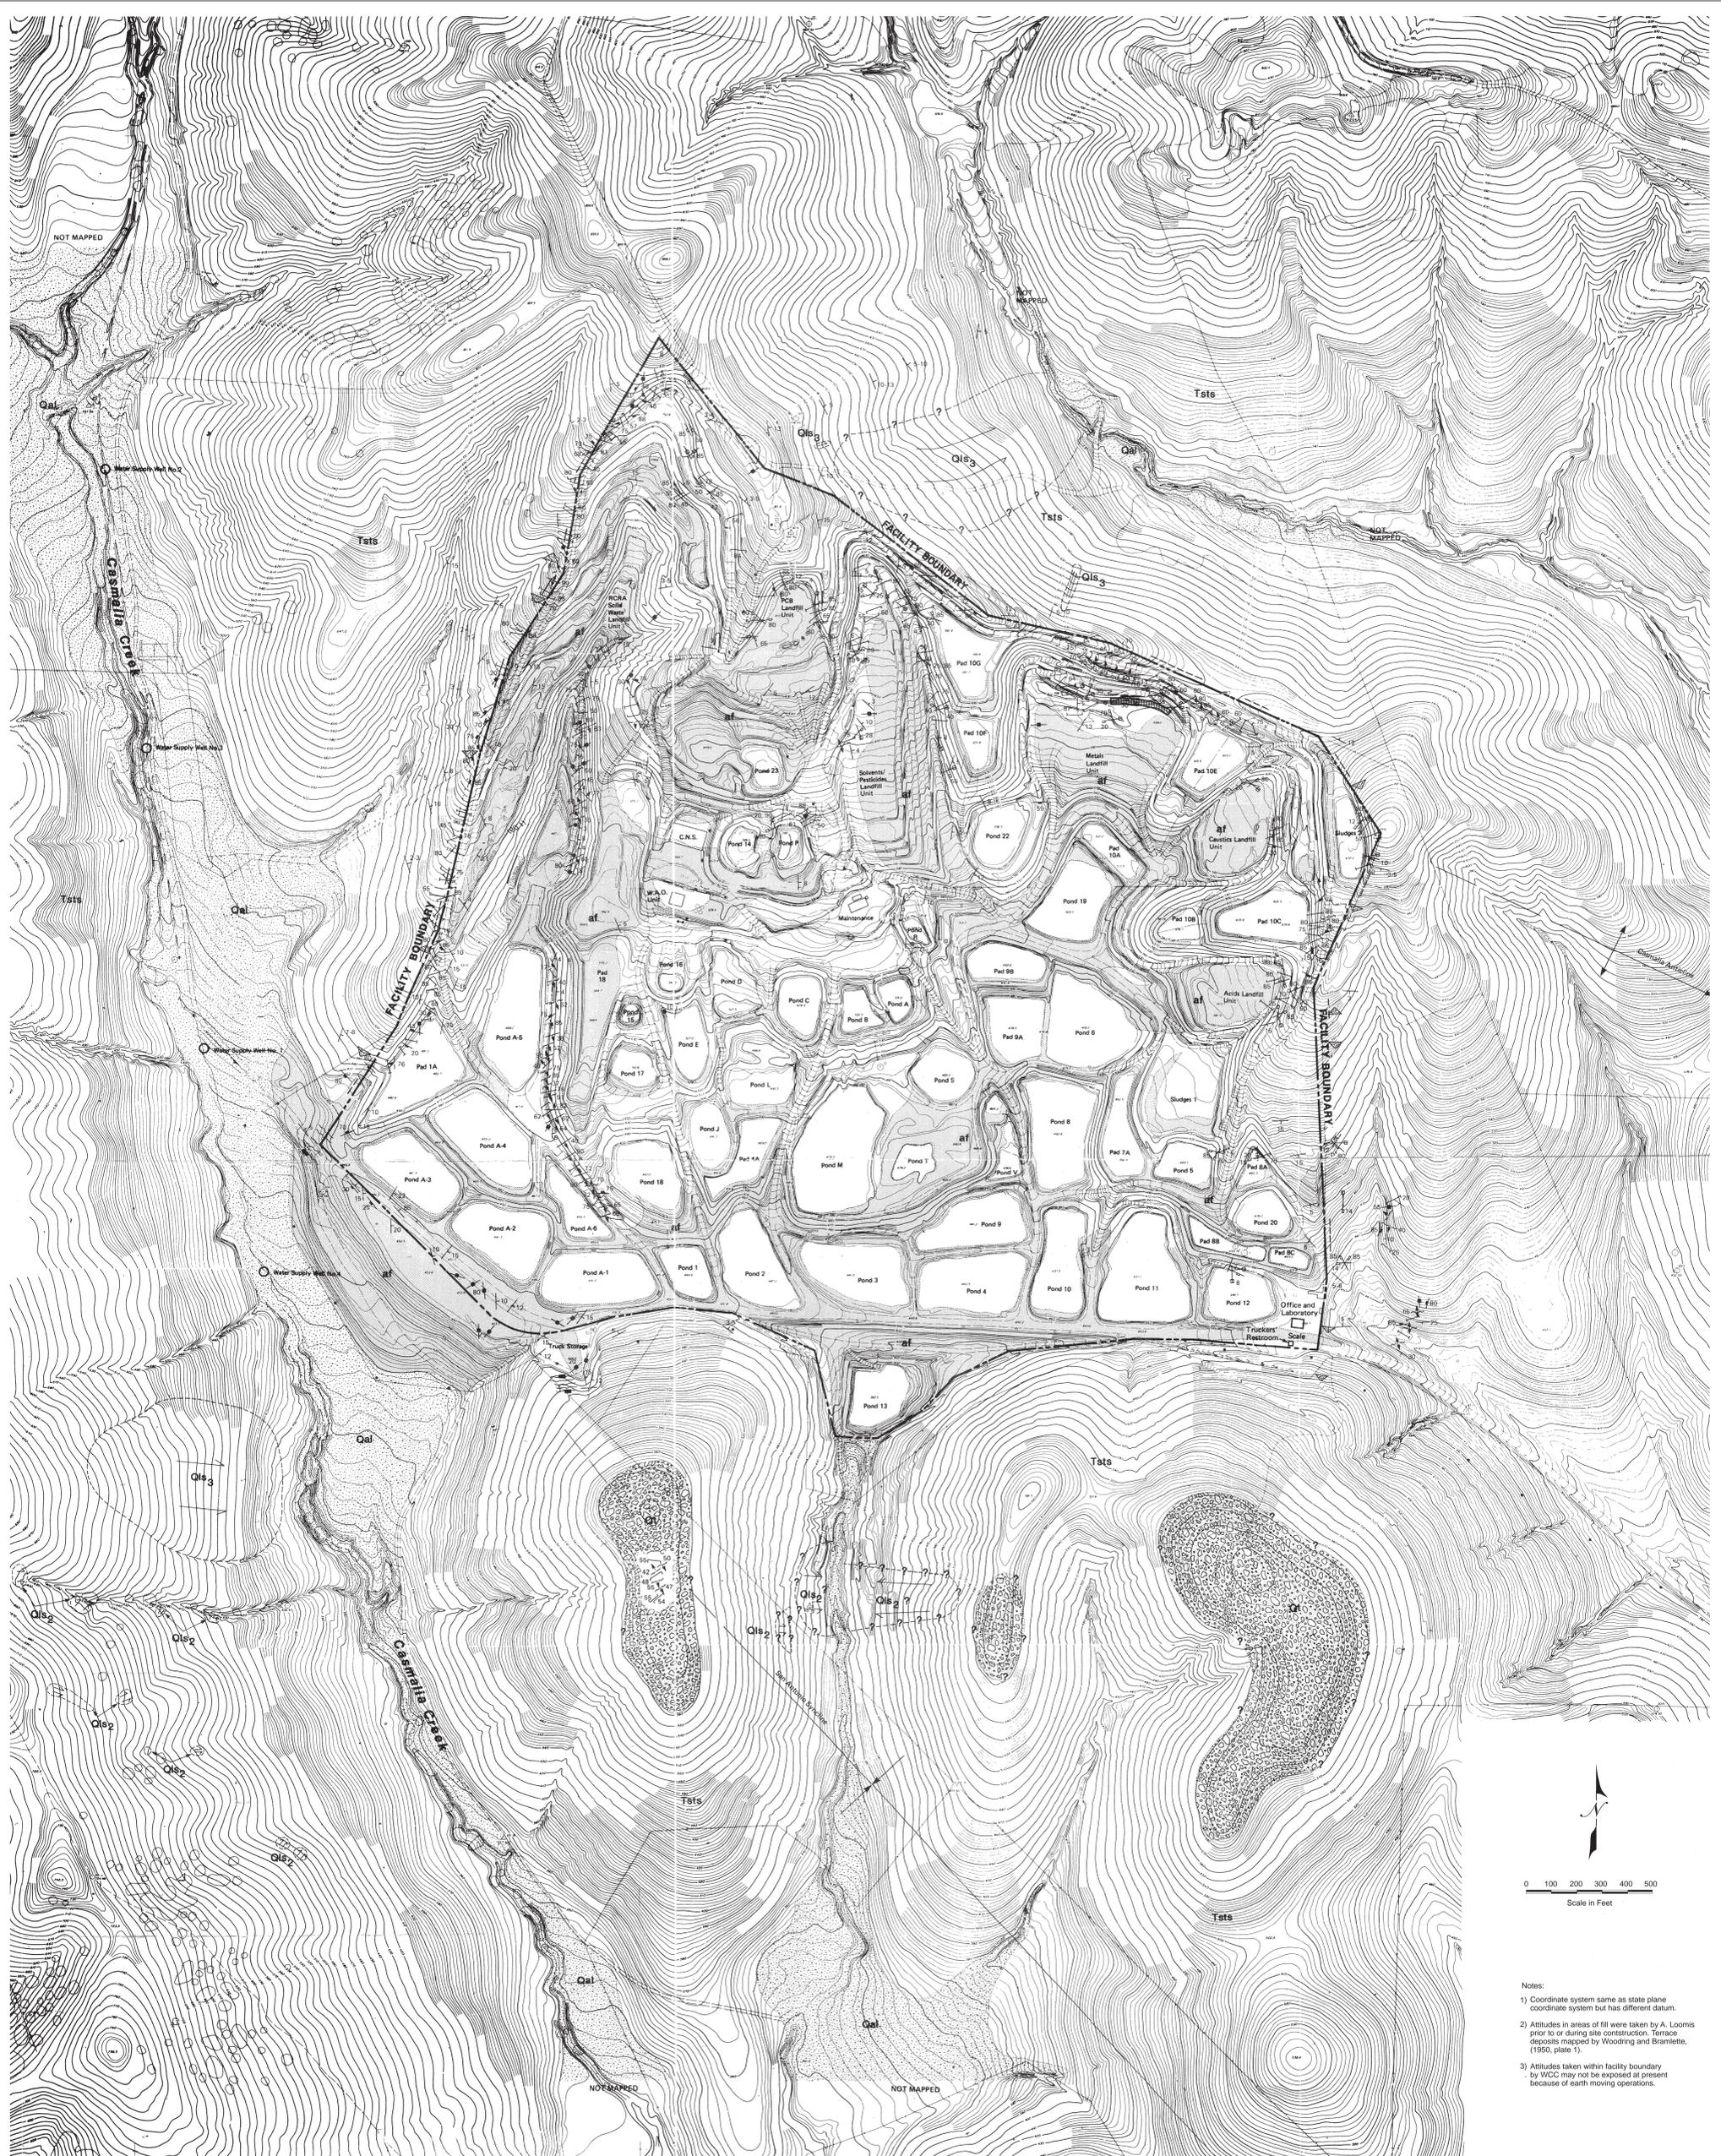
Notes:
 1) Coordinate system same as state plane coordinate system but has different datum.
 2) Altitudes in areas of fill were taken by A. Loomis prior to or during site construction. Terrace deposits mapped by Woodring and Bramlette, (1950, plate 1).
 3) Altitudes taken within facility boundary by WCC may not be exposed at present because of earth moving operations.

QUATERNARY	af	Artificial Fill Material Approximate Located	L-92.1	Strike and dip of bedrock fracture, containing significant clay	Approximate limits of landslide, arrows show inferred direction of movement of material Contact, approximately located Diagrammatic strike and dip of closely spaced jointing (from Loomis, 1982) Seep General location of trench on Metals Landfill Unit (see Figure 5.3-9 for log) Approximate axis of syncline (modified from: Woodring, W.P., and Bramlette, M.N., 1950) Approximate axis of anticline, arrow indicates direction of plunge (modified from: Woodring, W.P., and Bramlette, M.N., 1950)
	Qal	Alluvium and/or Colluvium Gravel, sand, silt, clay	L-29.1	Strike of vertical bedrock fracture, containing significant clay	
PLEISTOCENE	Qls1	Landslide Qls1 landslide debris (Loomis, June 1981)	L-29.2	Strike and dip of shear zone containing significant clay or crushed rock	
	Qls2	Qls2 landslide debris (WCC, 1986)	L-38	Strike and dip of fault, with minor displacement of bedding

Qls3	Qls3 landslide debris (WCC, 1986)	L-39	Strike and dip of fault, with minor displacement of bedding	
TERTIARY	Tsts	Terrace Deposits Fluvial deposits of silt, clay, sand, gravel and boulders	L-40	Strike and dip of bedding (from Loomis, 1980, 1982; Canonic Environmental, 1986; WCC, 1986)	
	Tts1	Todos Santos Claystone Member Somewhat porolaneous claystone, thin zones of porcelaneous shale.	L-41	Strike and dip of joints (WCC)	
	SISQUOC FM		L-42	Strike and dip of joints (from Loomis, 1980, 1982; Canonic Environmental, 1986; WCC, 1988)	
	MIOCENE TO PLIOCENE		L-43	Strike of vertical joints (WCC)	
			L-44	Strike of vertical joints (from Loomis, 1980, 1982; Canonic Environmental, 1986; WCC, 1988)

This map was compiled from photography dated 04/06/87 and supplemented with mapping from photography dated 06/02/82. Pacific Western

Reference:
 Figure 5-1-1, Site Geologic Map
 HSCER (WCC, 1988)
