FIGURE 5-5
CHROMIUM RESULTS FOR FIRST QUARTER 2018
GROUNDWATER MONITORING AND DOMESTIC WELL
SAMPLING AND MAXIMUM COMPOSITE PLUME
OUTLINE IN UPPER AQUIFER

FIRST QUARTER 2018 GROUNDWATER MONITORING
 REPORT AND DOMESTIC WELL RESULTS
 SITE-WIDE GROUNDWATER MONITORING PROGRAM

PACIFIC GAS AND ELECTRIC COMPANY
 HINKLEY COMPRESSOR STATION
 HINKLEY, CALIFORNIA

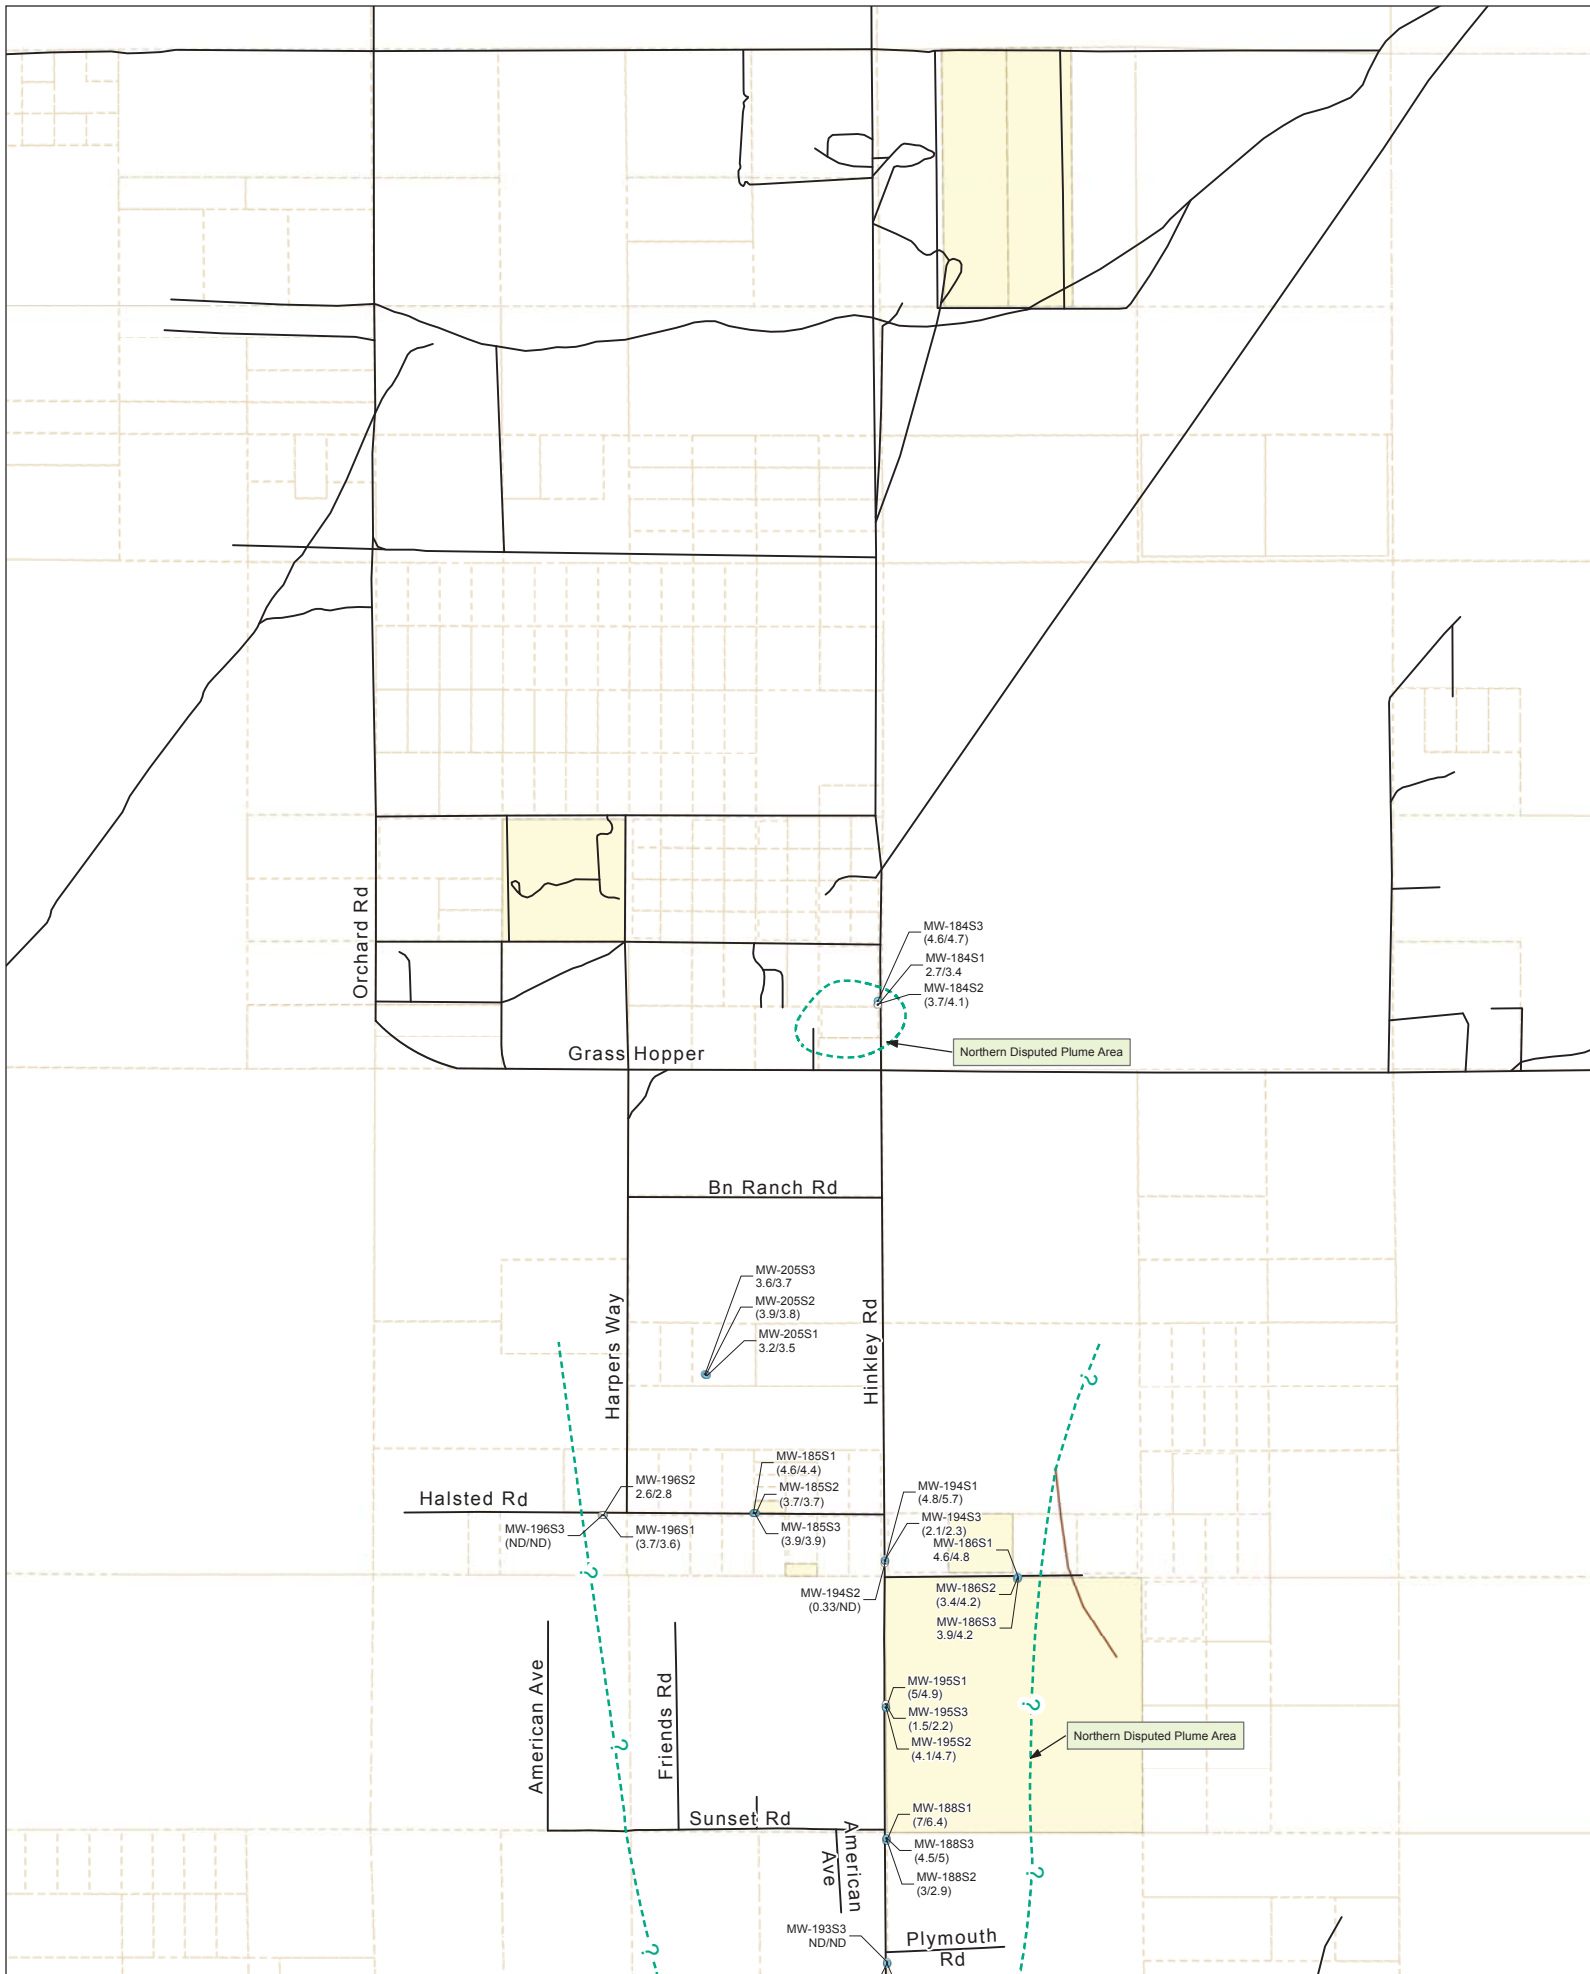
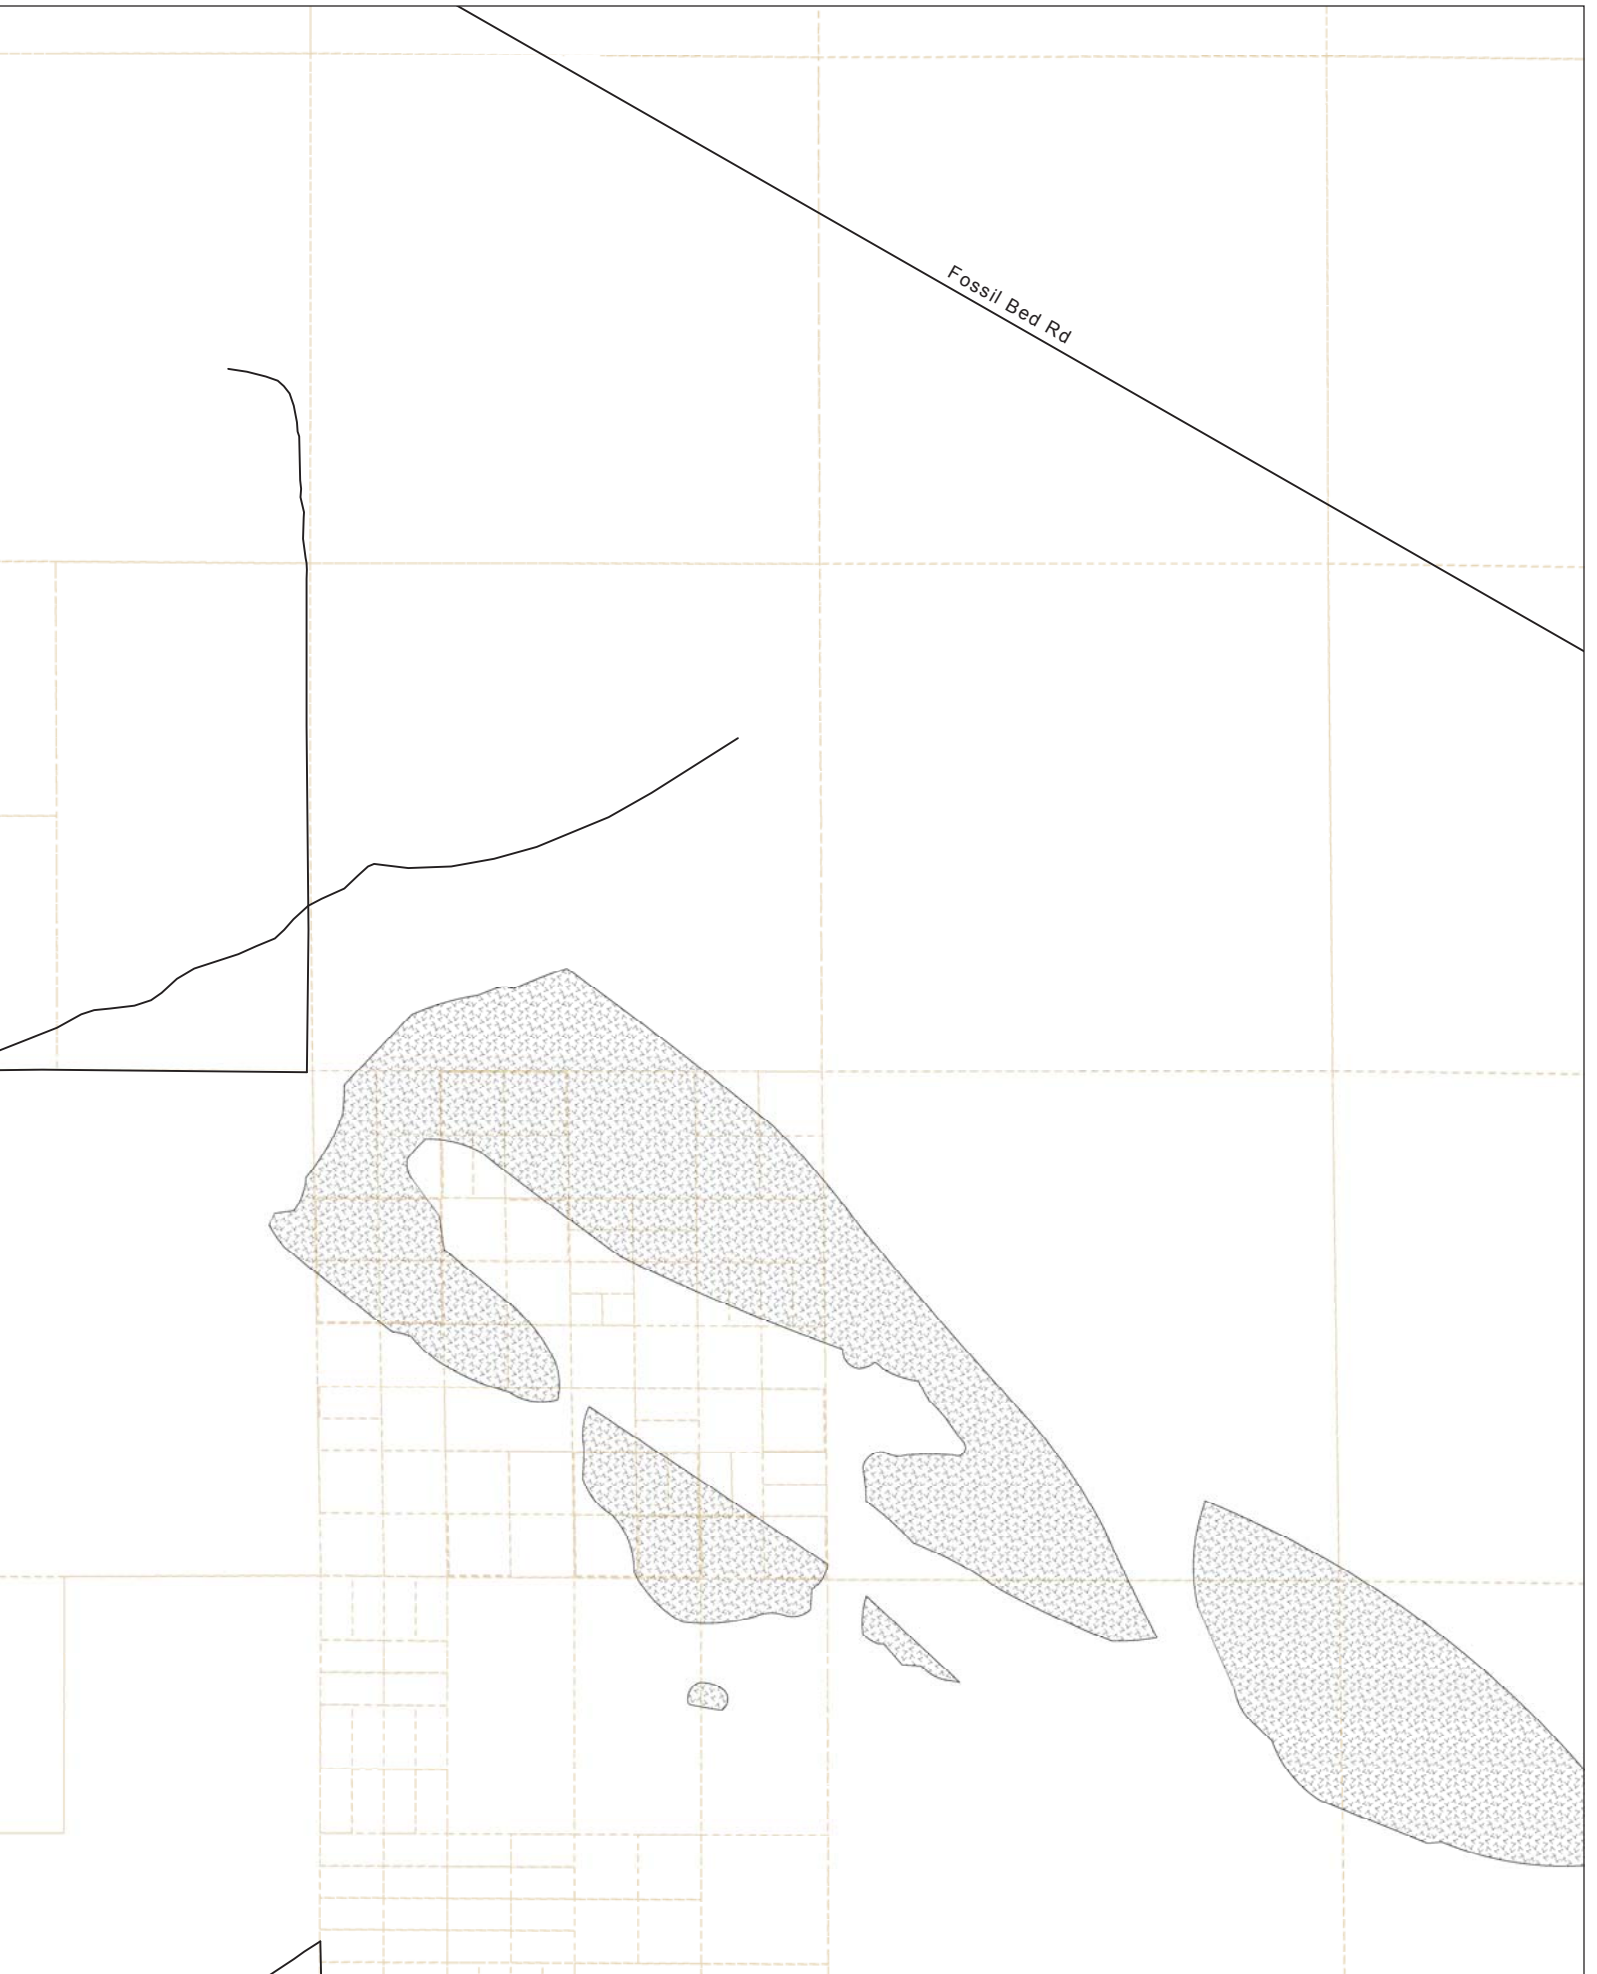
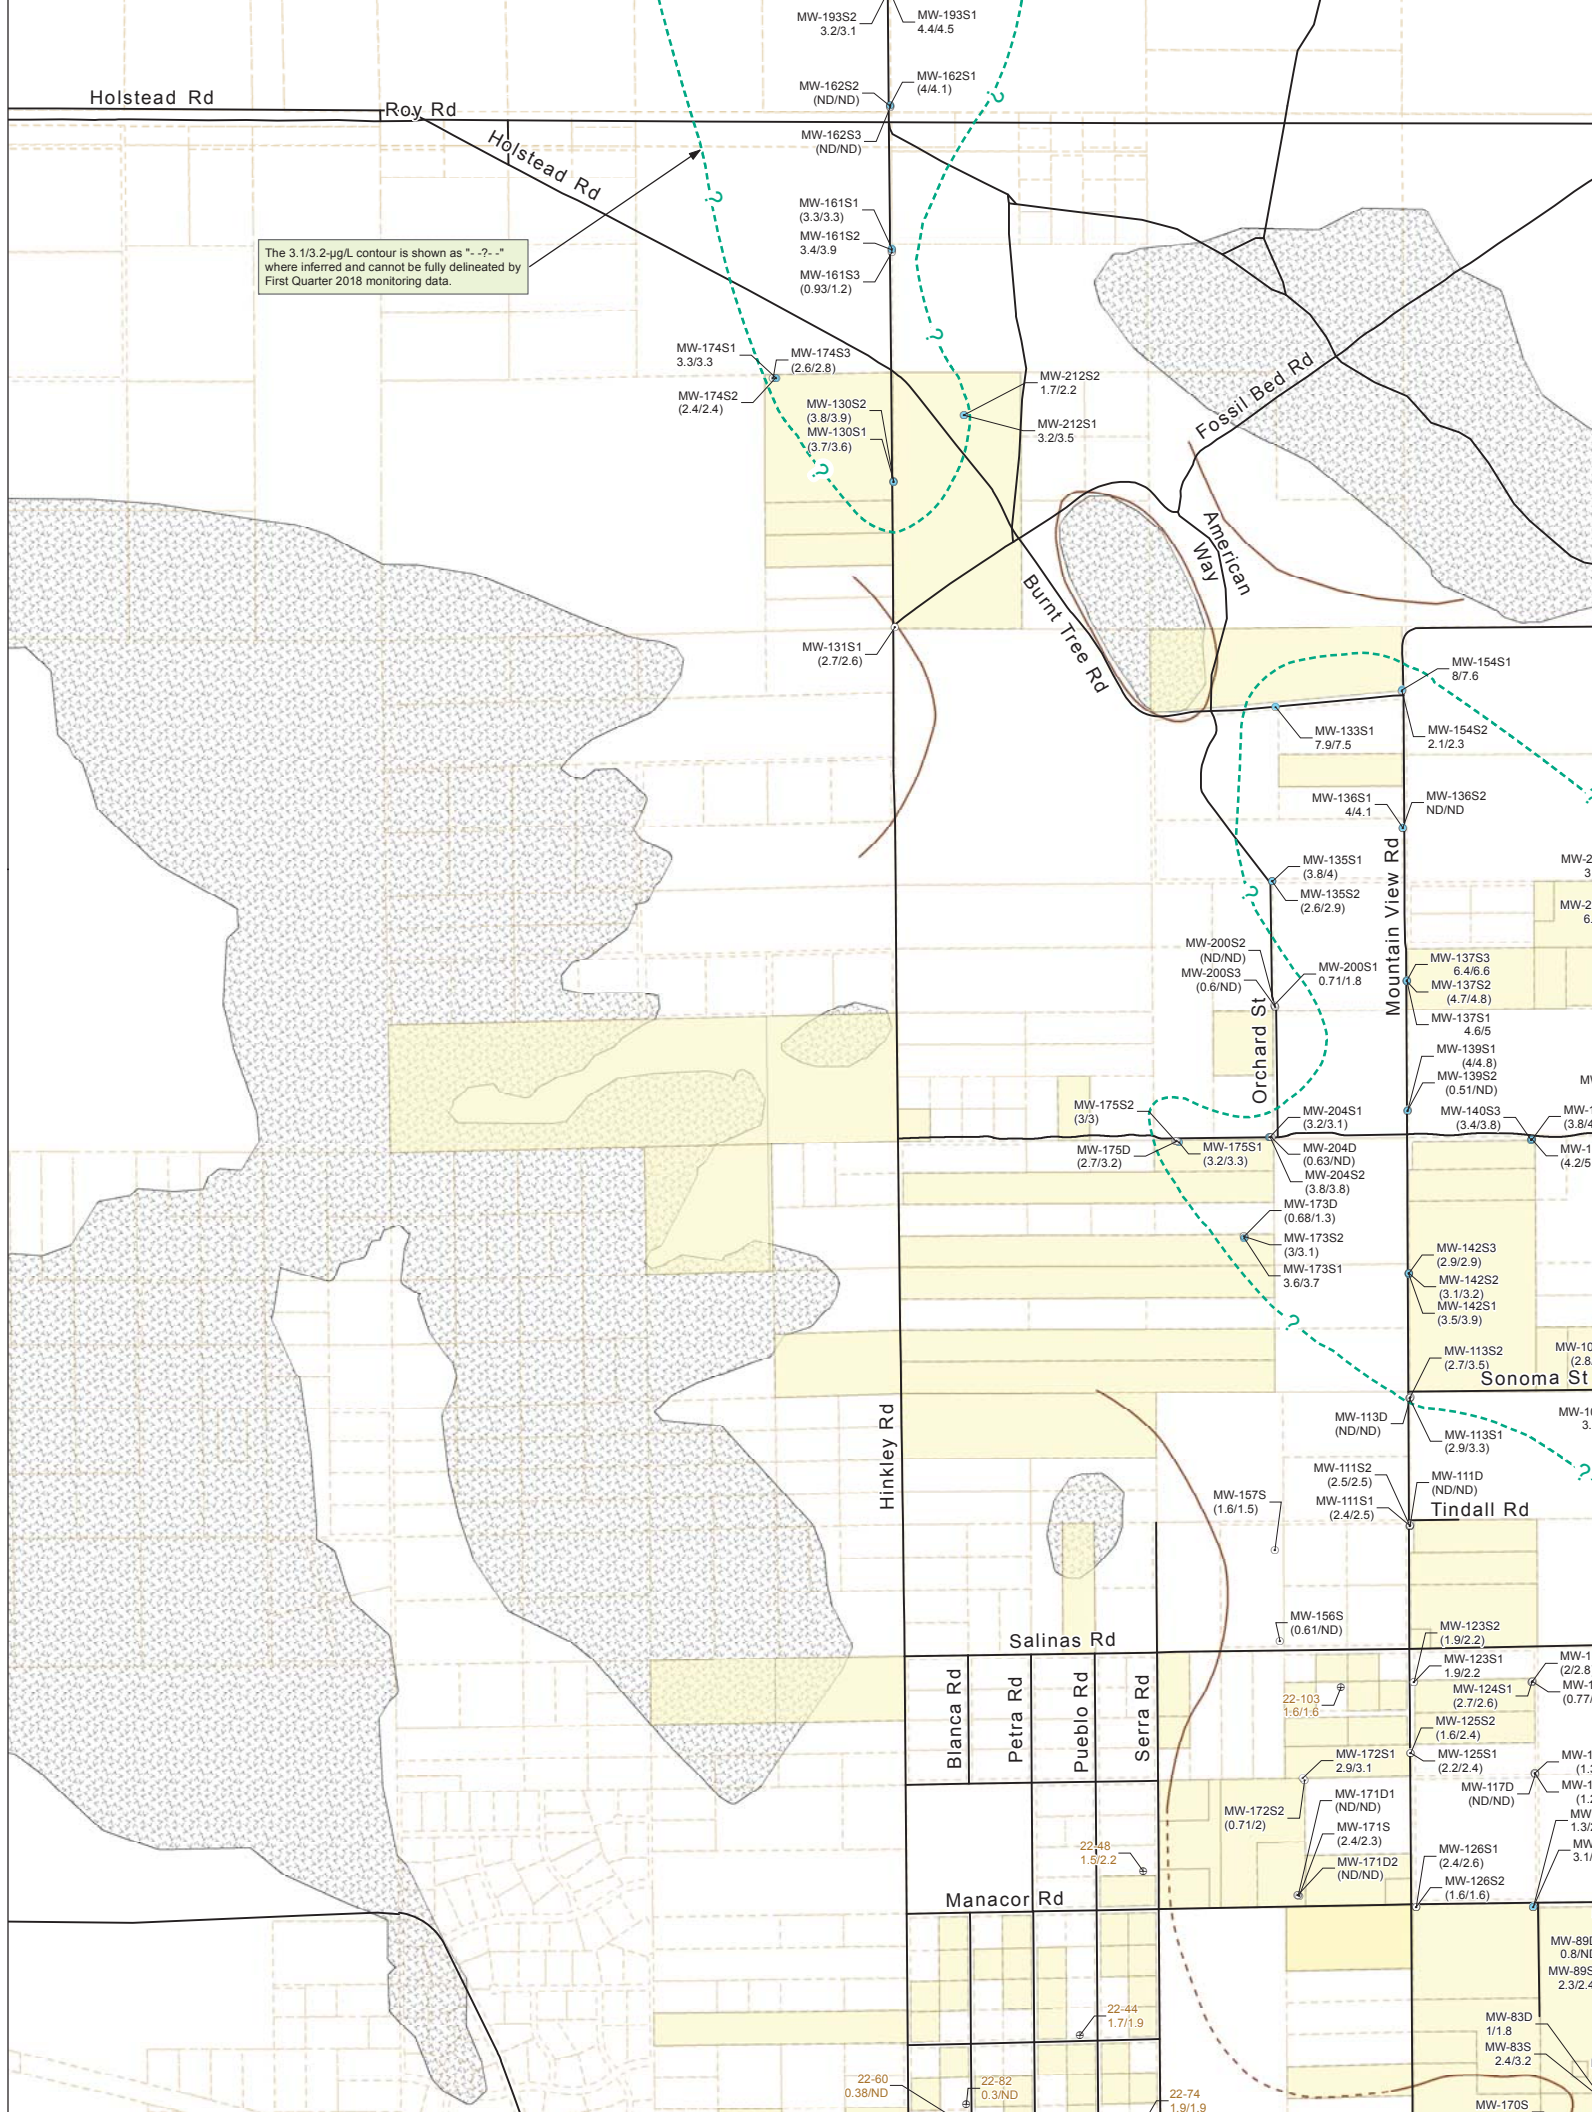
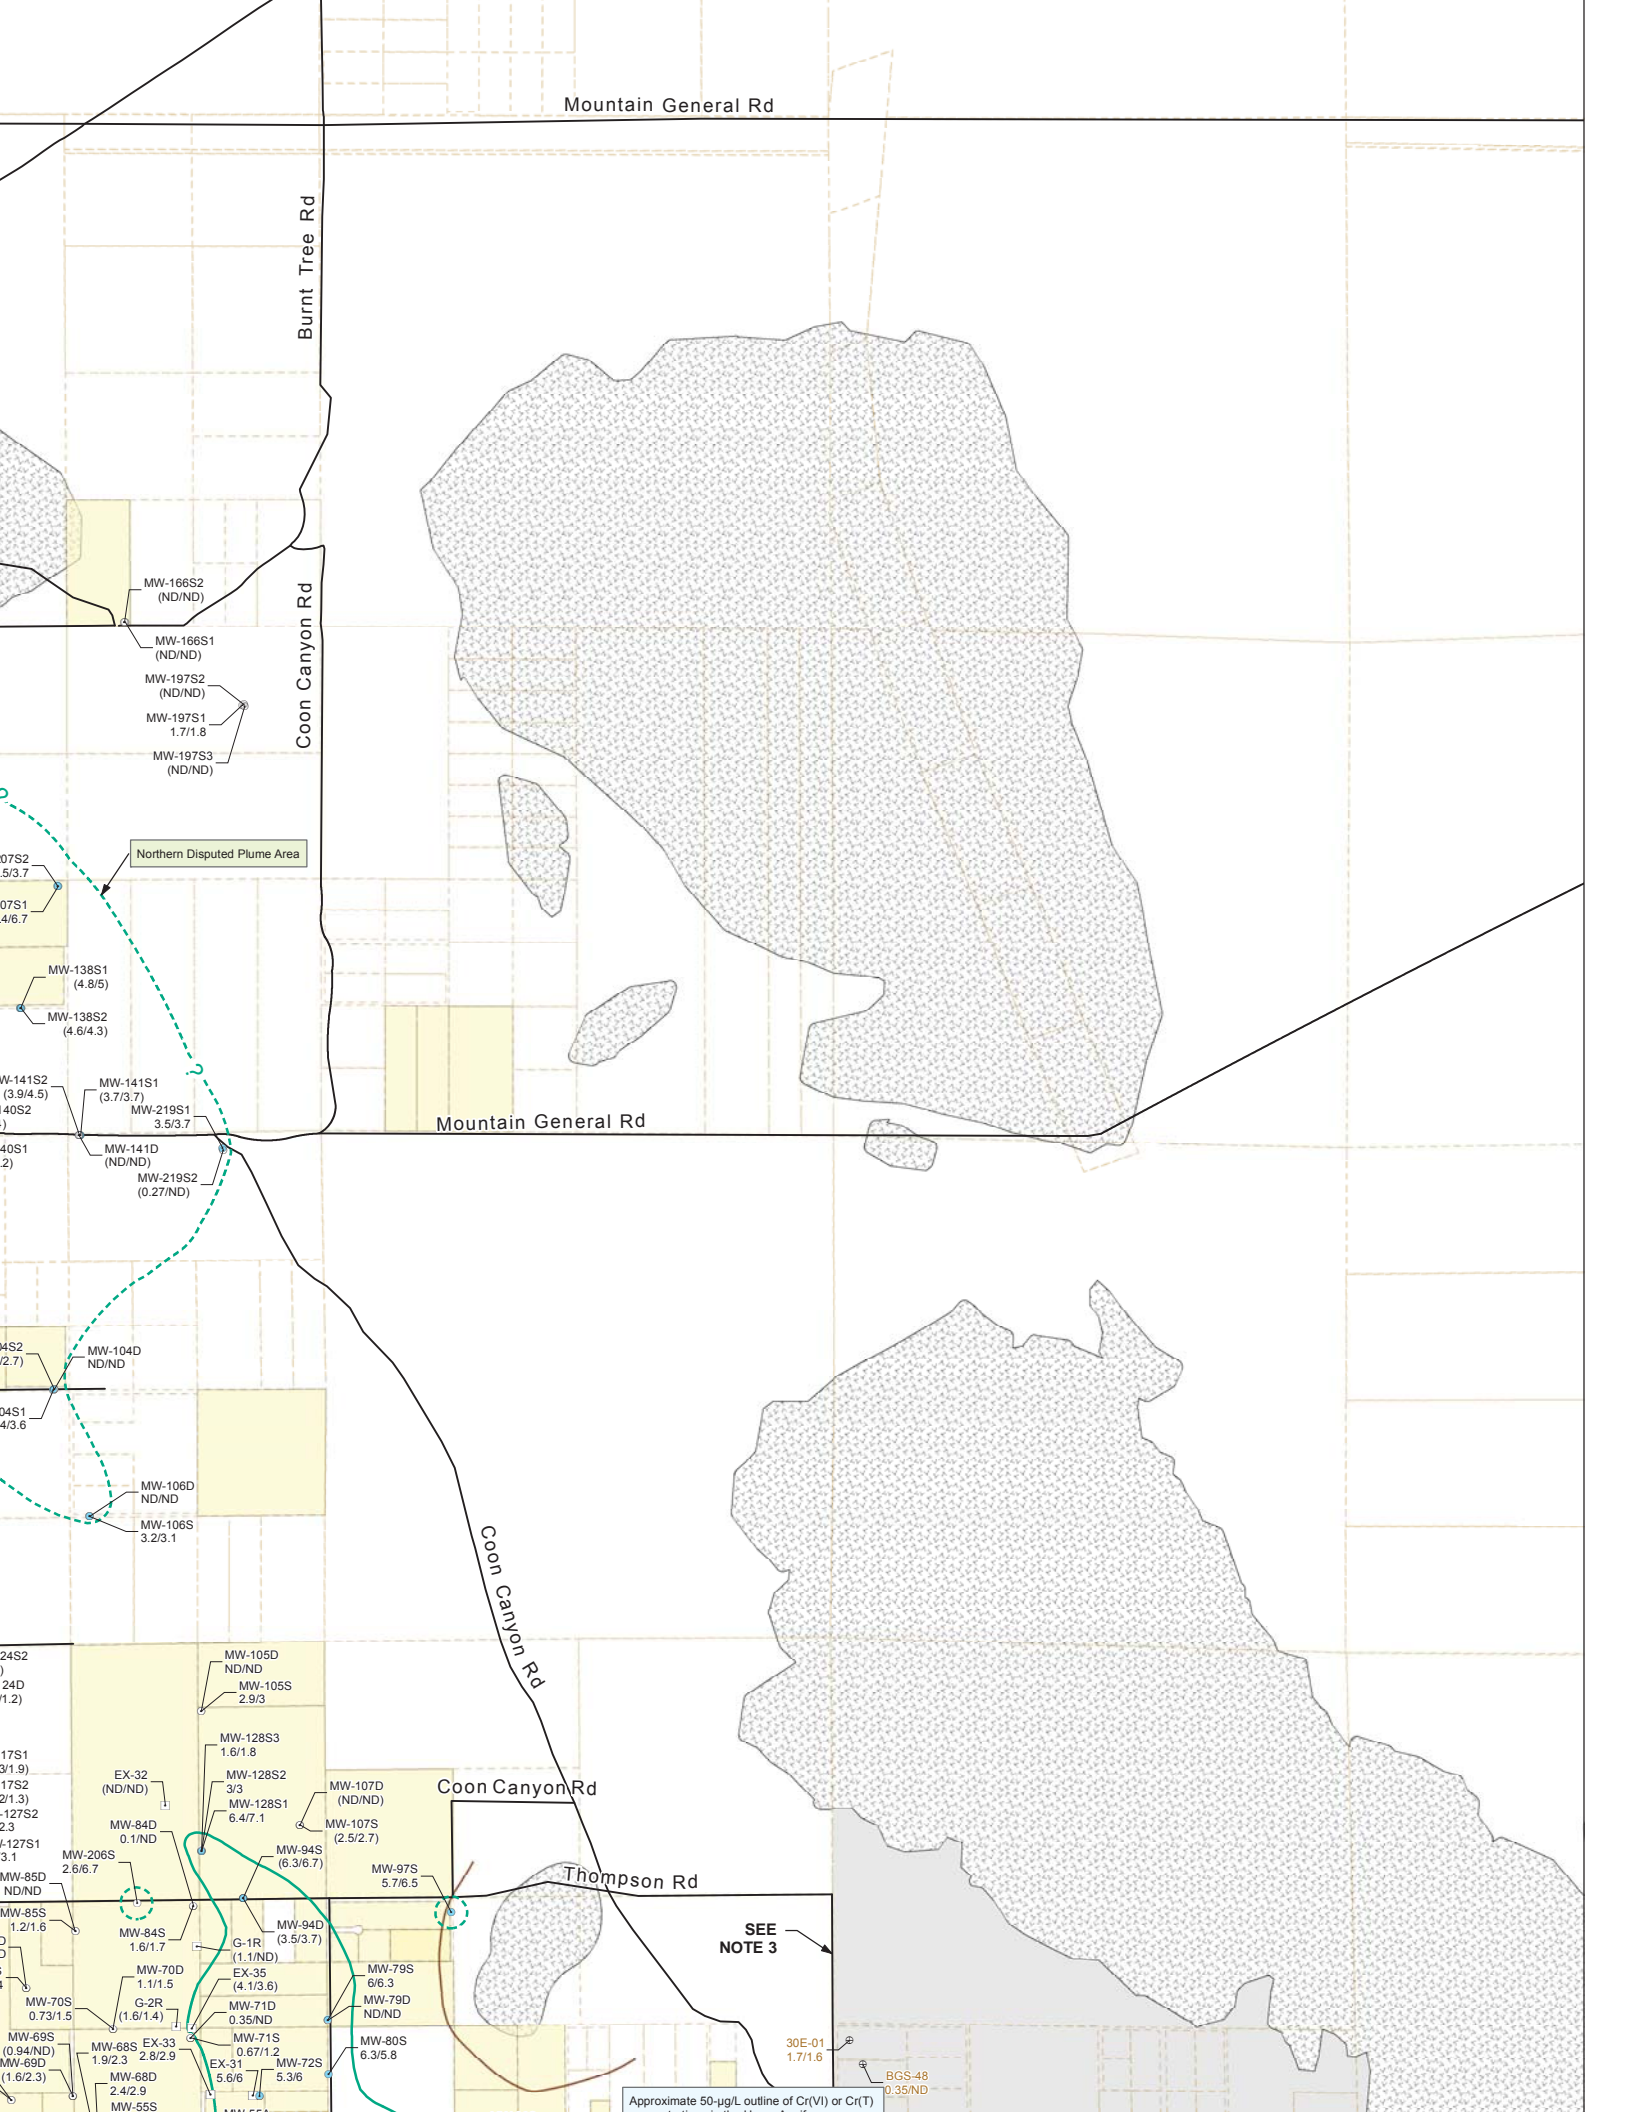
Approximate 50-µg/L outline of Cr(VI) or Cr(T)

MW-177D Well ID
1.5/2 Cr(VI)/Cr(T) concentrations in µg/L; maximum of primary and duplicate samples during First Quarter 2018 sampling. Data in parentheses are from previous reporting period. See Table E-1 for sample dates.

2. The concentration contours are based on First Quarter 2018 chromium results for the groundwater monitoring Figures 5-1 and 5-2. Results for domestic wells (brown-colored labels) were not used for chromium plume control Board's Cleanup and Abatement Order dated November 4, 2015 (Water Board 2015).

4. Chromium plume contours in the general area south of Highway 58, were developed using a larger set of monitoring wells from the Northwest Freshwater Injection Projects (Arcadis 2018). Select wells from that program are shown here.
