Map Grid Index

Groundwater Cr(VI) Concentrations in Monitoring Wells:

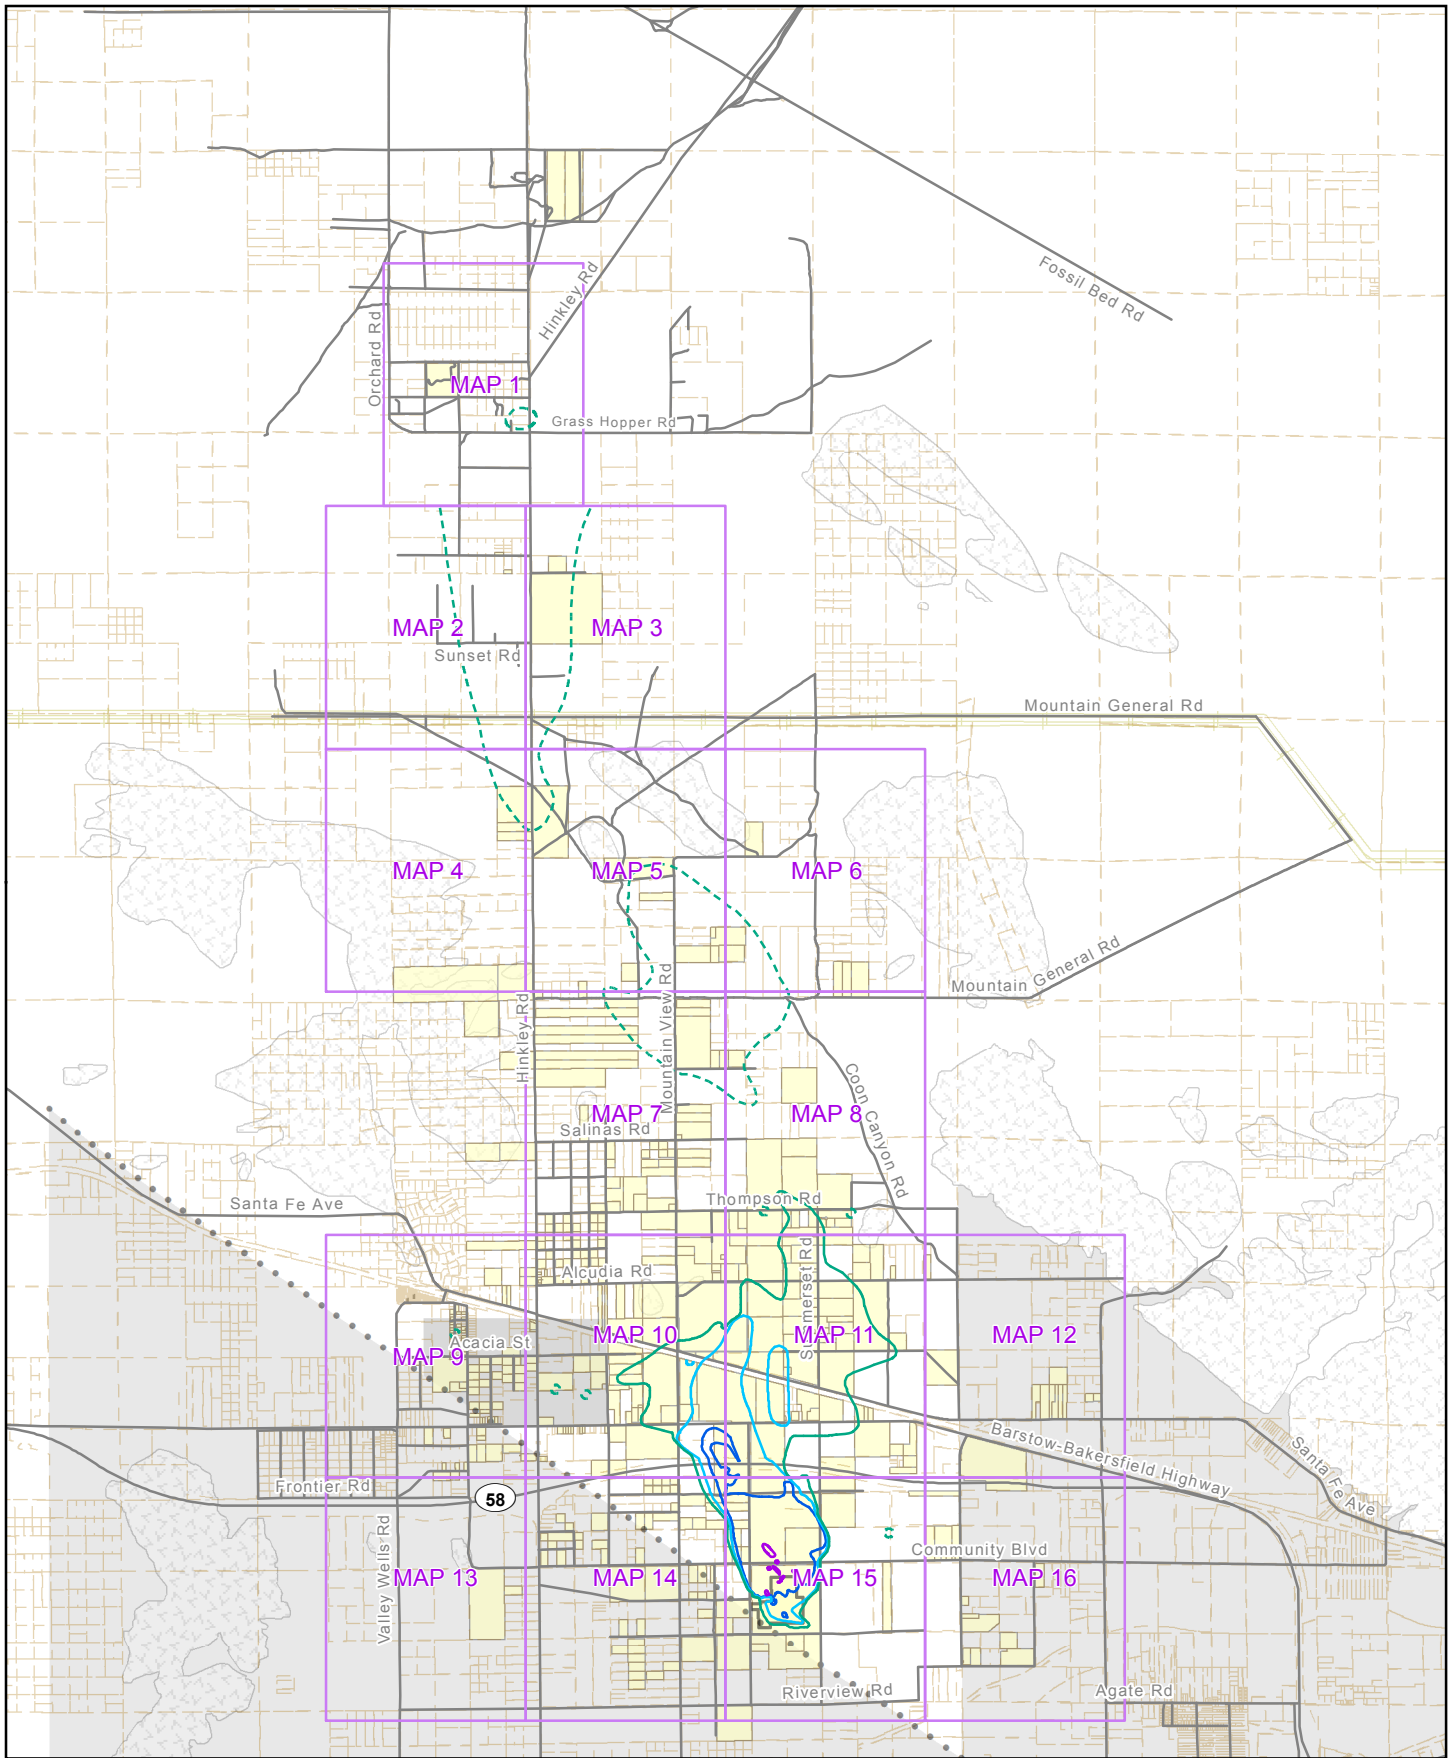
1. Chromium results are shown for Site-wide Groundwater Monitoring Program and domestic wells sampled in the First Quarter (January through March) 2018 monitoring period. For wells sampled multiple times during the reporting period, the most recent results are shown.

2. The concentration contours are based on First Quarter 2018 chromium results for the groundwater monitoring and extraction wells that are completed in the shallow zone and deep zone of the Upper Aquifer as noted on Figures 5-1 and 5-2. Results for domestic wells (brown-colored labels) were not used for chromium plume contouring, except for those in the northern disputed plume areas, pursuant to the Lahontan Regional Water Quality Control Board's Cleanup and Abatement Order dated November 4, 2015 (Water Board 2015).
