**FIGURE S-5**  
**CHROMIUM RESULTS FOR FOURTH QUARTER 2018**  
**GROUNDWATER MONITORING AND DOMESTIC WELL**  
**SAMPLING AND MAXIMUM COMPOSITE PLUME**  
**OUTLINE IN UPPER AQUIFER**

FOURTH QUARTER 2018 GROUNDWATER MONITORING REPORT AND DOMESTIC WELL RESULTS  
 SITE-WIDE GROUNDWATER MONITORING PROGRAM  
 PACIFIC GAS AND ELECTRIC COMPANY  
 HINKLEY COMPRESSOR STATION  
 HINKLEY, CALIFORNIA

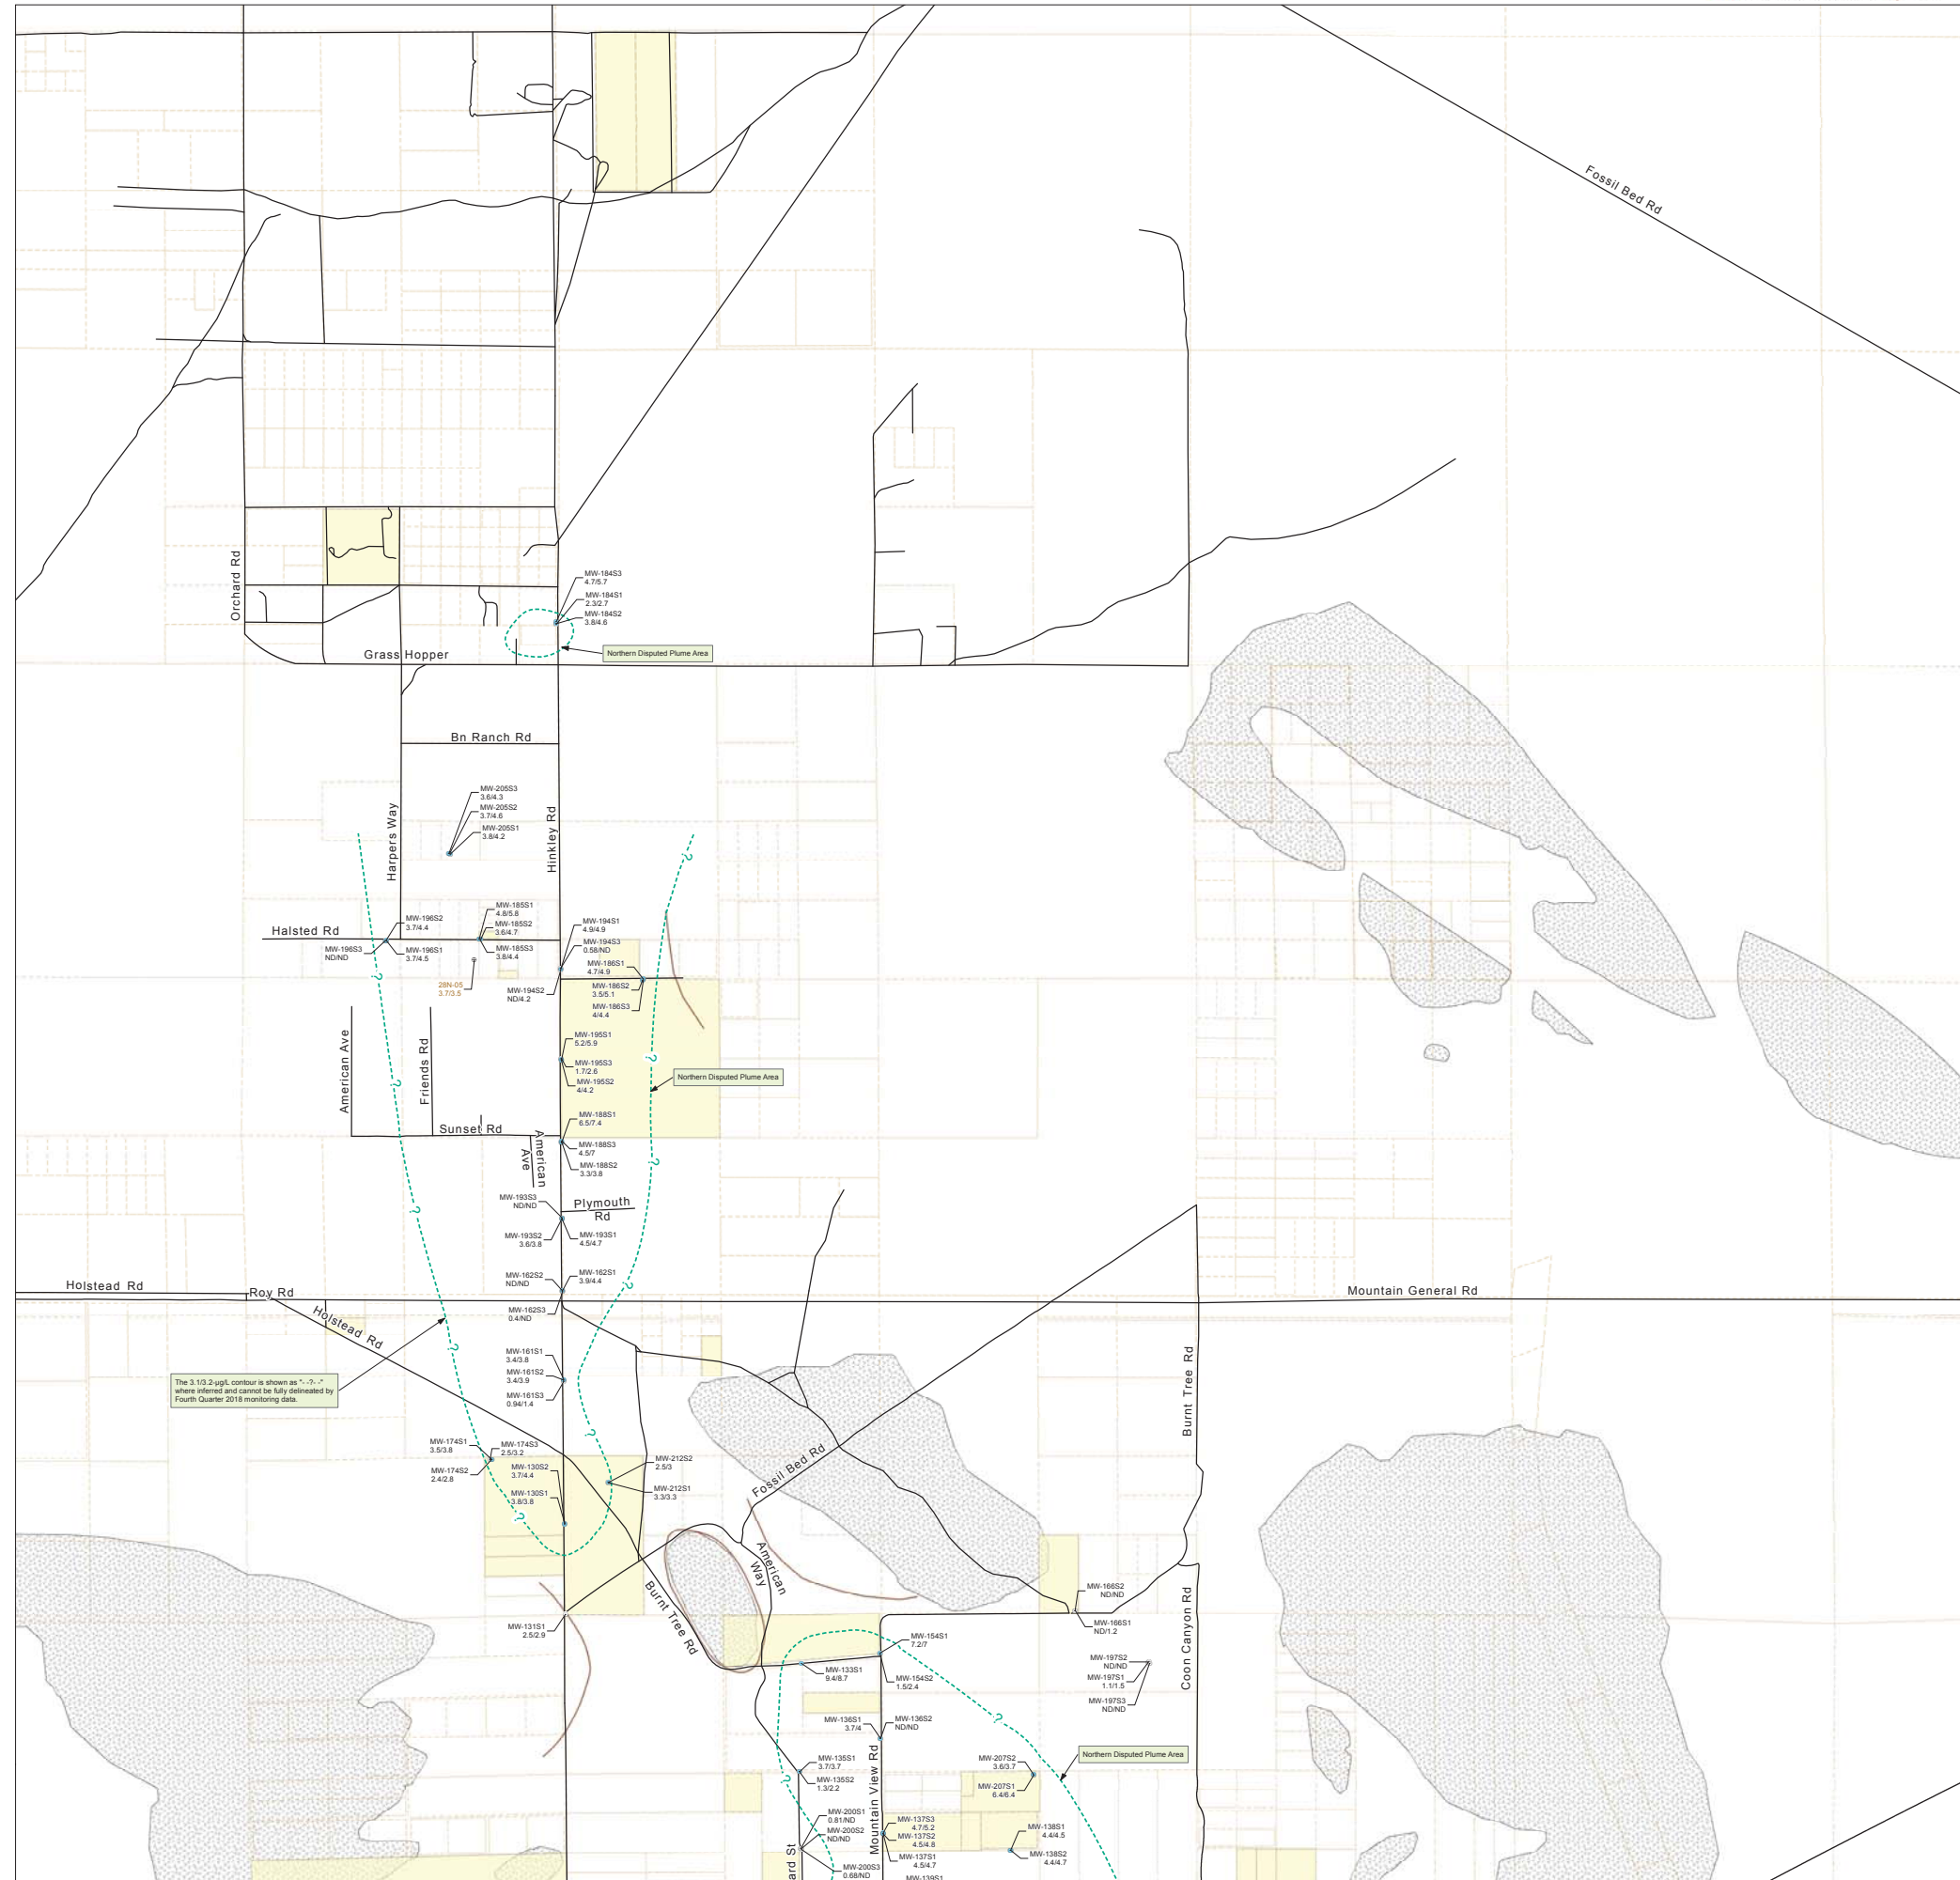
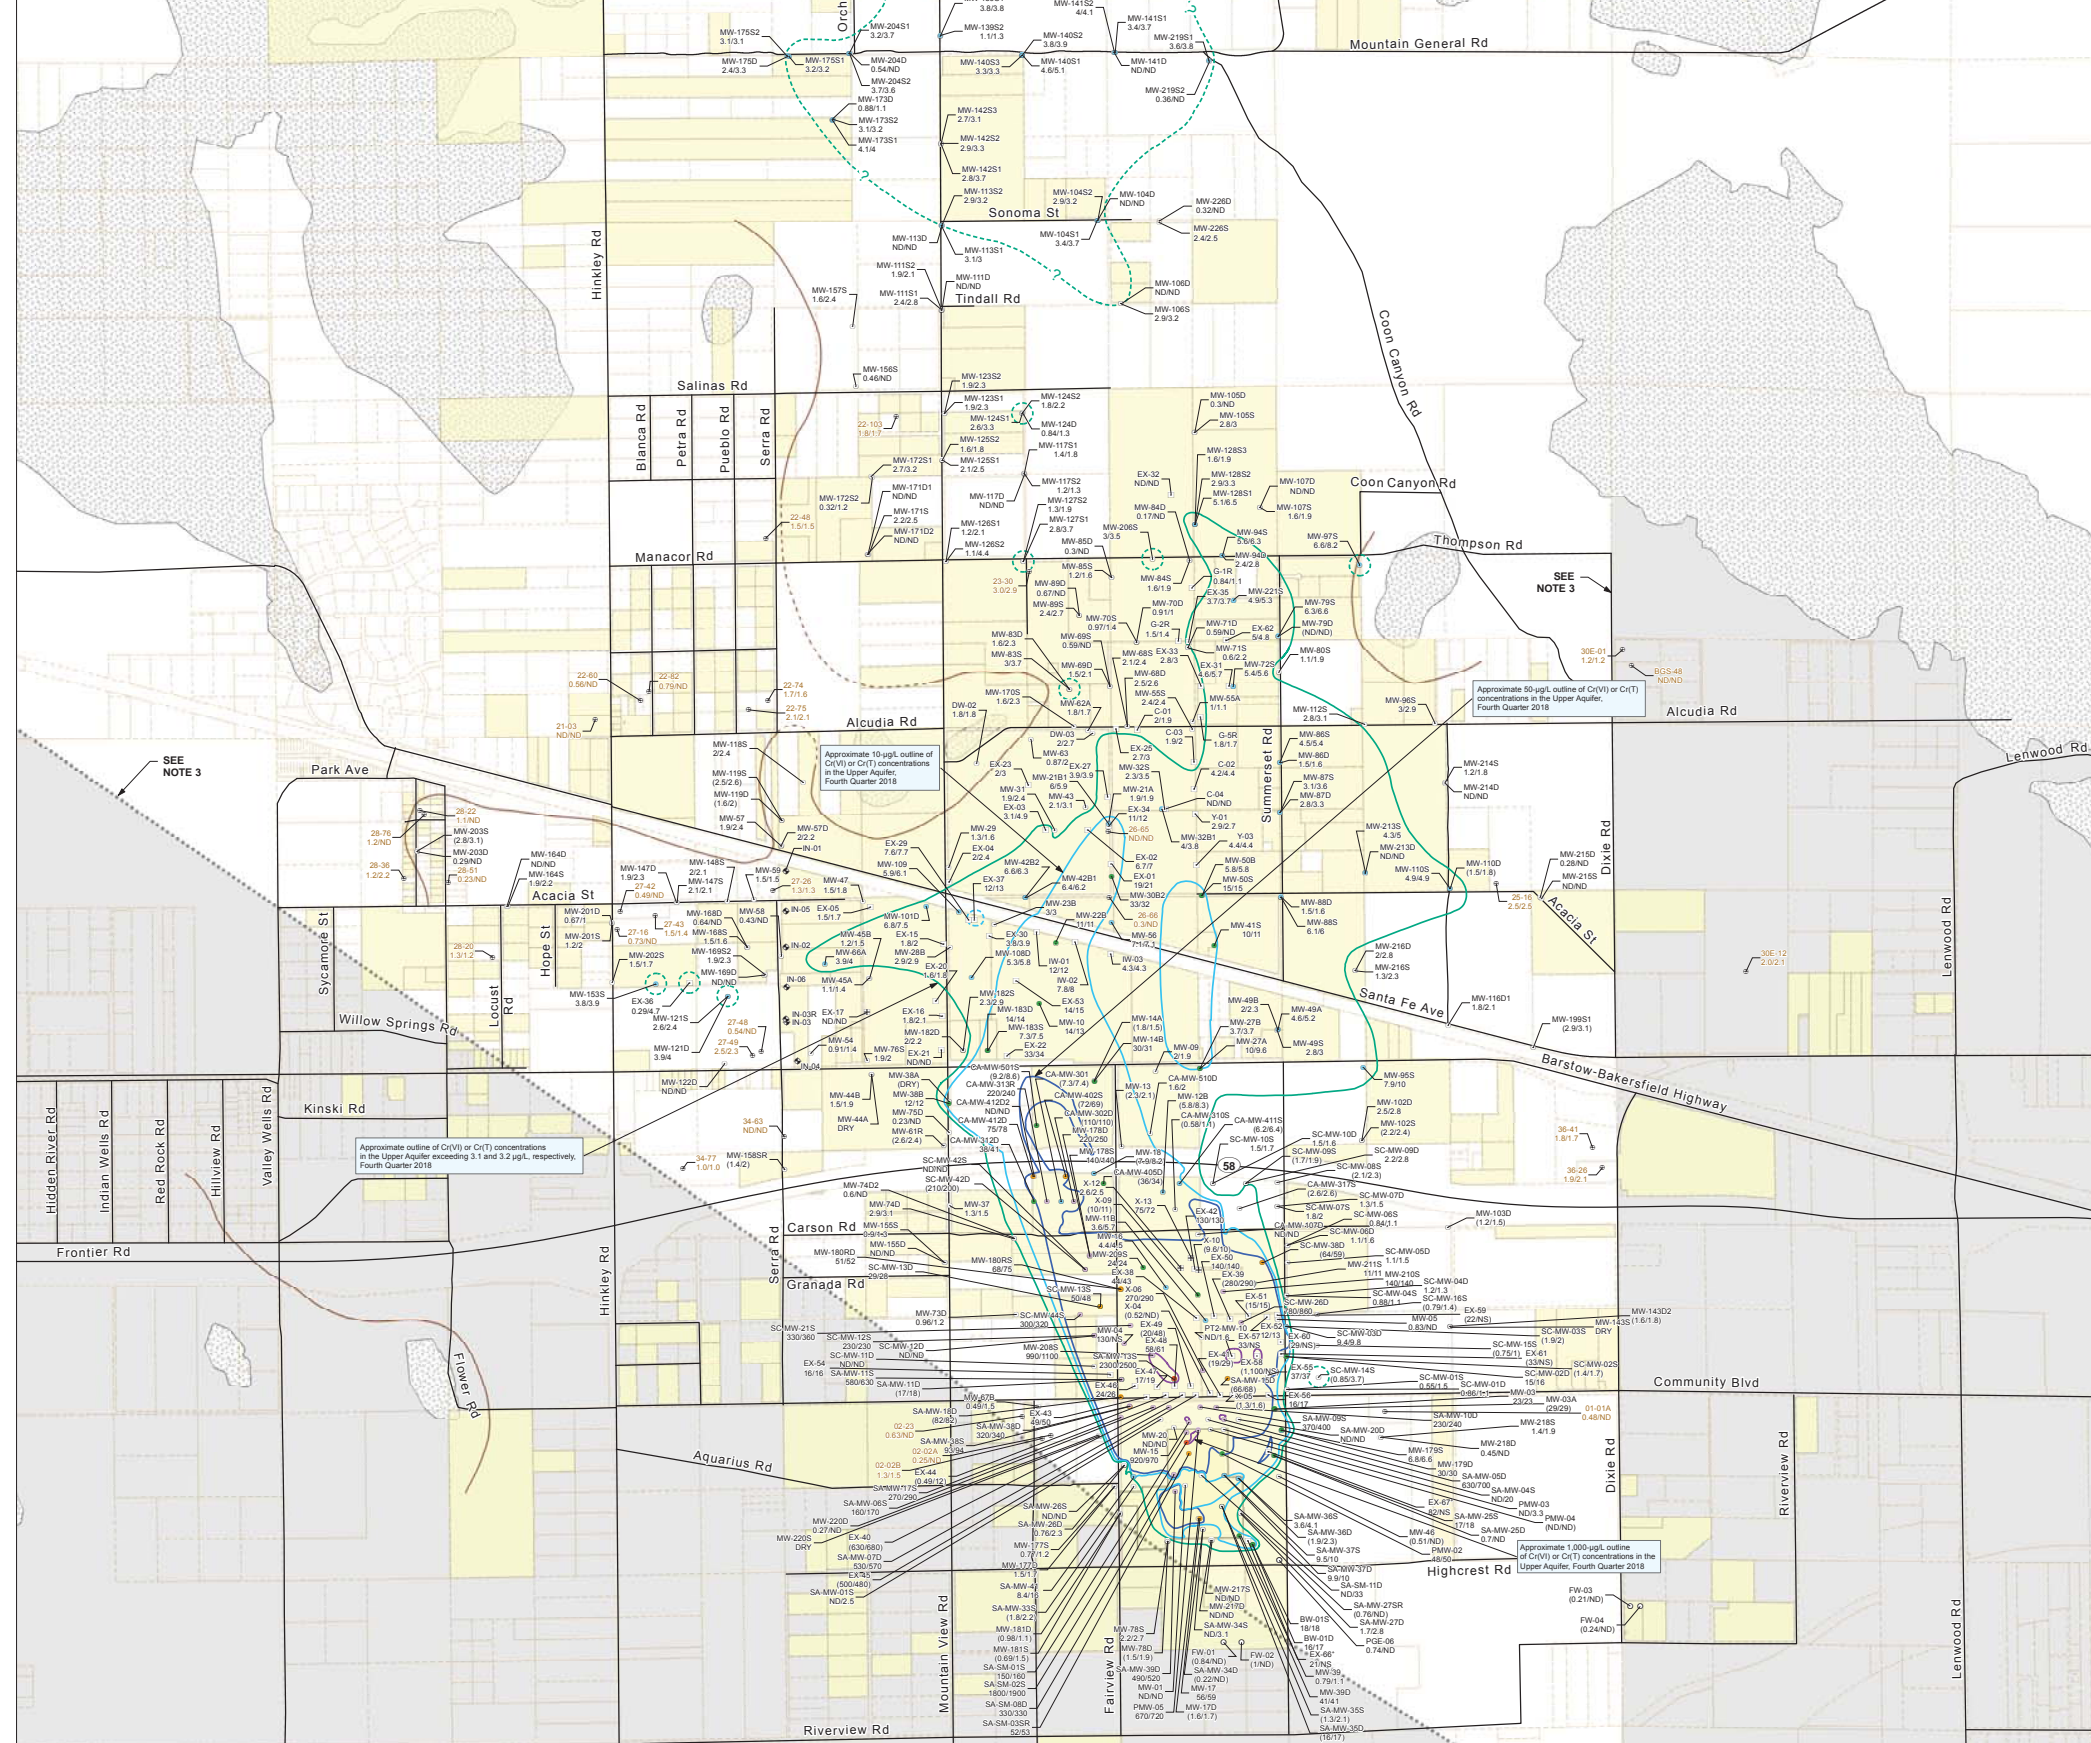
SA-MM-015 Well ID  
150/160 Cr(VI)/Cr(T) concentrations in µg/L, maximum of primary and duplicate samples during Fourth Quarter 2018 sampling.  
(500/480) Data in parentheses are from previous reporting period. See Table E-1 for sample dates.

- Chromium results are shown for Site-wide Groundwater Monitoring Program and domestic wells sampled in the Fourth Quarter (October through December) 2018 monitoring period. For wells sampled multiple times during the reporting period, the most recent results are shown.

- The concentration outlines are based on Fourth Quarter 2018 chromium results for the groundwater monitoring and extraction wells that are completed in the shallow zone and deep zone of the Upper Aquifer as noted on Figures S-1 and S-2. Results for domestic wells (brown-colored dots) were not used for chromium plume contouring, except for those in the northern dipper plume areas, as noted on the Lahontan Regional Water Quality Control Board's Cleanup and Abatement Order dated November 4, 2015 (Water Board 2015).

- Pursuant to the Lahontan Regional Water Quality Control Board's Cleanup and Abatement Order dated November 4, 2015 (Water Board 2015), groundwater monitoring wells are not used for chromium contouring if they are located in the areas southwest of the Lockhart Fault and on or east of Dixie Road. Monitoring wells sampled southeast of Lockhart Fault and east of Dixie Road were sampled in support of United States Geological Survey background chromium investigations.

- Chromium plume contours in the general area south of Highway 58, were developed using a majority of monitoring data which is presented in the Fourth Quarter 2018 Monitoring Report for the In Situ Reactive Zone and Northwest Freshwater Injection Projects (Arcadis 2019). Select wells from that program are shown here for reference.
