**Subject: Notice of Violation No. R9-2013-0008 City of Encinitas, Hall Property Park,
Order No. 2009-0009-DWR (NPDES No. CAS000002)**

NOTICE OF VIOLATION
No. R9-2013-0008

FACILITY INSPECTION REPORT

FACILITY: Hall Property Park, City of Encinitas Community Park **INSPECTION DATE/TIME:** 12/17/2012; 1300

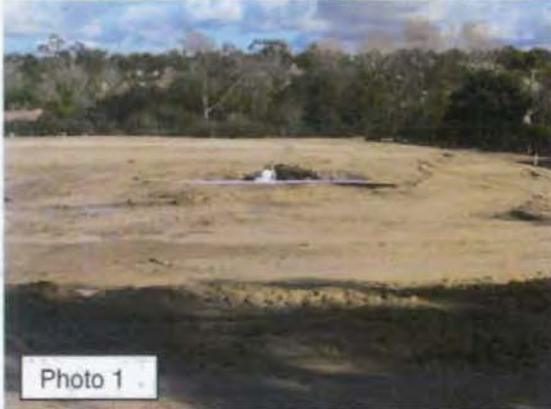
Photo 1

Finding 1: 43 acre site in rough grading stage, during the rainy season.

Photo 1: Looking south east over future *Dog Park* location. No erosion or sediment controls in place. Photo 2: Looking south towards *Caretta Way*. No erosion control and no sediment control in place on the site.

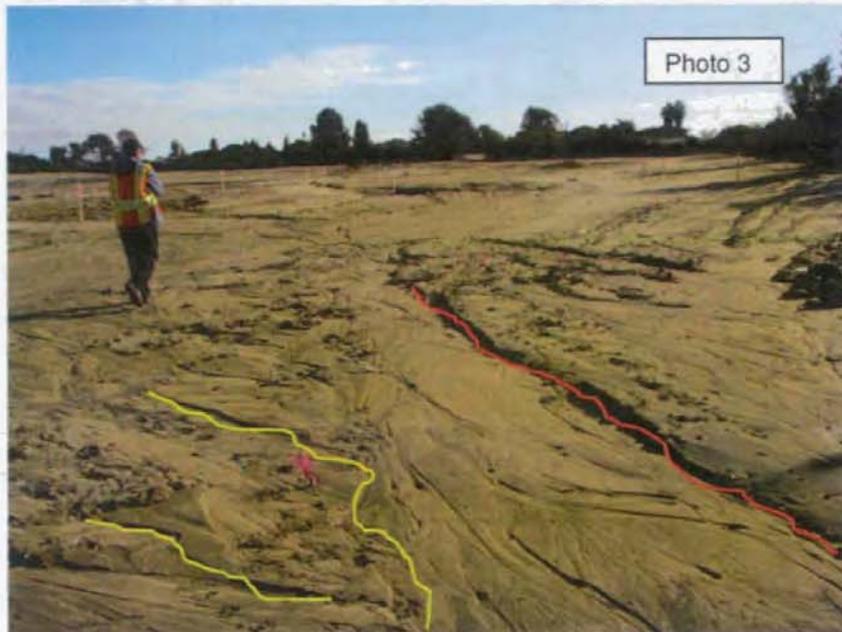
Photo 3

Finding 2: Erosion controls and sediment controls not in place at the site.

Photo 3: Looking uphill, over largest area of *Community Park* towards *Caretta Way*. Erosion and sediment controls not present on site. There are no check dams, erosion control blankets, or soil binders in place within the concentrated flow paths as specified in the SWPPP. Erosion evident by rills (a few shown in yellow) and channel incisions (a few shown in red) seen in soil on site.

5. Adequate erosion control BMPs shall be implemented at the site on all slopes and other areas necessary to prevent the discharge of sediment.

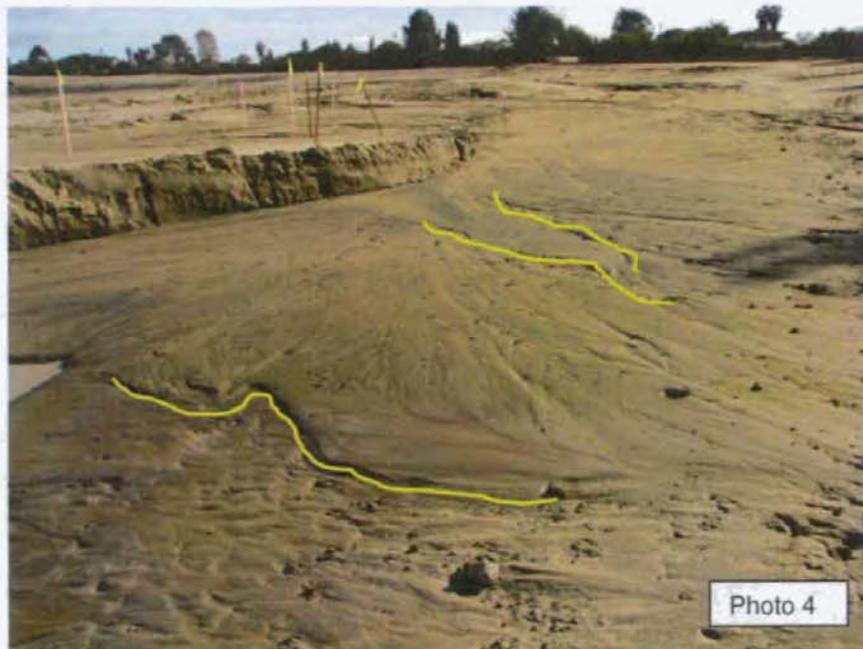
Photo 4: Erosion (rills shown by yellow lines) occurred due to lack of erosion and sediment control BMPs on site prior to the rainy season. There are no check dams, erosion control blankets, or soil binders in place within the concentrated flow paths as specified in the SWPPP.

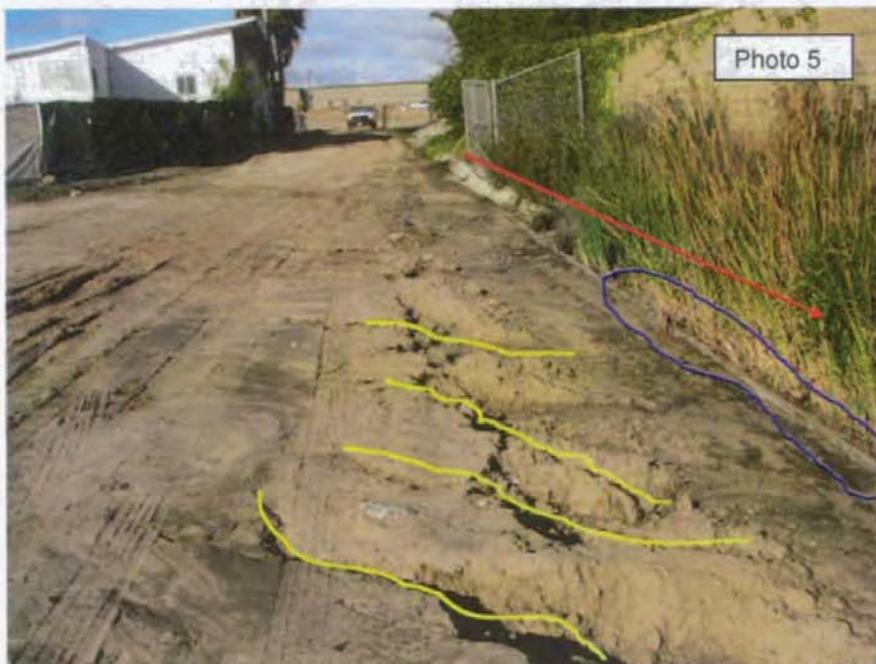
Drainage path leading to Rossini Creek (red arrow). Sediment discharge to drainage ditch evident by large erosion rills (yellow lines) and sediment within vegetation (blue outline).

Photo 5: Significant erosion occurred due to lack of erosion control and sediment control BMPs on site prior to the rain. There are no check dams, erosion control blankets, or soil binders in place within the concentrated flow paths as specified in the SWPPP. Sediment discharged from the site to the concrete ditch (at the right of the photo) that discharges to Rossini Creek.

3. Failure to direct run-on away from the site caused a discharge of sediment from the site to Rossini Creek. BMPs should be installed to protect the site from erosion due to run-on flow volumes.

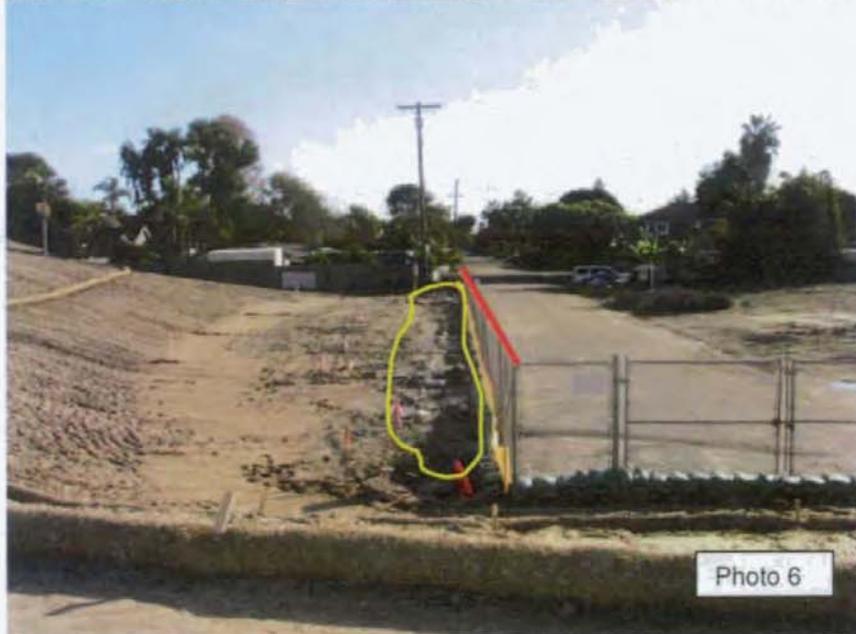
Finding 3: Erosion control BMPs (runoff control and soil stabilization) were not present on site. Sediment-laden storm water was discharged from the construction to Rossini Creek.

Photo 6: Soil binders were reportedly used in conjunction with "track-up/track-down" BMPs on the slope. These BMPs failed to secure soil and prevent erosion. This photo shows sedimentation at the base of the slope (outlined in yellow) along the fence line (shown in red).

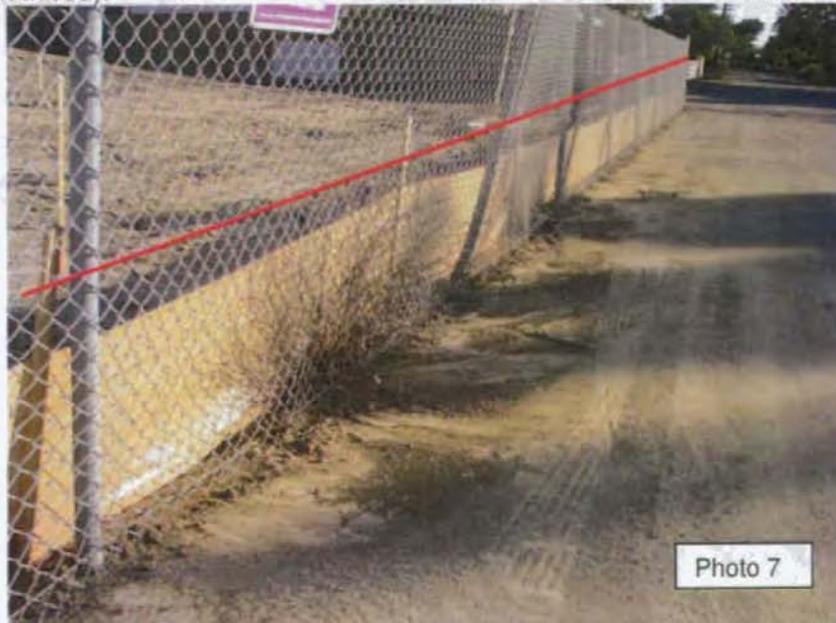
Photo 7: This is the same fence line (in red) shown in Photo 6. Soil binders and track-up/track-down BMPs failed to secure soil and prevent erosion. This photo shows sediment left the site and was discharged to Starlight Drive. This sediment still had not been cleaned up at the time of inspection. This silt fence looked new because of how clean it is. It is unknown if a silt fence was there prior to the rain event.

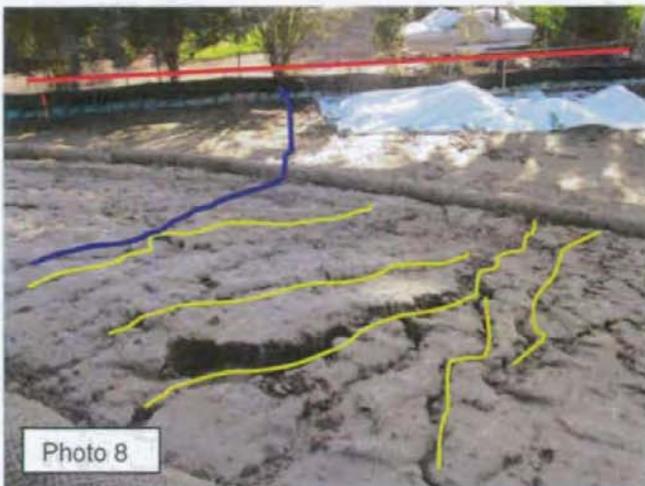
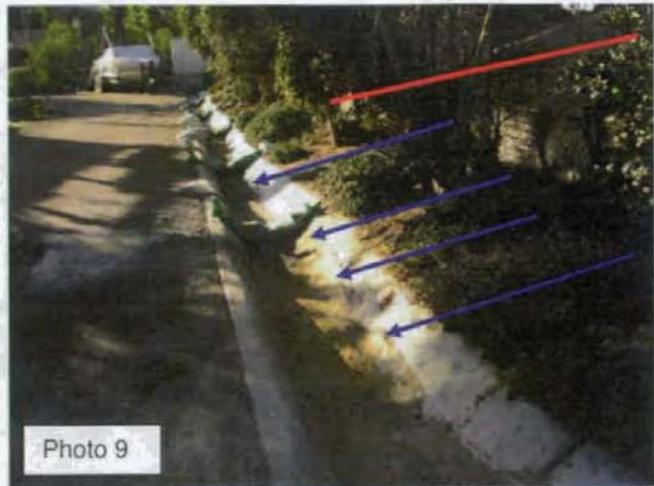
Photo 8 shows evidence of significant erosion rills (outlined in yellow). This slope was reportedly treated with soil binders and the track-up/track-down BMP. As seen in Photo 9, sediment discharged beyond the site fence (outlined in red). This is the same fence as seen in Photo 8. Sediment discharged from the site after the last rain event still seen in the drainage ditch in Photo 9. Sediment deposits can also be seen on the asphalt of Caretta Way in Photo 9. Flow and sediment left the site along a path shown by the blue lines.

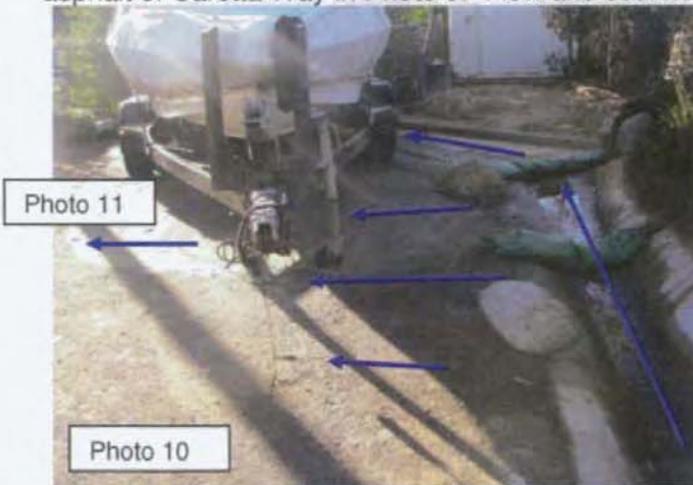
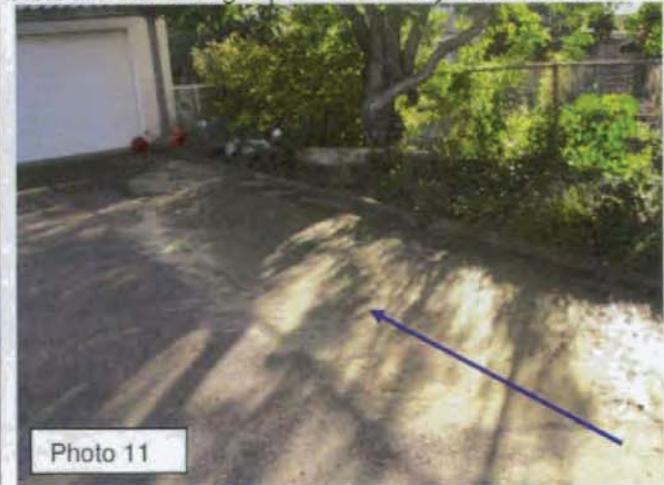
Flow and sediment from the site discharged past the fence line shown in Photo 8 and flowed the path shown by the blue line in Photo 9, 10 and 11. As seen in Photo 11 sediment discharged from the site travel quite a distance documenting the lack of erosion control BMPs on the construction site.

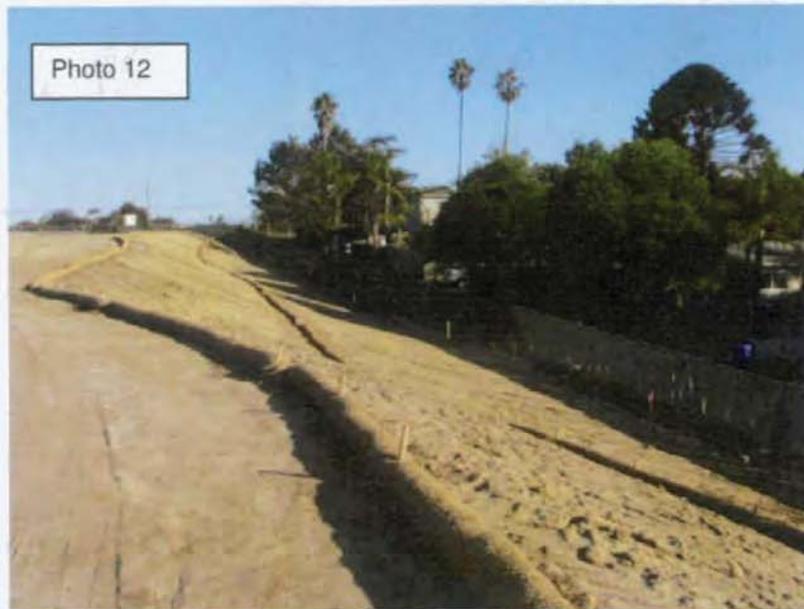
Finding 4: Sediment Control on slopes along Caretta Way.

Photo 12: Soil binder plus "track-up/track down" was reportedly used as a sediment control BMP on the slope shown in Photo 12. The fiber rolls in Photo 12 and the gravel bags at the fence line were placed after the rain event and before the inspection because they were free of any sediment and very clean.

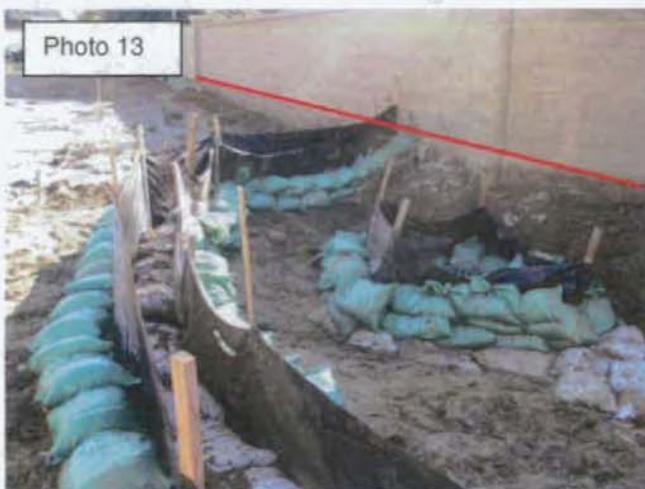
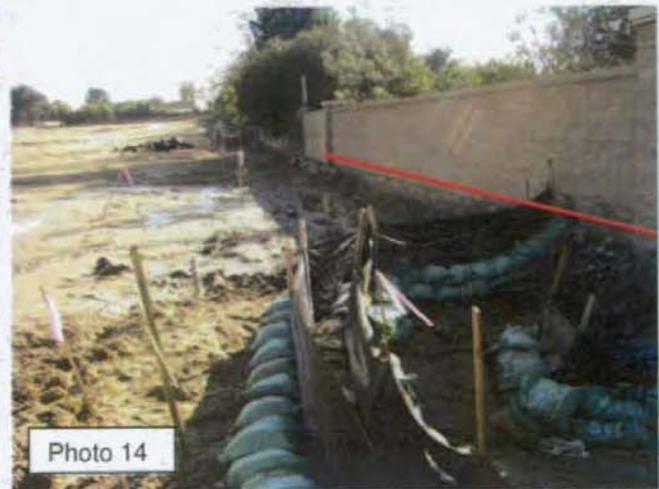
Photo 13 and 14 show new gravel bags (green bags) were placed after the rain event and prior to the inspection. The outer most silt fence was also placed after the rain event and prior to the inspection. The middle silt fence has sediment all over it indicating it was in place before the rain event. The outer most silt fence and stakes were clean. This area was inundated with sediment laden water as indicated by the sediment line on the brick wall (red line). The elevation of the red line is well above the storm drain inlet indicating a discharge of site sediment to the storm drain.

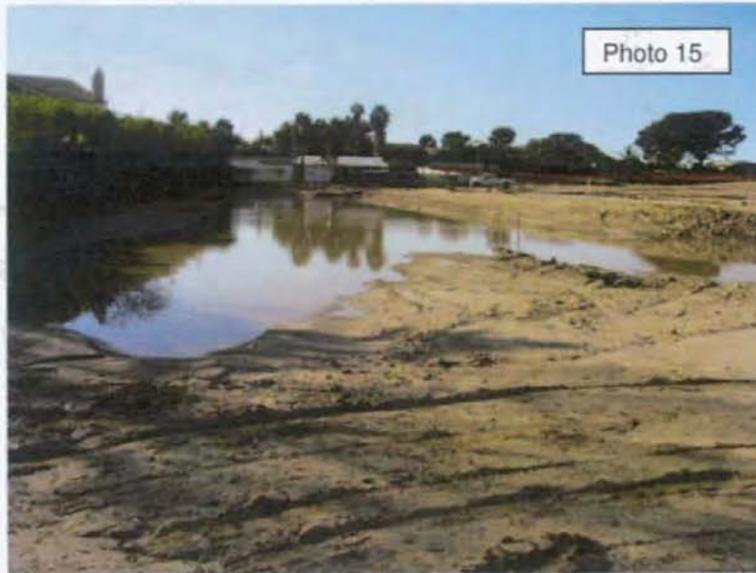
Finding 5: Storm water detention basins to control sediment were not present on site.

Photo 15 shows reported location where a sediment basin will be constructed.

2. Sediment control basins can be used provided they are designed with adequate capacity to capture and treat sediment-laden storm water generated from the site. Implementation of adequate erosion control BMPs, sediment control BMPs, and sediment basins are required to prior to the rainy season (October 1), as described in the SWPPP.
