Rhodia Martinez  
Peyton Slough

Project No. 26812485

Proposed Project  
Plan View

Figure  
2.5-1

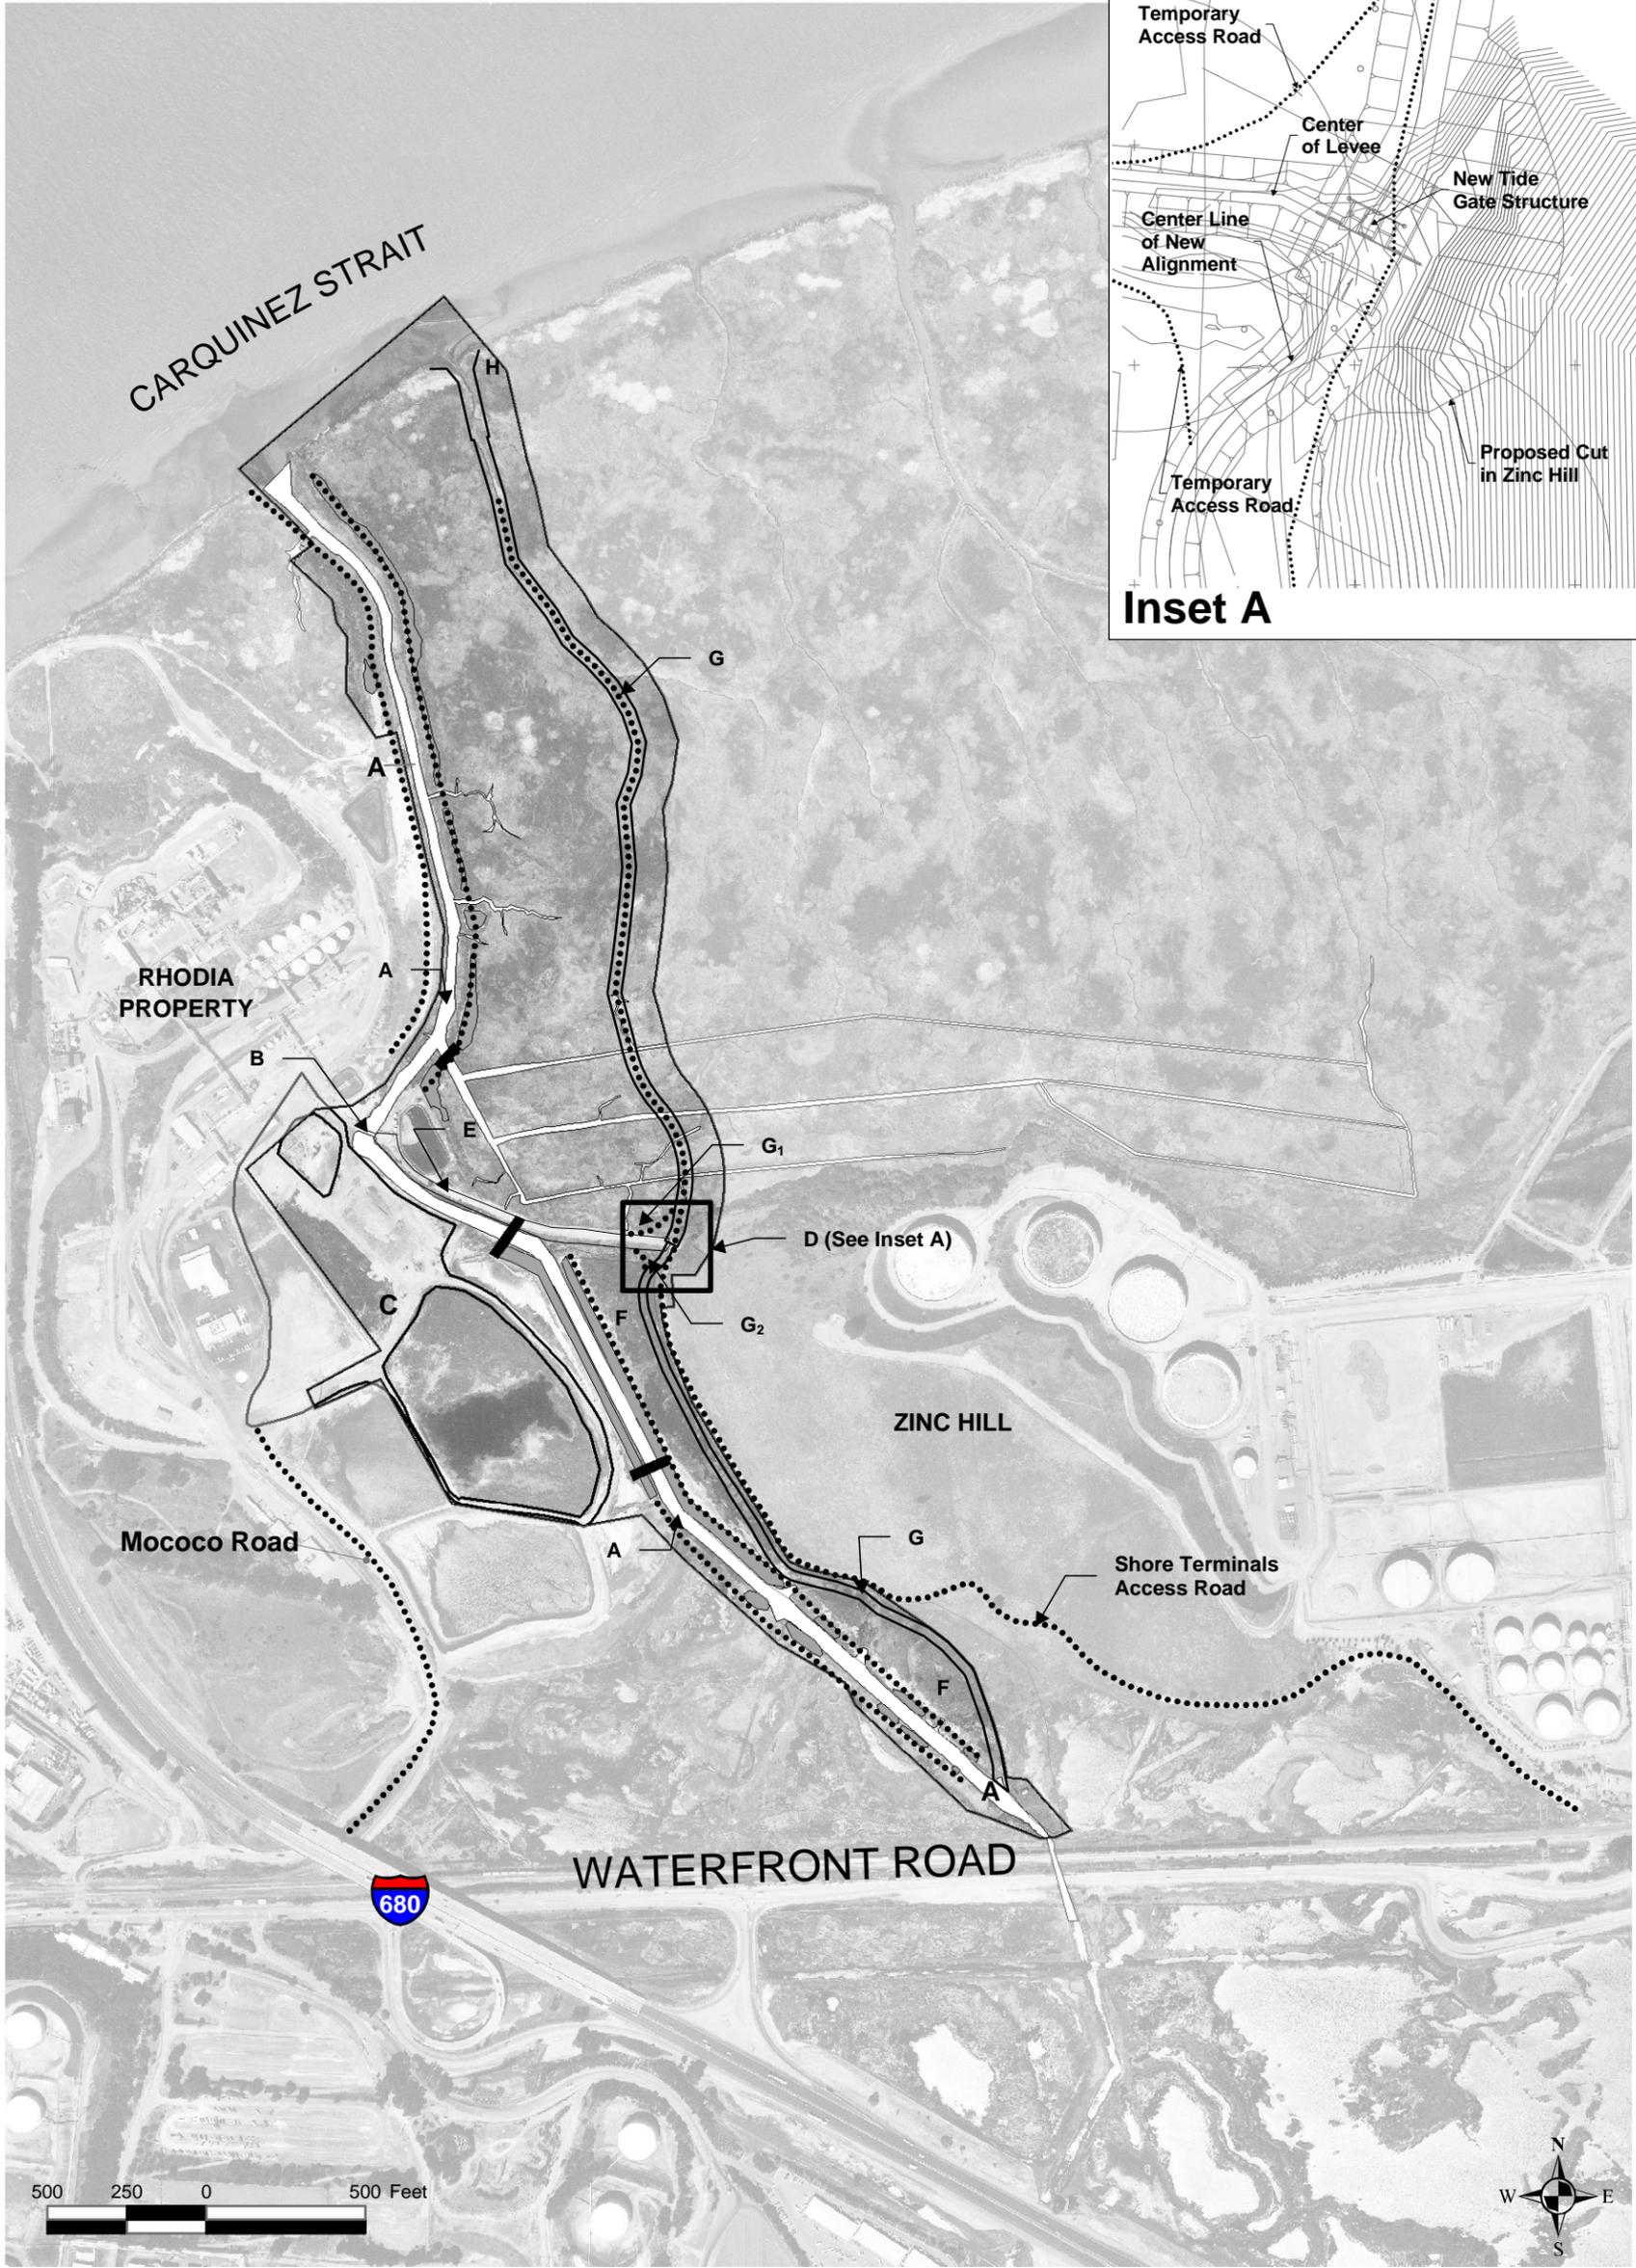
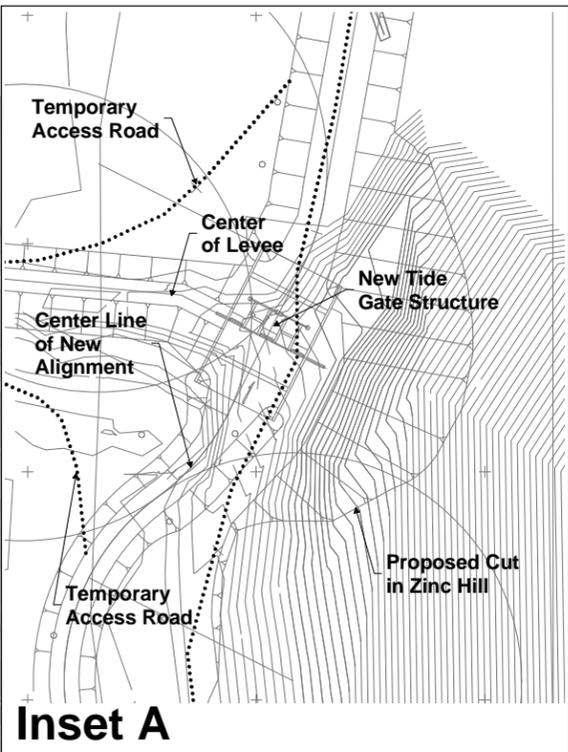
- Temporary Slough Crossings
- Temporary Access Roads
- Dredge Spoil Piles

- A** - Existing Peyton Slough (Place an engineered cap)
- B** - Existing Tide Gate (Closed in place)
- C** - Temporary Staging/ Stockpiling Area (Upland Area to be graded and paved)

- D** - New Tide Gate Location (See Inset for D, cross-sections on Fig. 3)
- E** - Levee
- F** - South Spread Area (Wetlands to be excavated and backfilled with clean soil to new wetland design grade, and then restored to wetlands)

- G** - New Alignment (30' wide, 2' to 4' of fill for temporary access road, then removed during excavation of channel)
- G<sub>1,2</sub>** - Temporary Access Roads (North and south side of levee to bypass tide gate)
- H** - Mouth of New Alignment (Widen to approximately 50' using a barge-based clamshell excavator)
