CITY OF DUBLIN
FISCAL YEAR
2014-2015 ANNUAL
REPORT OF
STORMWATER
PROGRAM
IMPLEMENTATION

Submitted to:
California Regional Water
Quality Control Board, San
Francisco Bay Region,
September 15, 2015

CITY OF DUBLIN

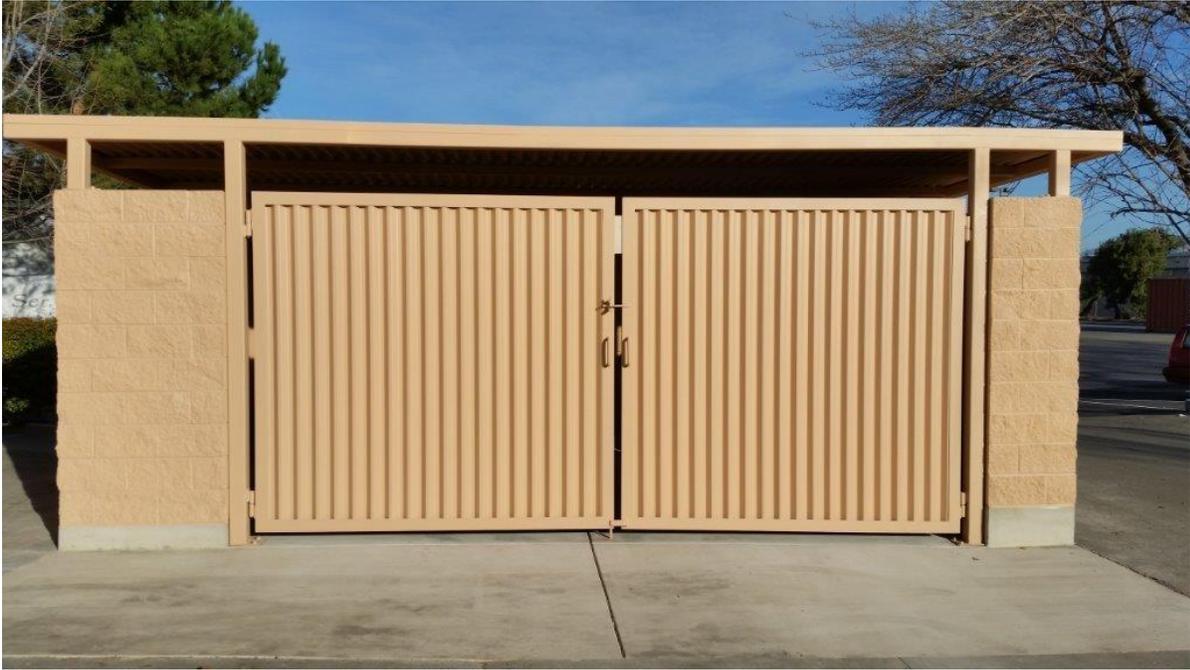
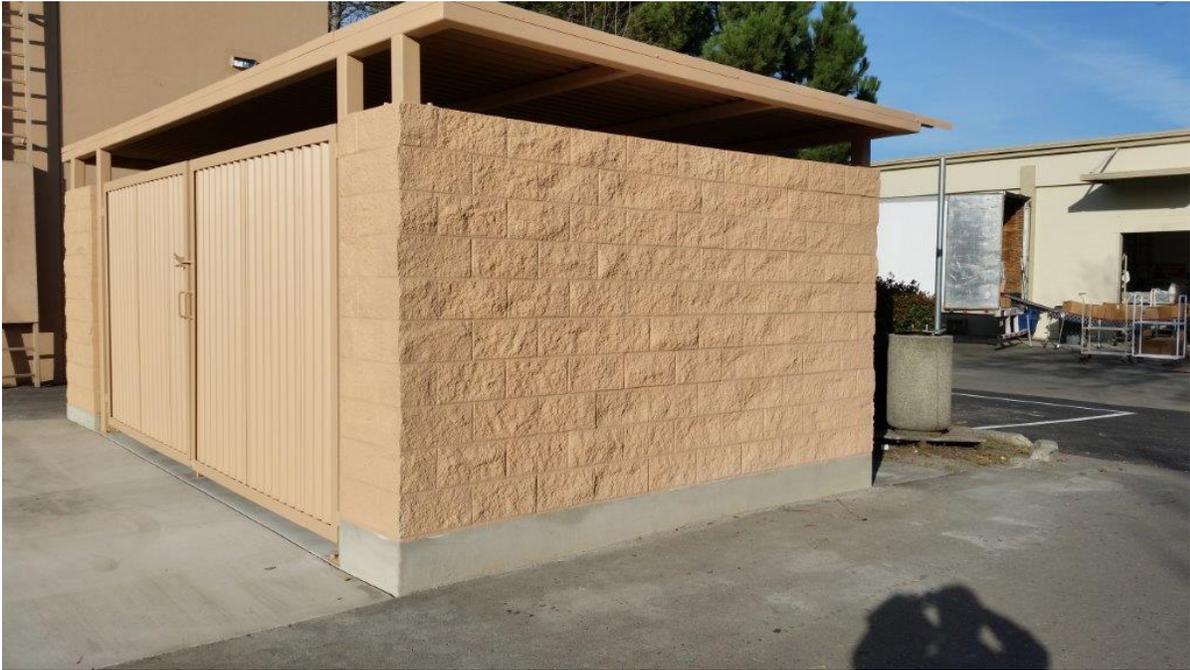
New Trash Enclosure at 7123 Amador Plaza (Trash Management Area 1):
Enclosure funded through Small Business Grant Assistance Program
