MERCURY

LOSSES AND RECOVERY

STAFF REPORT PREPARED BY:
Rick Humphreys,
Division of Water Quality,
California Water Boards

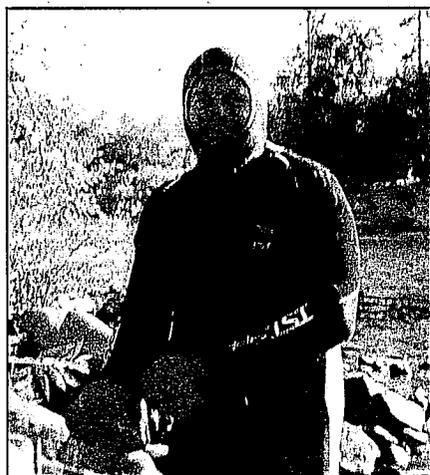
FIGURE 2: Steve Franklin and SWRCB staff sampled the hotspot on July 8, 2003, and recovered about 125 grams of mercury in about three hours from the river using simple suction recovery tools. Mercury was visible as droplets ranging from one to ten millimeters on bedrock in the river channel. (Photo by: Rick Humphreys, DWQ)

mercury droplets permeate the sediment at the thin upstream edge of the downstream wedge (see fig.2). Hand "fanning" stirs up fine-grained sediment, which is carried away by the river current. Elemental mercury, however, remains on bedrock, and continued fanning causes small mercury droplets to fall into bedrock depressions and fractures. When mercury droplets touch, they fuse into much **large** droplets (up to 25 millimeters). **Hand fanning the upstream sediment wedge also exposes elemental mercury in bedrock depressions and fractures** but in much smaller amounts than on the downstream side.

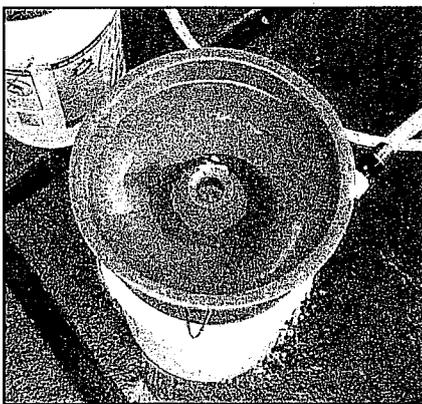
FIGURE 9. Liquid mercury (about 0.5kg) separated from sediment captured by the dredge. (Photo by: Rick Humphreys, DWQ)

The team dredged about four yards or about 5,900 kilograms (6.5 tons) of sediment from the hotspot. Team members used special care to find and dredge large liquid mercury droplets as well as mercury-laden sediment from the site. During clean up after the test, team members noted large mercury droplets captured on the sluice. From the 30-mesh passing fraction, SWRCB staff separated about 0.5kg liquid mercury (see fig. 4). The remaining 2.2kg of sediment retained a substantial amount of liquid mercury as small (e.g., 1mm) and fine droplets of floured mercury, which floated on water used to immerse the sediment. Separating residual mercury from the sediment by physical means proved impossible. The mercury content of a 1.1kg sample was determined directly heating the sample and recovering the mercury vapor (i.e., retorting). The retorted sample contained 20gm of mercury or 1.8 percent. The dredge concentrate contained 540gm of mercury (liquid mercury + retorted mercury/ 1.1kg x 2), which accounted for about 20 percent of the sample mass (540gm mercury/2.7kg sieved sample x 100). Note that the mercury concentration of captured sediment from the in river test is about ten times higher than that reported for the efficiency test. The difference likely reflects the success of the dredge team in finding and dredging up mercury droplets during the in river test.
