United States
Department of
Agriculture

Forest
Service

San Bernardino National Forest
Supervisor's Office

**SBNF Hydrologic Restoration Project
Following the Butler II and Slide Fires of 2007**

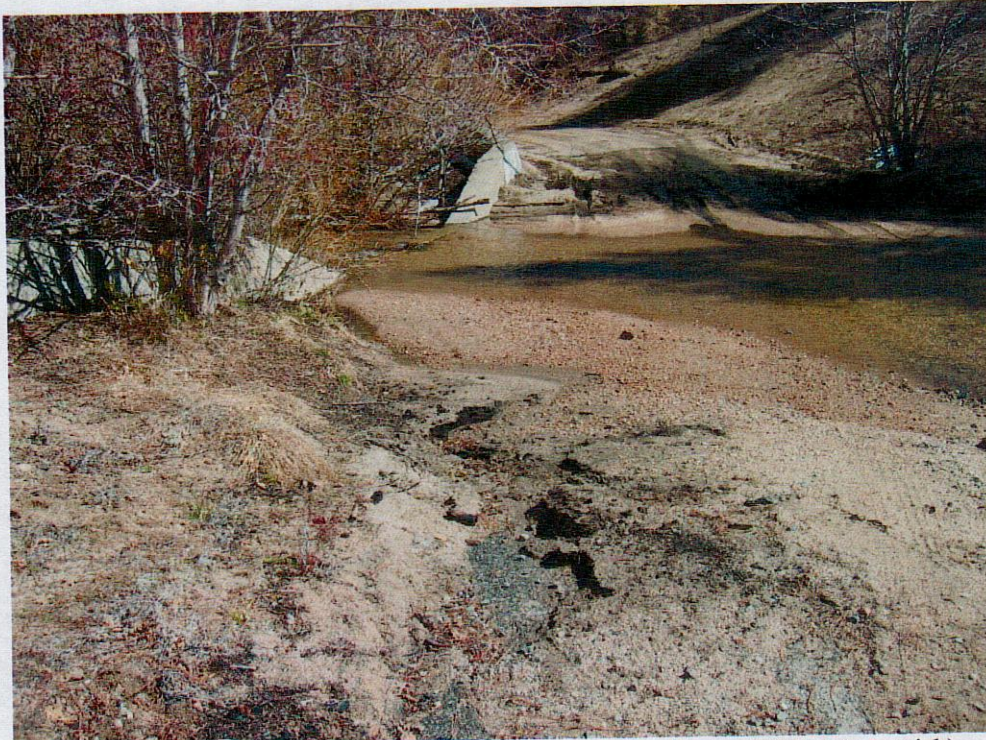
3N16 and Crab Creek, focusing on road delivery to crossing (Spring 2008, Erin Lutrick)

sediment loading and turbidity due to fuels related issues. Sediment delivery issues from 3N16 are also addressed. Attached photos show a progression in the crossing.

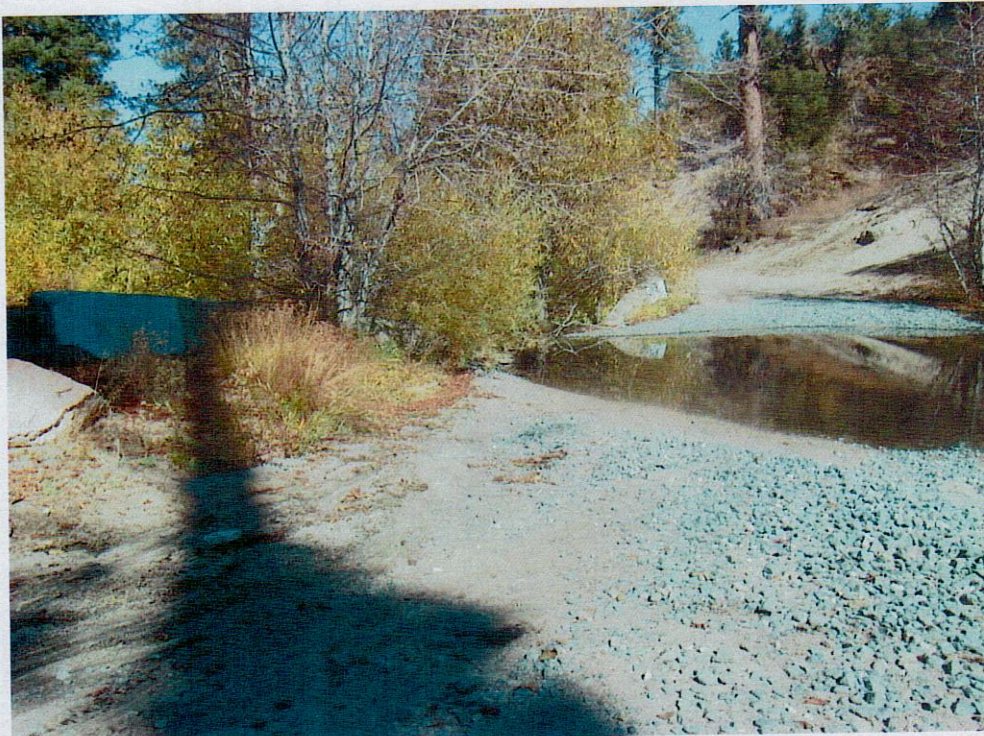
Same location as above, but shows more of south creek bank. Shows rill entering the creek from the road bed. (Fall 2008, Robert Taylor)

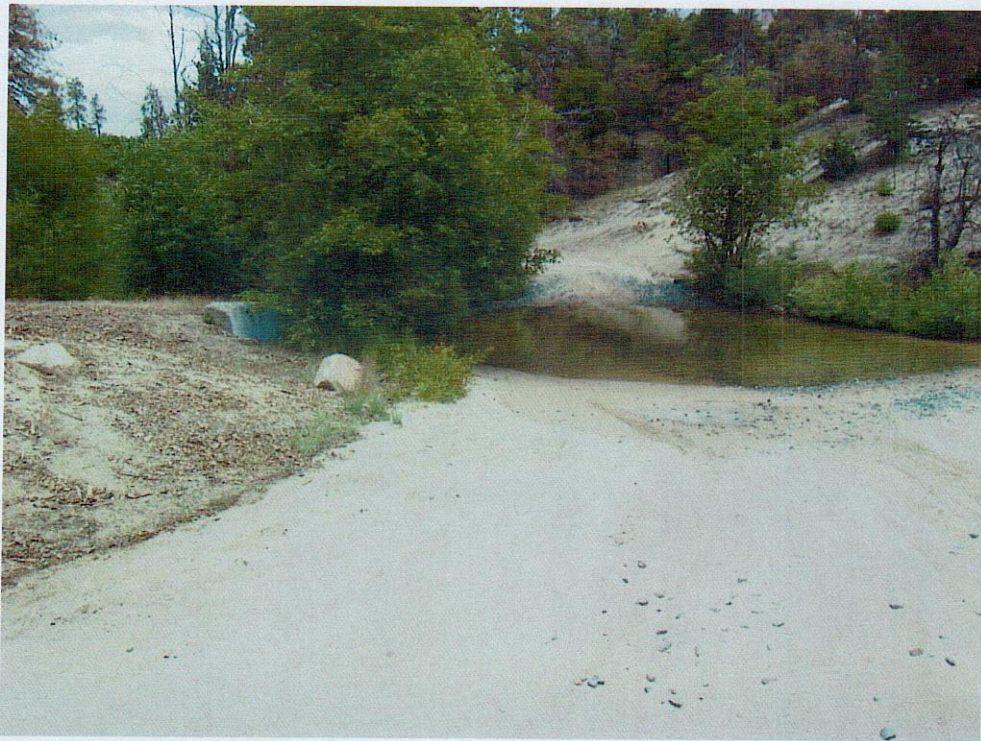
Less gravel seen - some likely buried. Road work removed rill entering the creek from the road. (June 2009, Robert Taylor)

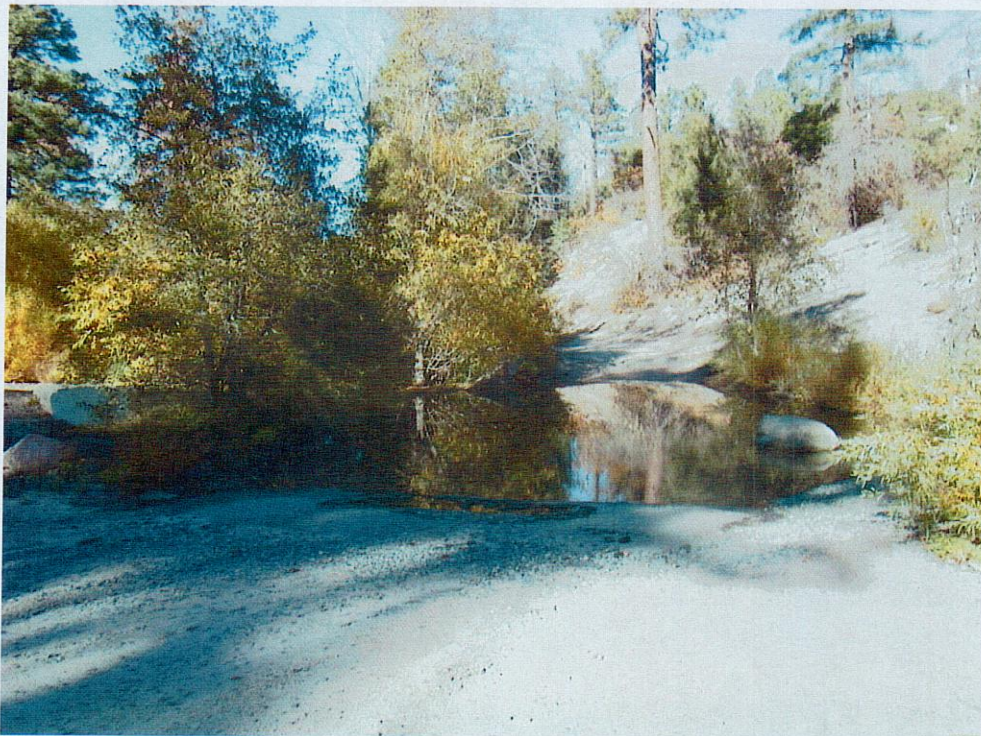
More gravel seen; road has had maintenance work (October 2009, Mikaila Rimbenieks)
