STREAM INVENTORY REPORT

Lacks Creek

A stream inventory was conducted during the summer of 1995 on Lacks Creek. The inventory was conducted in two parts: habitat inventory and biological inventory. The objective of the habitat inventory was to document the habitat available to anadromous salmonids in Lacks Creek. The objective of the biological inventory was to document the presence and distribution of juvenile salmonid species.

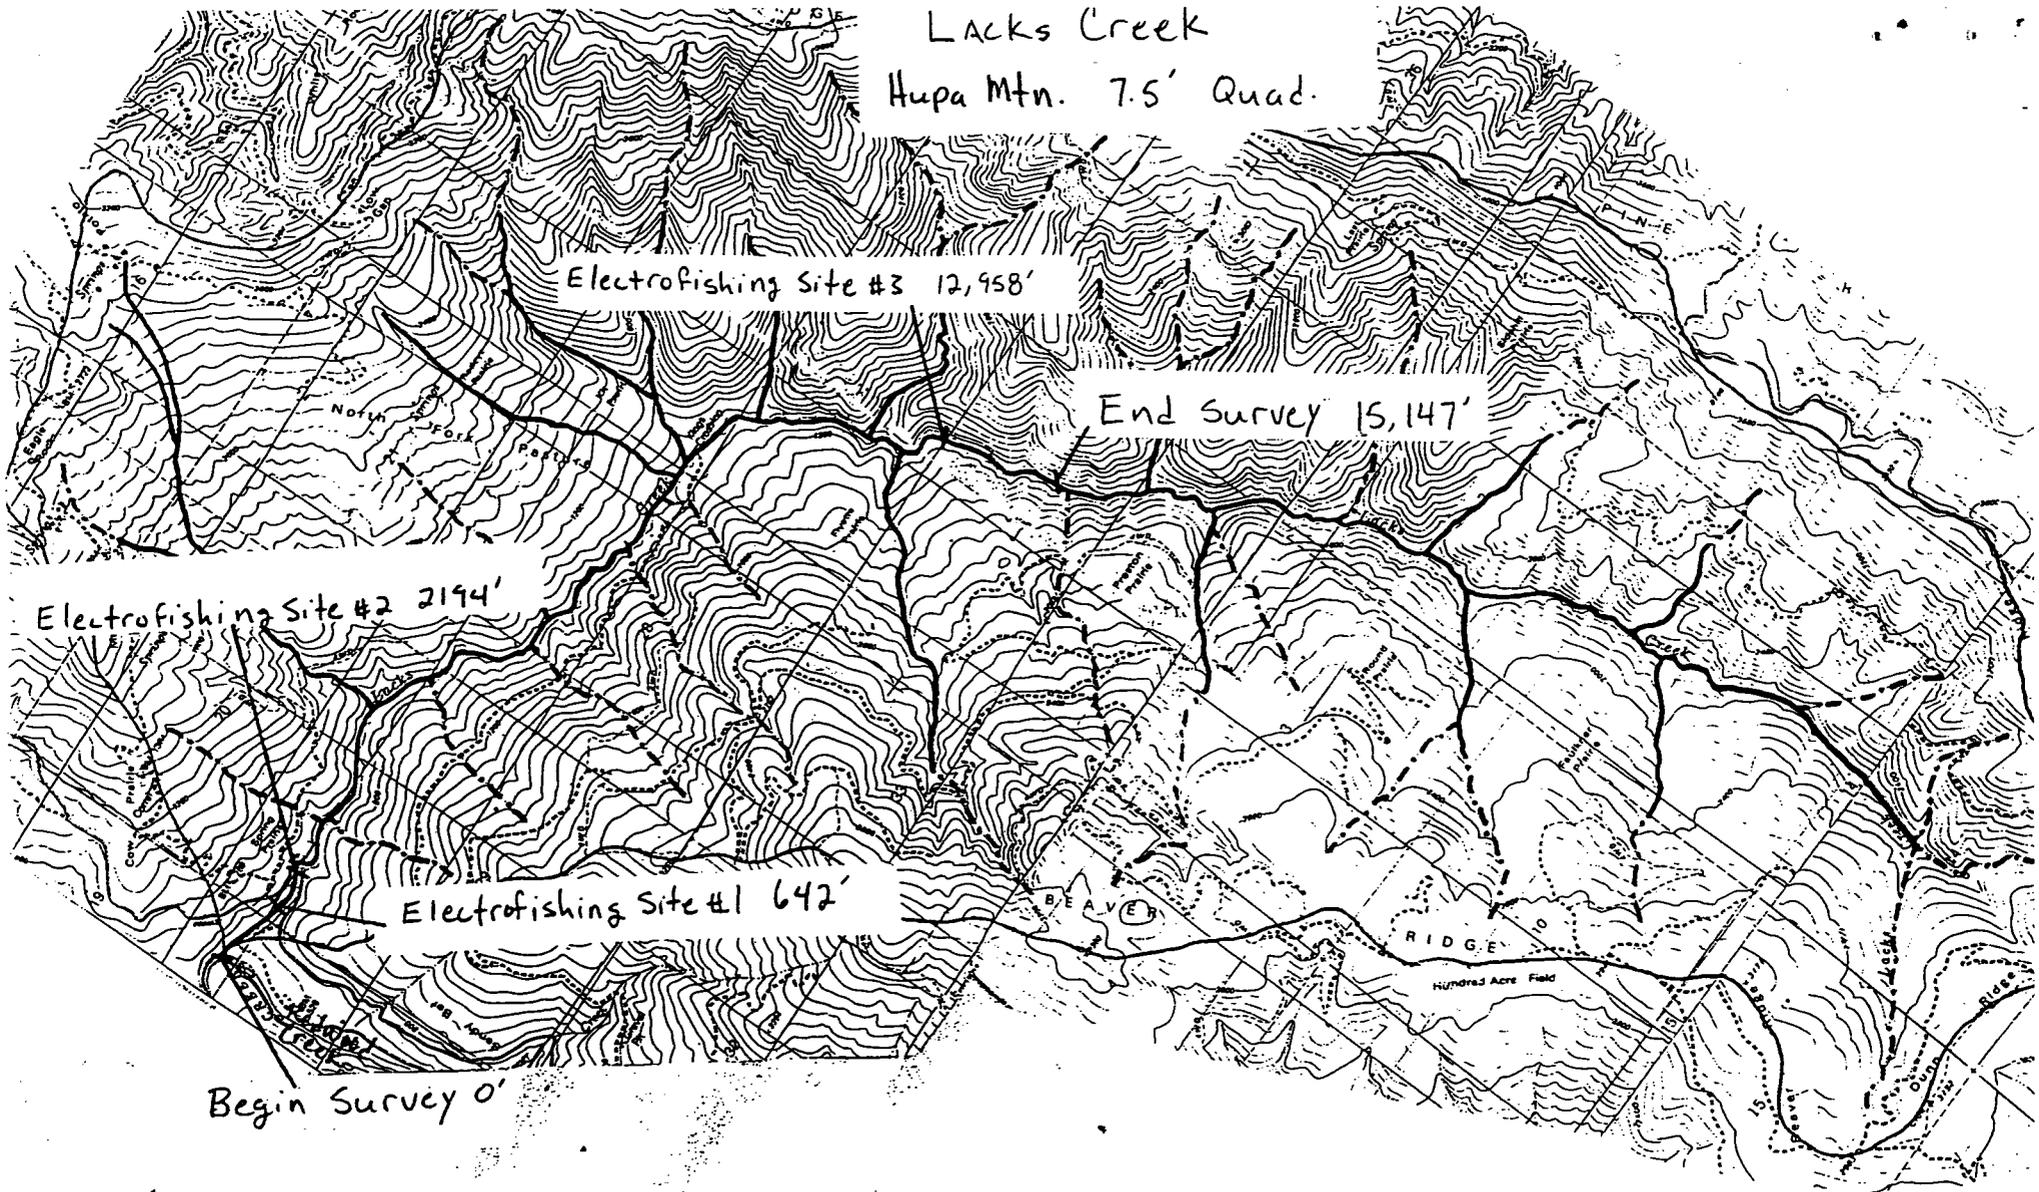
Lacks Creek
Hupa Mtn. 7.5' Quad.

Electrofishing Site #3 12,958'

End survey 15,147'

Electrofishing Site #2 2194'

Electrofishing Site #1 642'

Begin Survey 0'

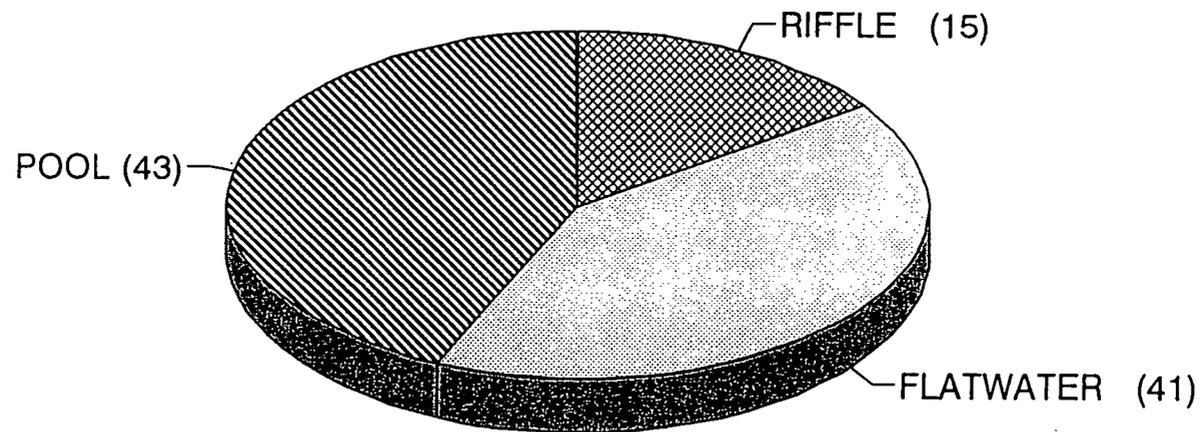
GRAPH 1

Table 1 summarizes the Level II riffle, flatwater, and pool habitat types. Based on frequency of **occurrence** there were 15% riffle units, 41% flatwater units, and 43% pool units (Graph 1). Based on total **length** of Level II habitat types there were 9% riffle units, 49% flatwater units, and 41% pool units (Graph 2).

HABITAT TYPES BY PERCENT OCCURRENCE

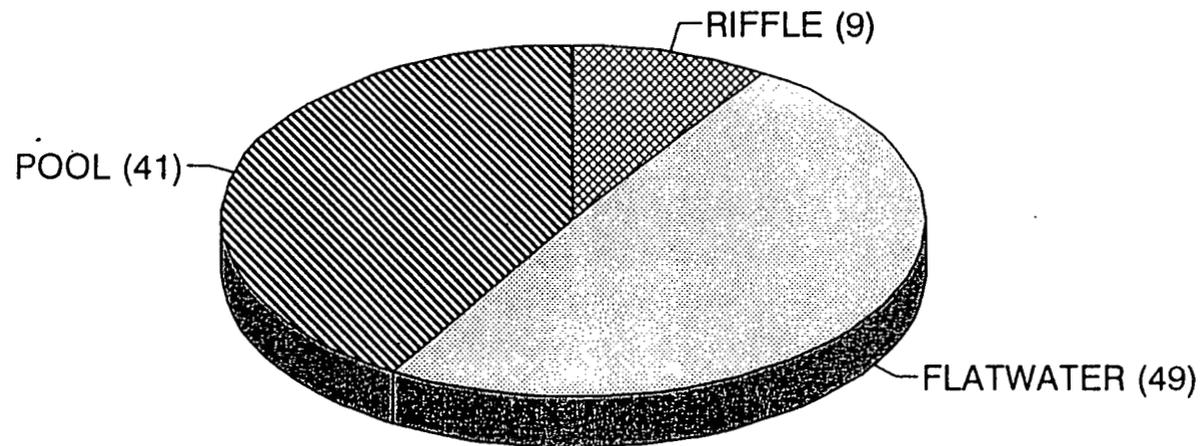
GRAPH 2

HABITAT TYPES BY PERCENT TOTAL LENGTH

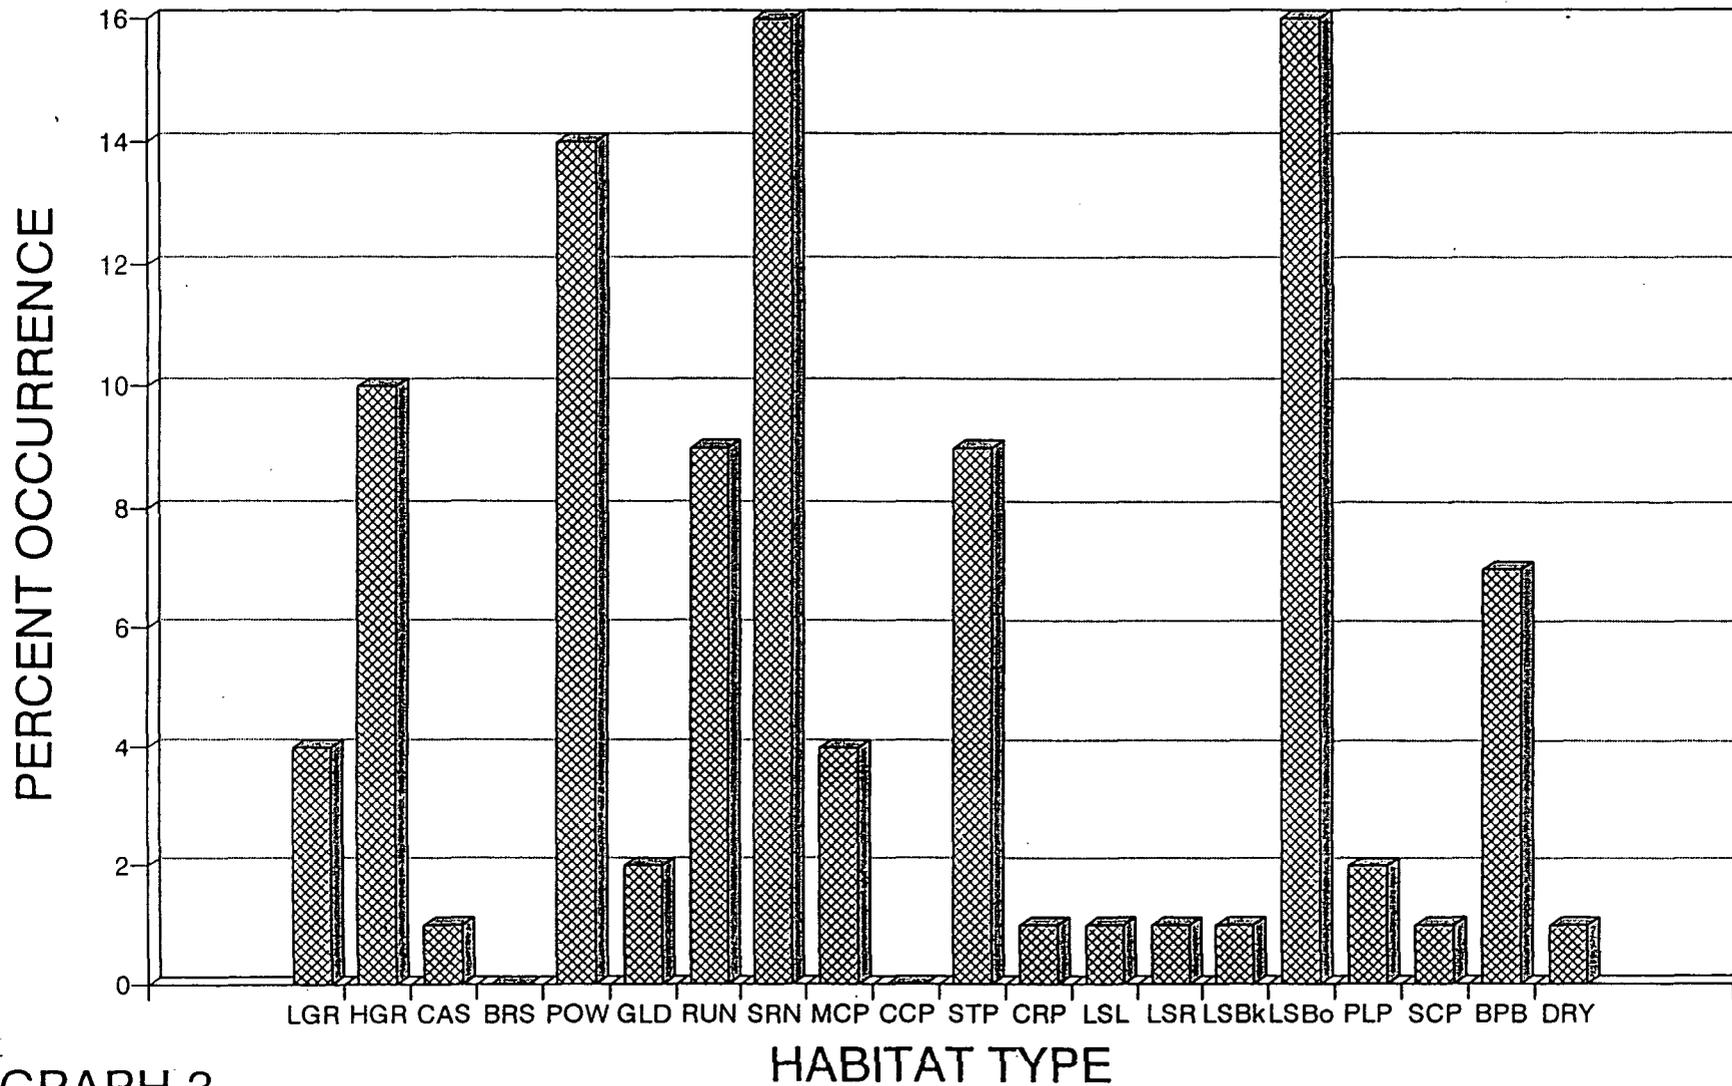
GRAPH 3

Nineteen Level IV habitat types were identified (Table 2). The most frequent habitat types by percent **occurrence** were step runs, 16%; lateral scour pool - boulder formed, 16%; and

pocket water, 14% (Graph 3). Based on percent total **length**, step runs made up 26%, lateral scour pool - boulder formed 15%, and step pools 14%.

HABITAT TYPES BY PERCENT OCCURRENCE

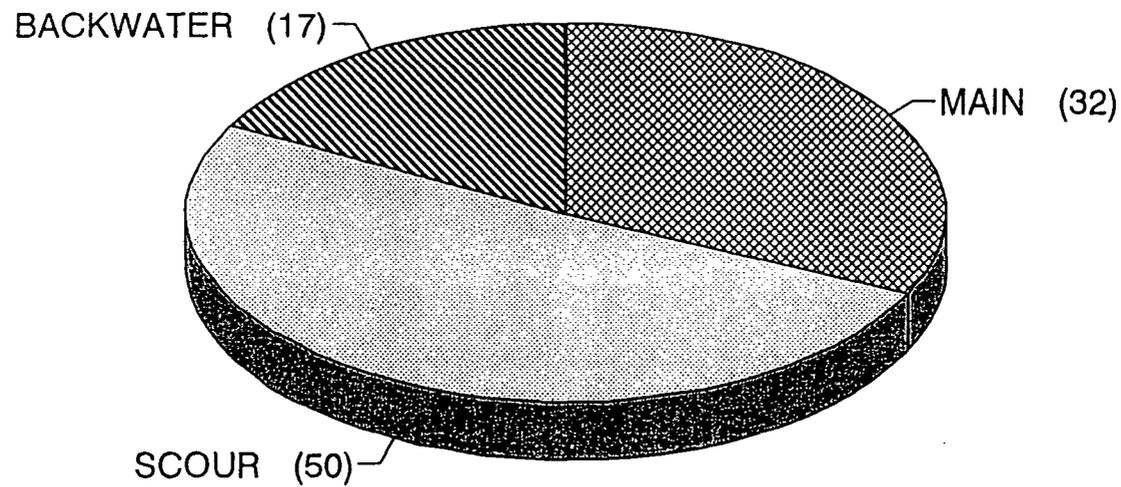
GRAPH 4

A total of 167 pools were identified (Table 3). Scour pools were most frequently encountered at 50% and comprised 45% of the total length of all pools (Graph 4).

POOL HABITAT TYPES BY PERCENT OCCURRENCE

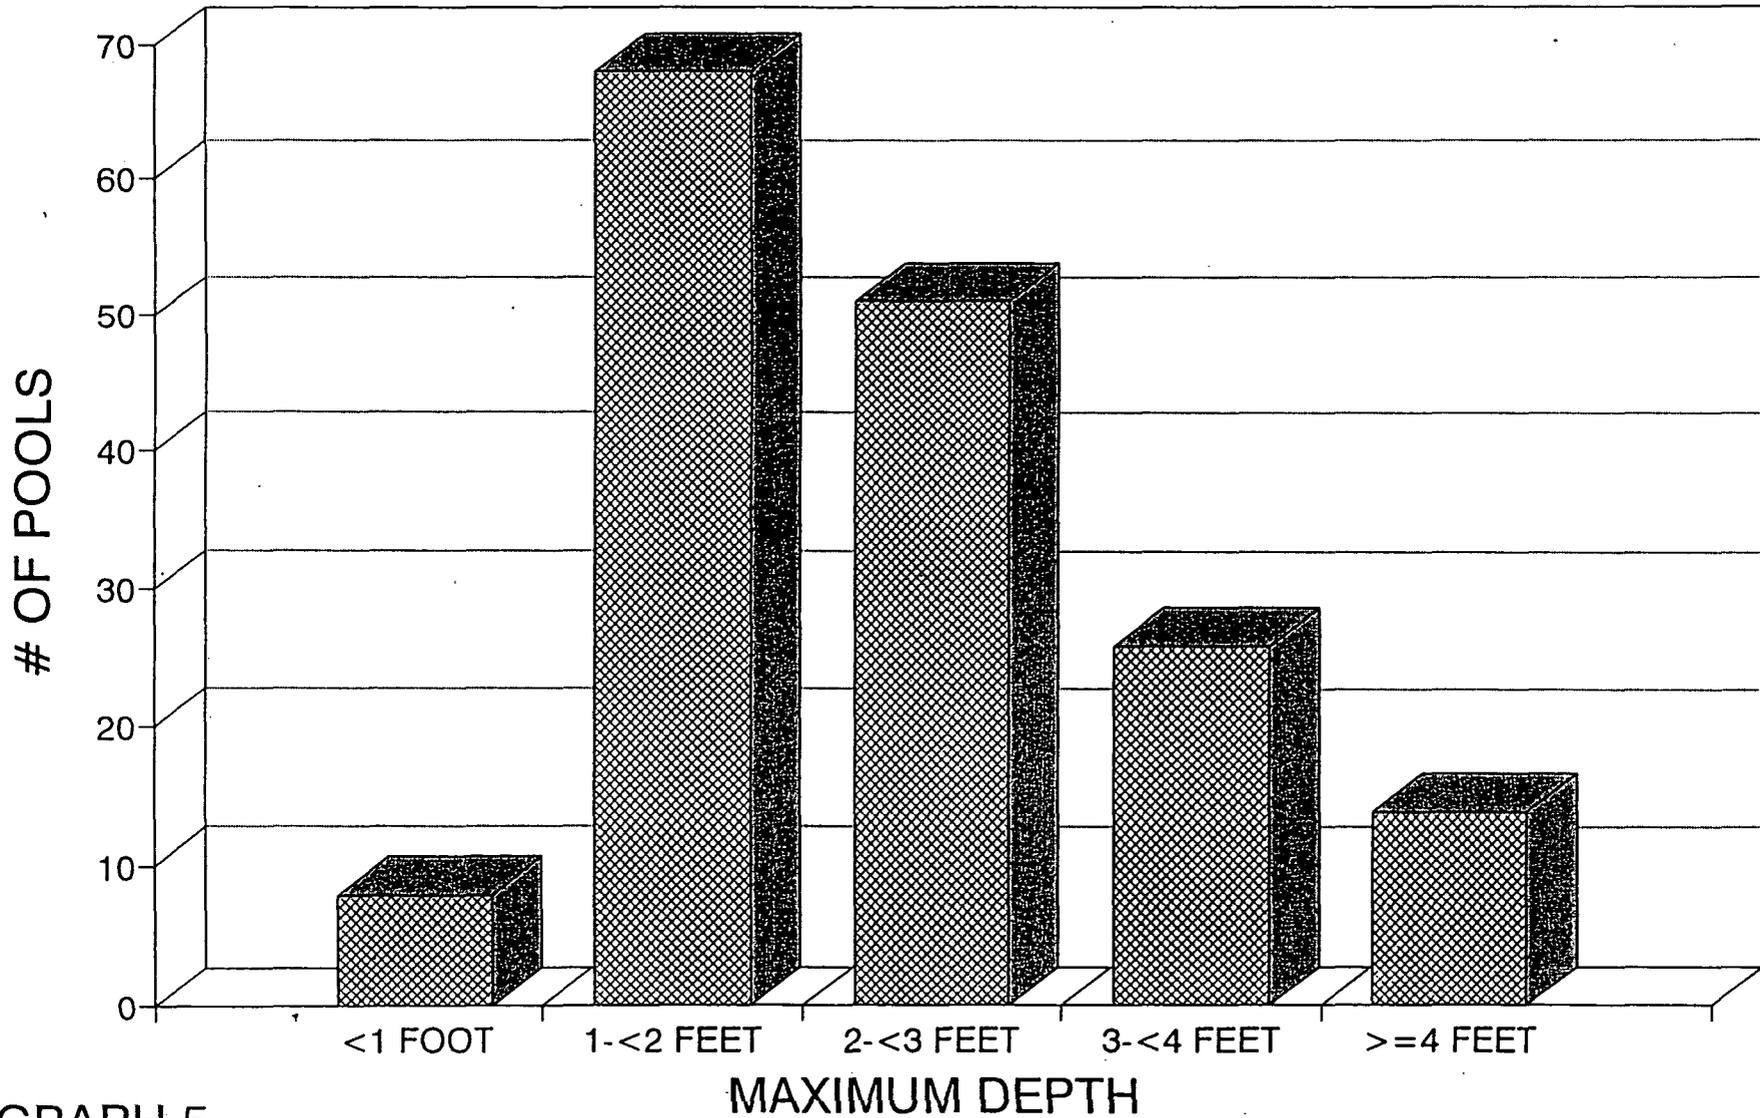
GRAPH 5

Table 4 is a summary of maximum pool depths by pool habitat types. Pool quality for salmonids increases with depth. Forty of the 167 pools (24%) had a depth of three feet or greater (Graph 5).

Flatwater habitat types comprised 49% of the total length of this survey, riffles 9%, and pools 41%. The pools are relatively shallow, with 40 of the 167 (24%) pools having a maximum depth greater than three feet. In general, pool enhancement projects are considered when primary pools comprise less than 40% of the length of total stream habitat. In third and fourth order streams, a primary pool is defined to have a maximum depth of at least three feet, occupy at least half the width of the low flow channel, and be as long as the low flow channel width. Installing structures that will deepen pool habitat is recommended for the F4 and B3 stream reaches.

MAXIMUM POOL DEPTHS

- 3) In the F4 and B3 channel type reaches, design and engineer pool enhancement structures to deepen the existing pools. This must be done where the banks are stable or in conjunction with stream bank armor to prevent erosion.

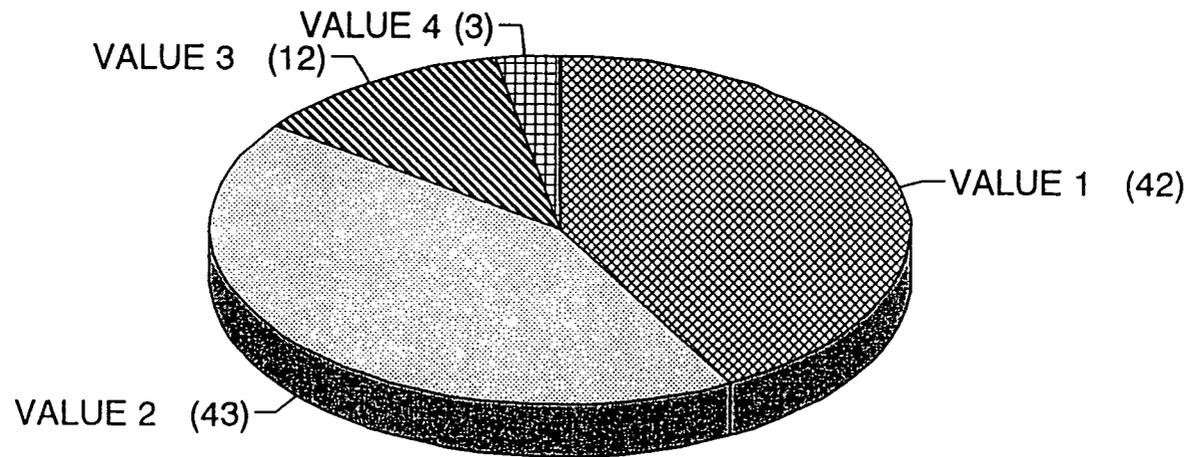
GRAPH 6

The depth of cobble embeddedness was estimated at pool tail-outs. Of the 135 pool tail-outs measured, 57 had a value of 1 (42%); 58 had a value of 2 (43%); 16 had a value of 3 (12%); 4 had a value of 4 (3%); and none had a value of 5 (Graph 6). On this scale, a value of 1 indicates the highest quality of spawning substrate.

Twenty of the 135 pool tail-outs measured had embeddedness ratings of 3, 4, or 5. Fifty-seven had a 1 rating. Cobble embeddedness measured to be 25% or less, a rating of 1, is considered to indicate good quality spawning substrate for salmon and steelhead.

PERCENT EMBEDDEDNESS

- 5) Inventory and map sources of stream bank erosion and prioritize them according to present and potential sediment yield. Identified sites should then be treated to reduce the amount of fine sediments entering the stream.

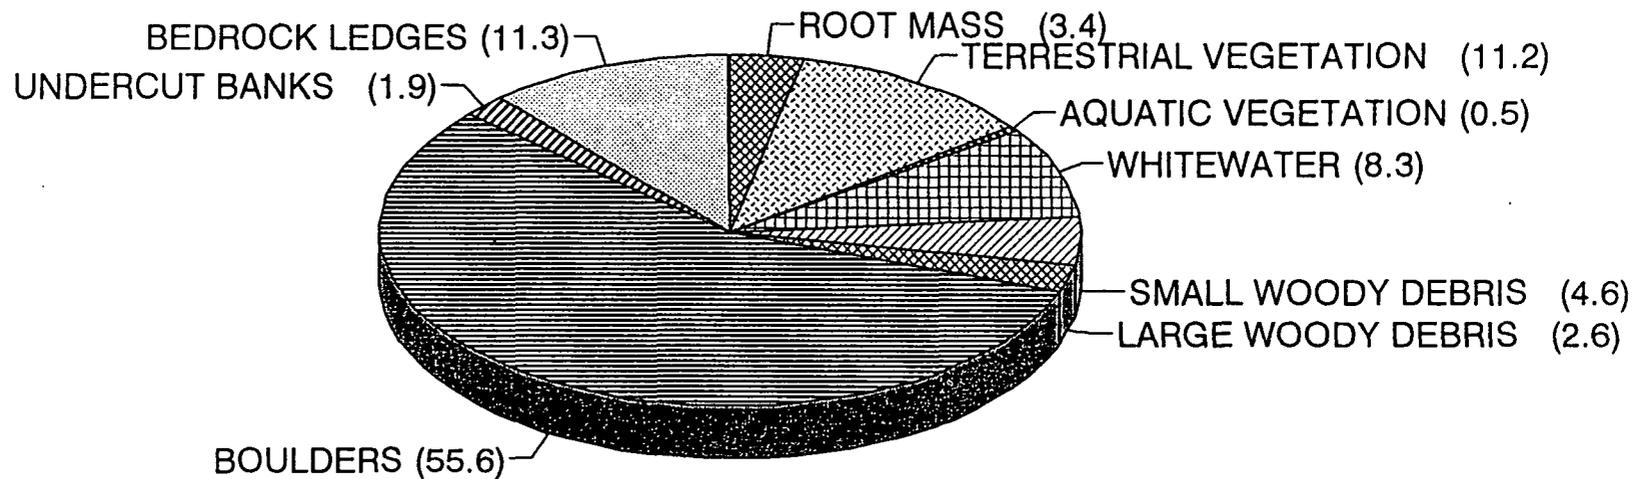
GRAPH 7

Table 5 summarizes mean percent cover by habitat type. Boulders are the dominant cover type in Lacks Creek. Large and small woody debris are lacking in nearly all habitat types. Graph 7 describes the pool cover in Lacks Creek.

MEAN PERCENT COVER TYPES IN POOLS

- 4) Increase woody cover in the pools and flatwater habitat units. Most of the existing cover is from boulders. Adding high quality complexity with woody cover is desirable and in some areas the material is locally available.

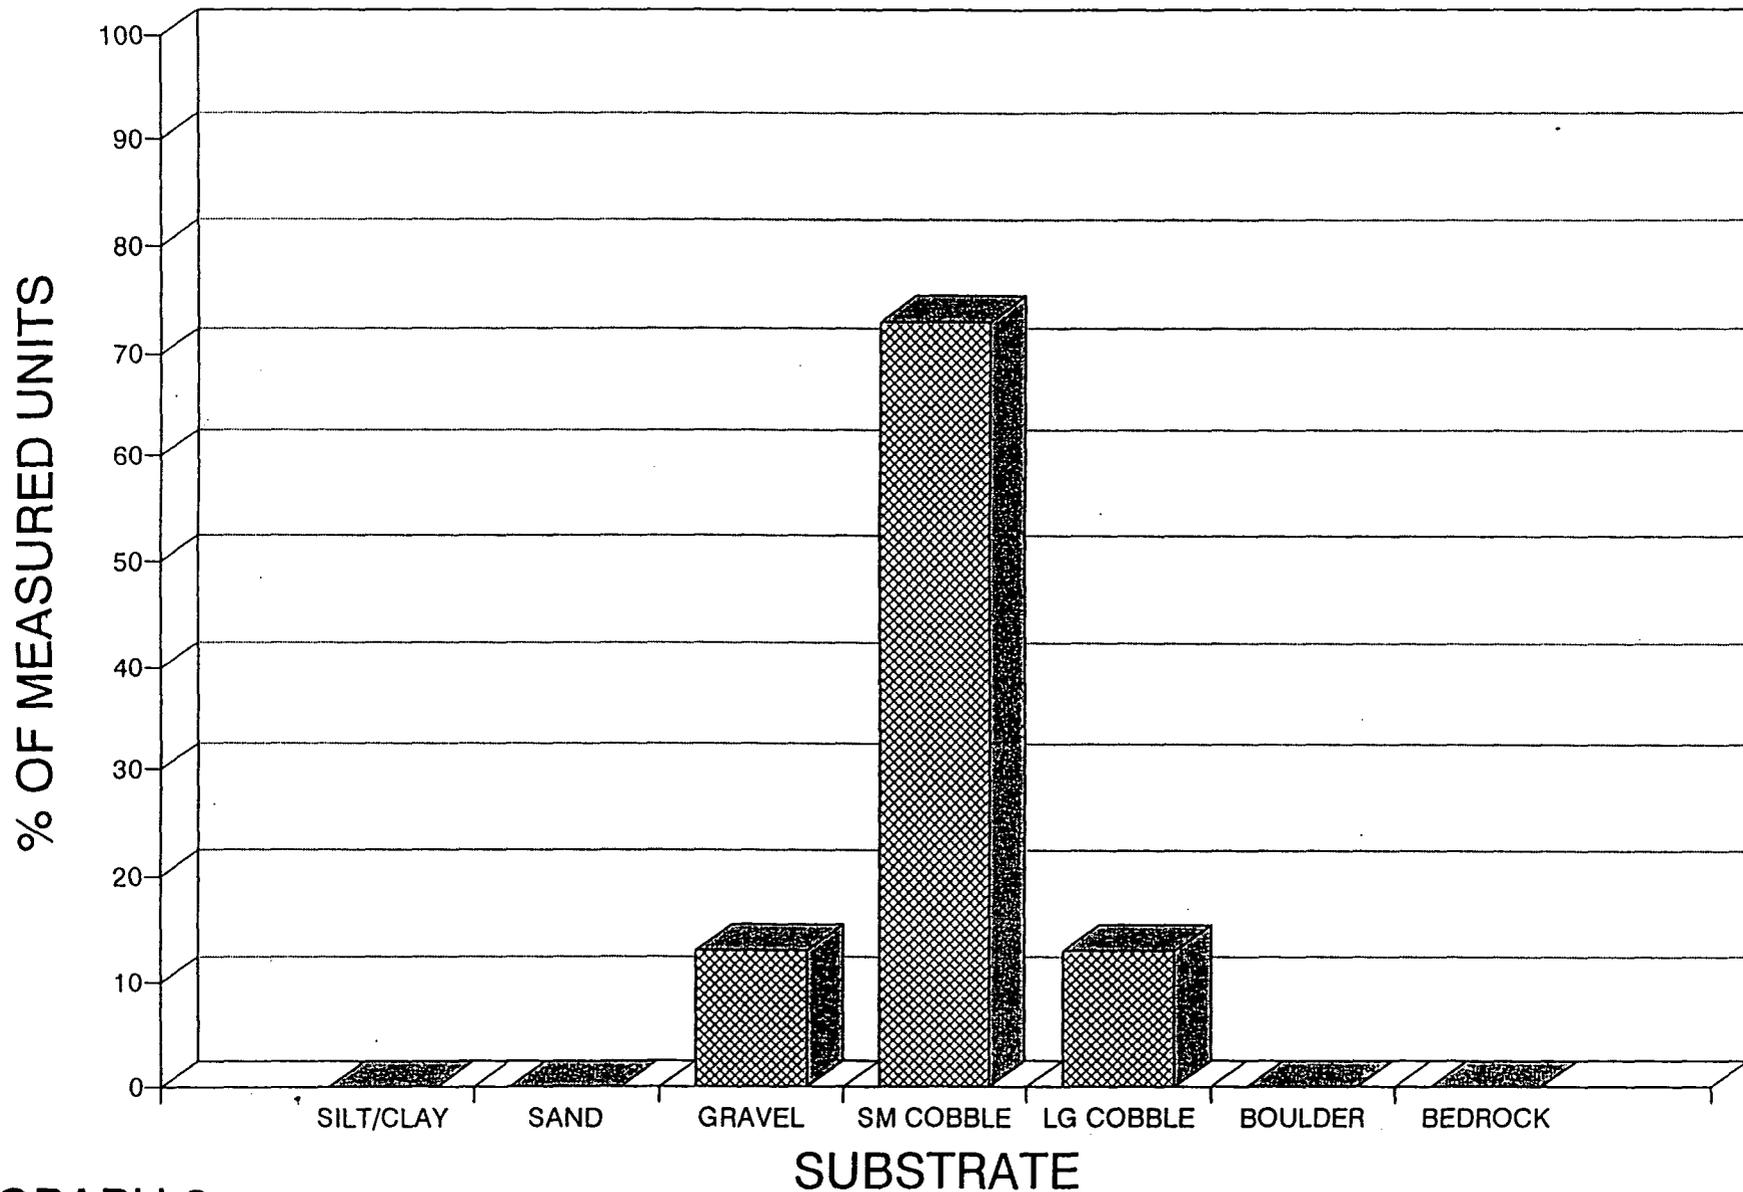
GRAPH 8

Table 6 summarizes the dominant substrate by habitat type. Small cobble was the dominant substrate observed in 11 of the 15 low gradient riffles measured (73%). Gravel and large cobble were the next most frequently observed dominant substrate types and both occurred in 13% of the low gradient riffles (Graph 8).

Thirteen of the 15 low gradient riffles measured had gravel or small cobble as the dominant substrate. This is generally considered good for spawning salmonids.

SUBSTRATE COMPOSITION IN LOW GRADIENT RIFFLES

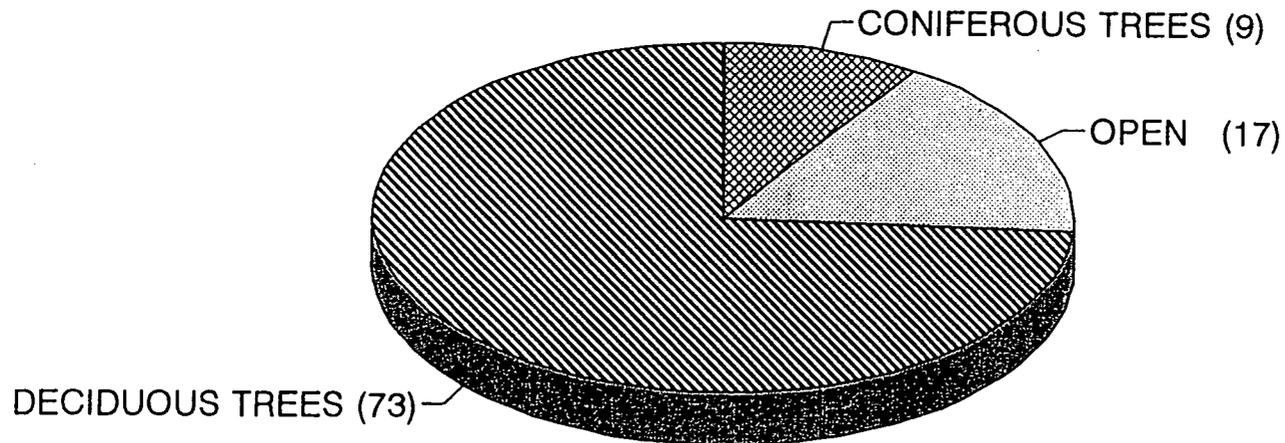
GRAPH 9

The mean percent canopy density for the stream reach surveyed was 83%. The mean percentages of deciduous and coniferous trees were 88% and 11%, respectively. Graph 9 describes the canopy in Lacks Creek.

The mean percent canopy density for the stream was 83%. This is a relatively high percentage of canopy. In general, re-vegetation projects are considered when canopy density is less than 80%.

PERCENT CANOPY

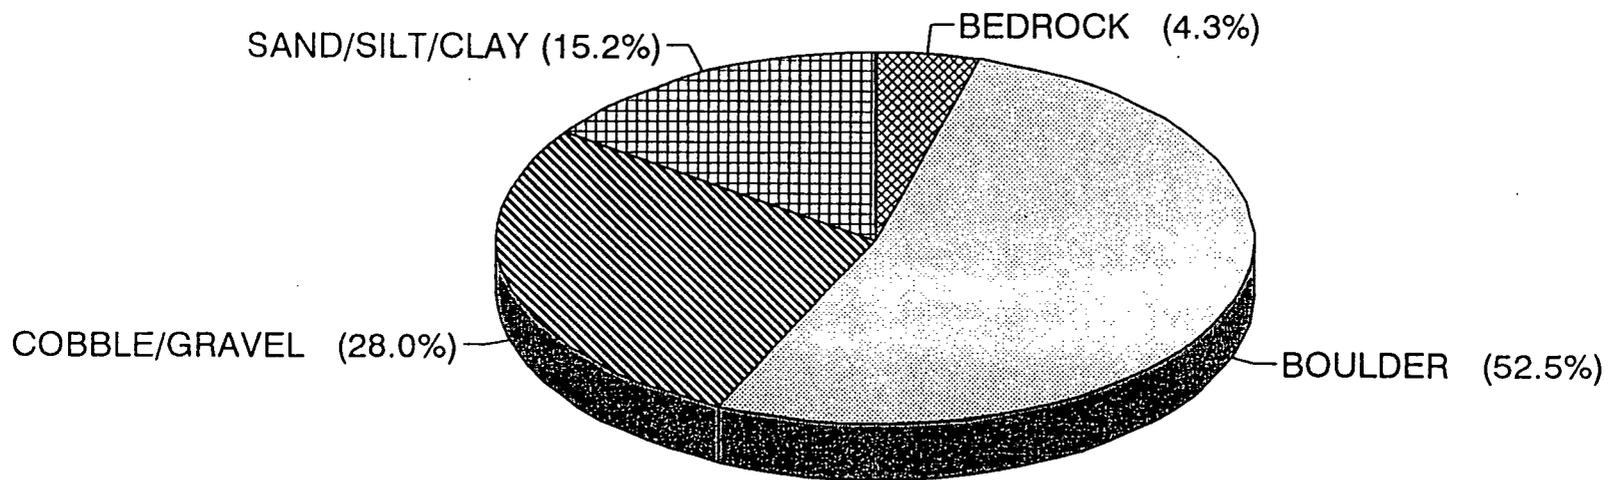
GRAPH 10

For the stream reach surveyed, the mean percent right bank vegetated was 50.7%. The mean percent left bank vegetated was 52.2%. The dominant elements composing the structure of the stream banks consisted of 4.3% bedrock, 52.5% boulder, 28.0% cobble/gravel, and 15.2% sand/silt/clay (Graph 10). Brush was the dominant vegetation type observed in 71.8% of the units surveyed. Additionally, 19.4% of the units surveyed had deciduous trees as the dominant vegetation type, and 0.13% had coniferous trees as the dominant vegetation, including down trees, logs, and root wads (Graph 11).

DOMINANT BANK COMPOSITION IN SURVEY REACH

The percentage of right and left bank covered with vegetation was moderate at 50.7% and 52.2%, respectively. In areas of stream bank erosion or where bank vegetation is not at acceptable levels, planting endemic species of coniferous and deciduous trees, in conjunction with bank stabilization, is recommended.

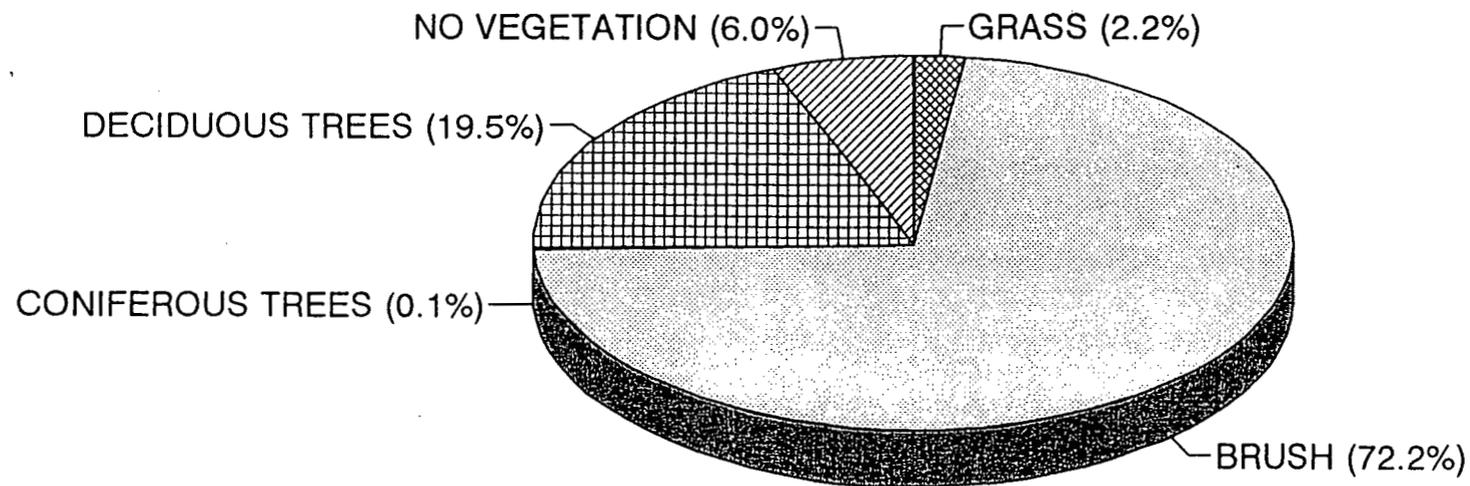
GRAPH 11

DOMINANT BANK VEGETATION IN SURVEY REACH
