Nursery Products, LLC.  
12277 Apple Valley Road, Suite 131  
Apple Valley, California 92308

**FINAL CONSTRUCTION  
QUALITY ASSURANCE REPORT  
EAST WASTE PILE COMPOSTING PAD and  
SURFACE IMPOUNDMENT A and B**

**HAWES COMPOSTING FACILITY**

May 2012

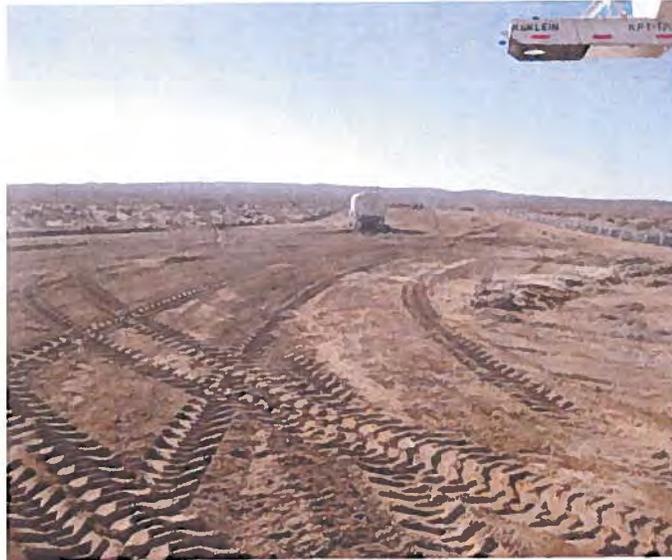
**Water truck moisture conditioning soil**

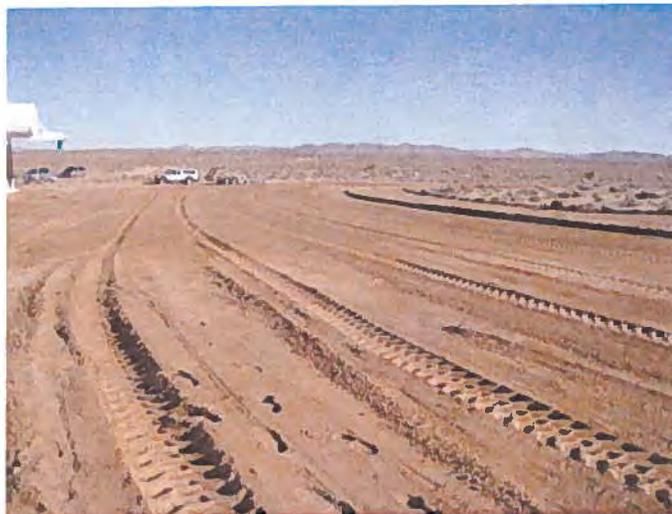
**Clear and Grubbing on Surface Impoundment Pond**

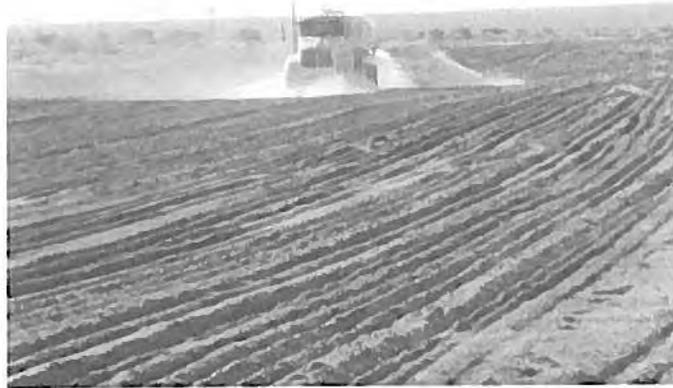
**Water truck moisture conditioning soil**

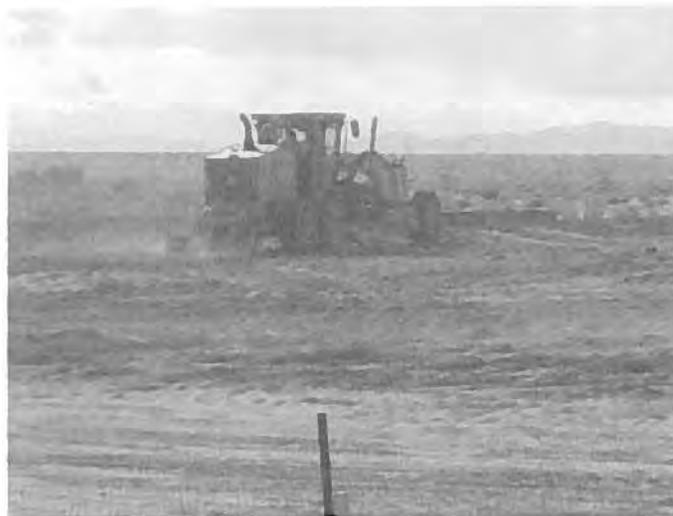
**Blade scarifying sub grade**

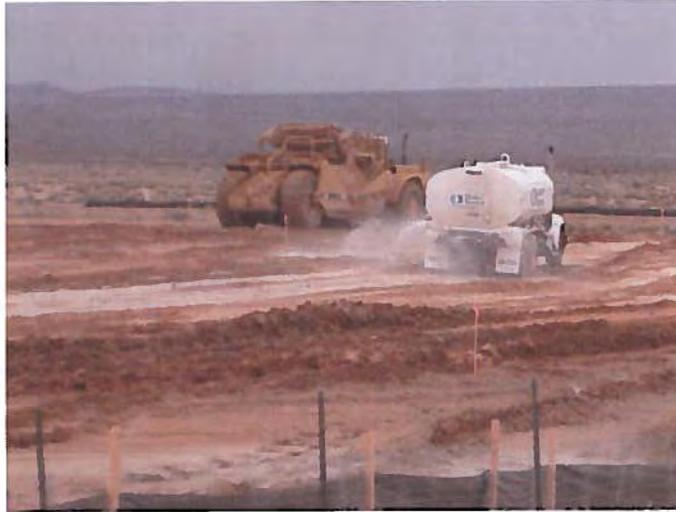
**Water truck moisture conditioning material and scrapper is removing from pond B**

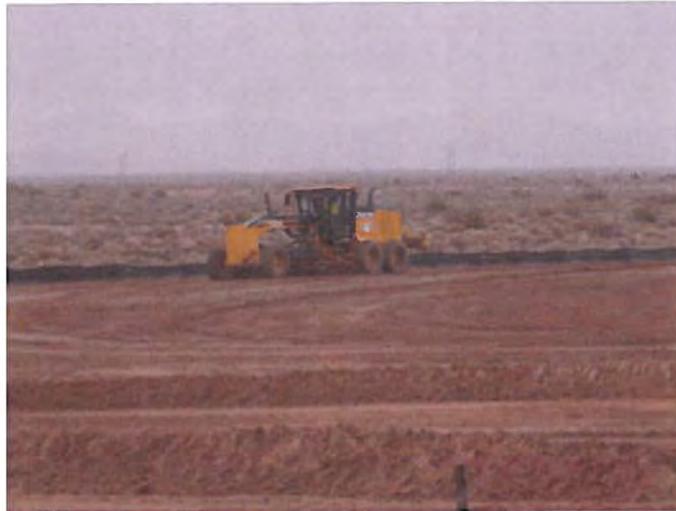
**Blade wind rolling material in east fill area**

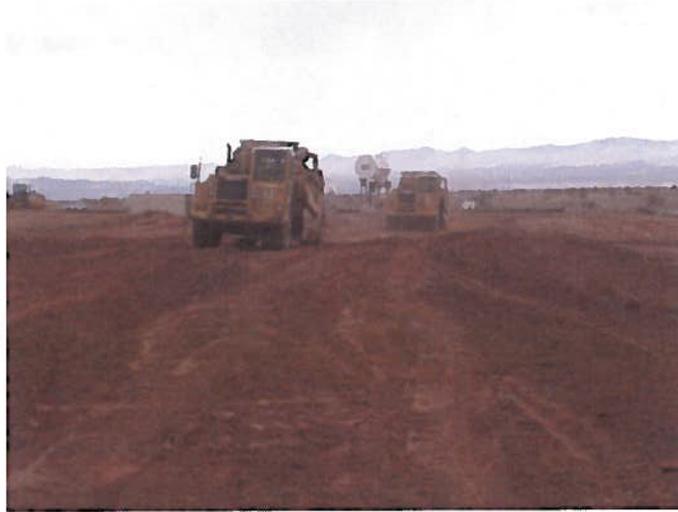
**Two 623 scrapers placing fill material on the East side**

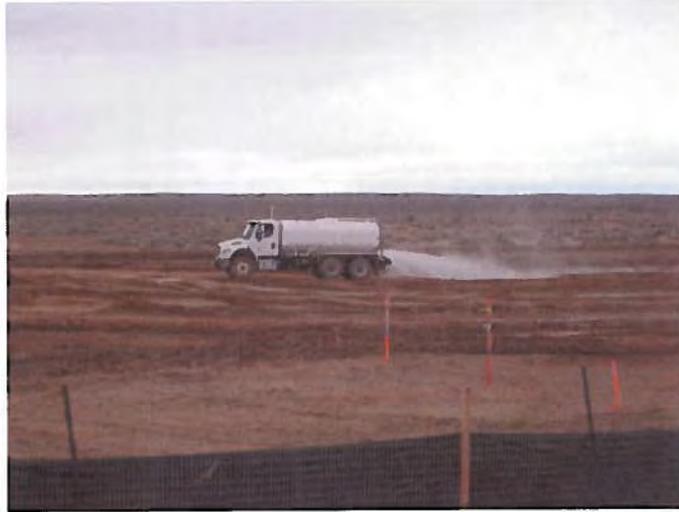
**Water truck moisture conditioning material in pond B**

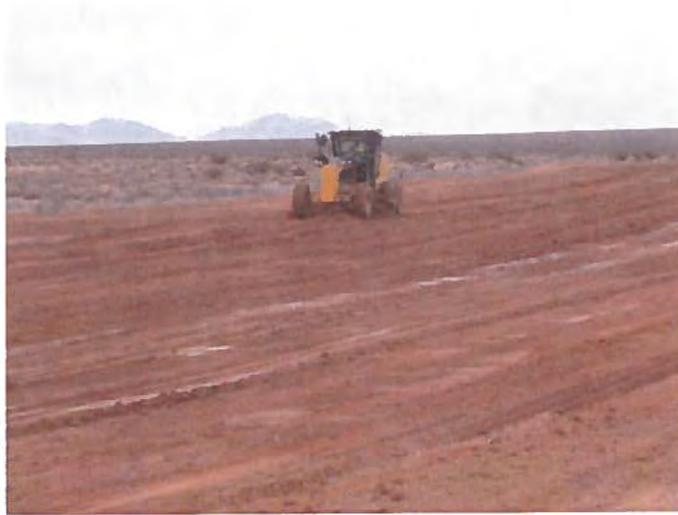
**Blade wind rolling material in East fill area**

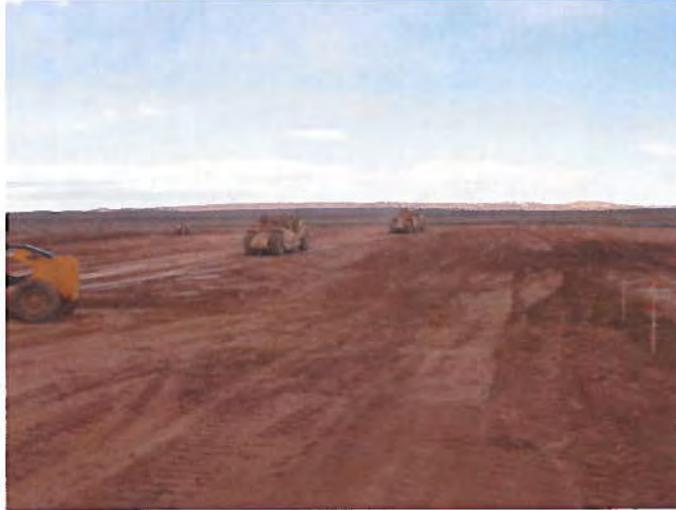
**Two 623 scrapers placing fill material on the East side**

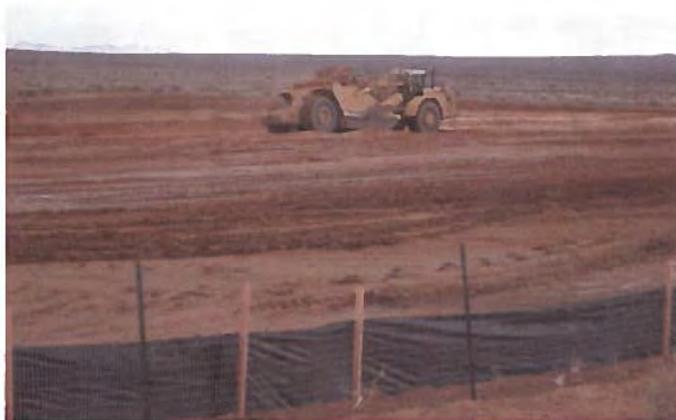
**623 scrapper removing material from pond B**

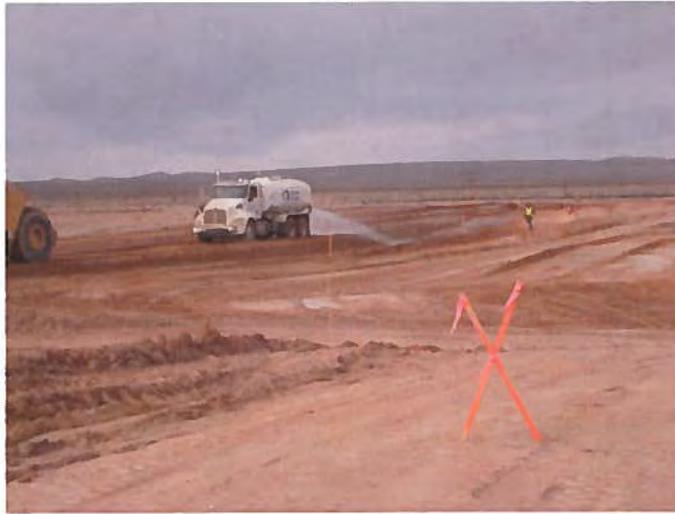
**Water truck moisture conditioning material in pond B**

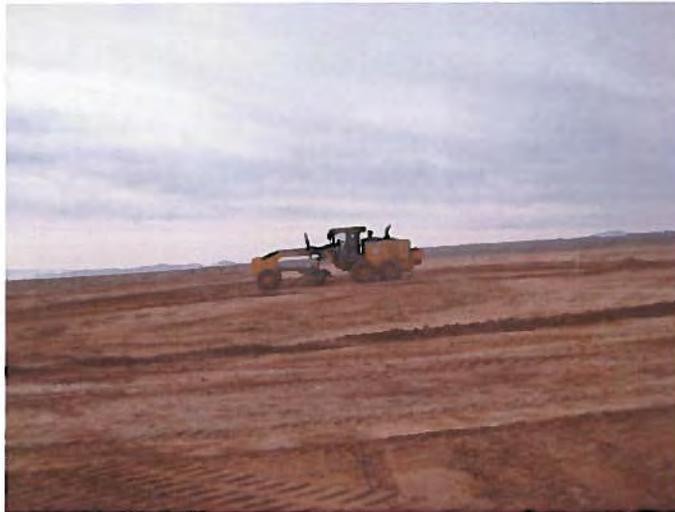
**Blade wind rolling material in East fill area**

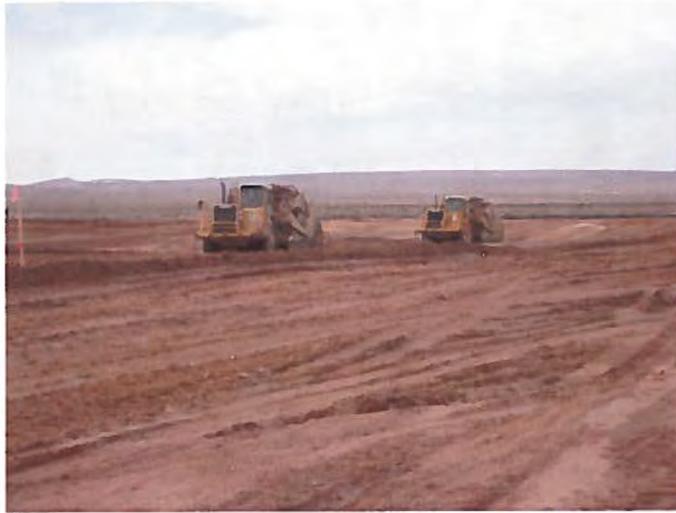
**Two 623 scrapers placing fill material on the East side**

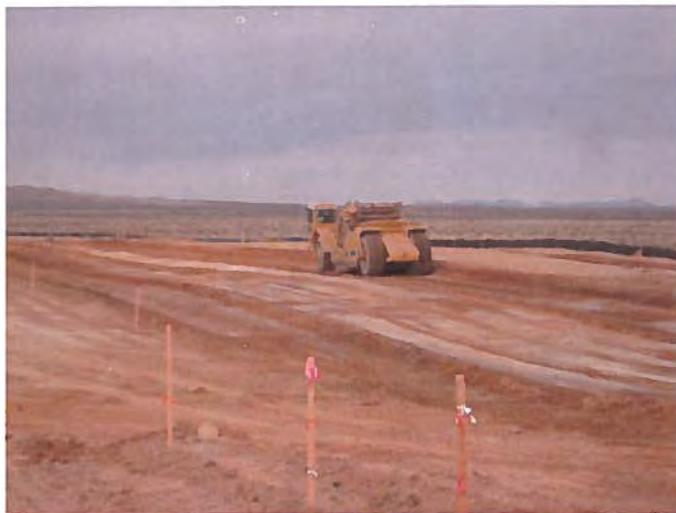
**623 scrapper removing material from pond B**

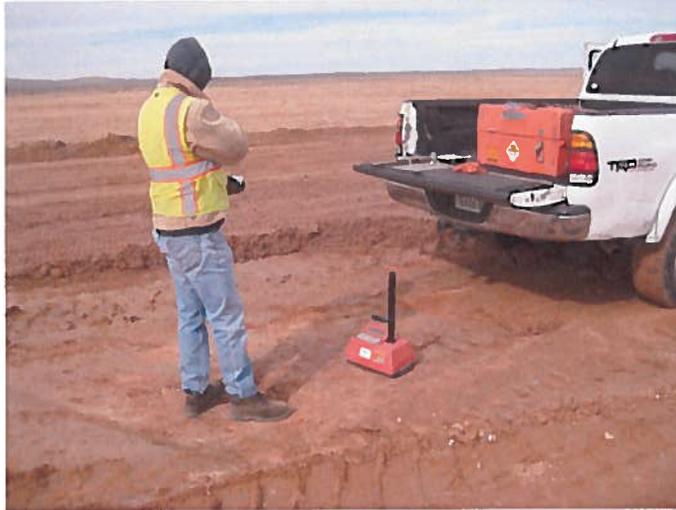
**Testing soil placed on the East side of composting area**

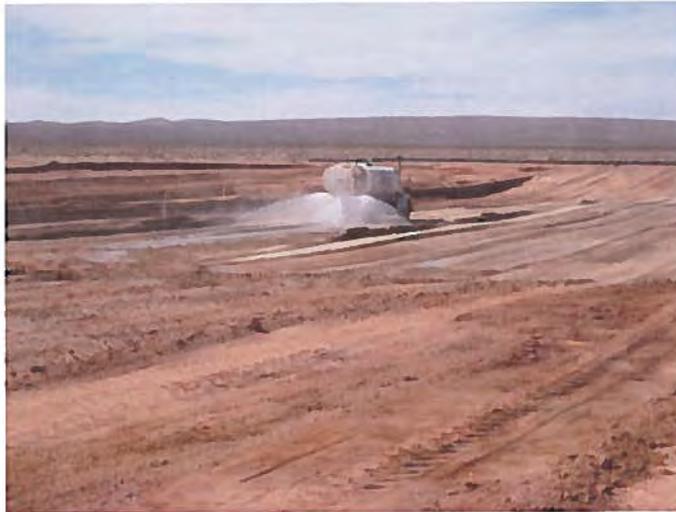
**Water truck moisture conditioning material in pond B**

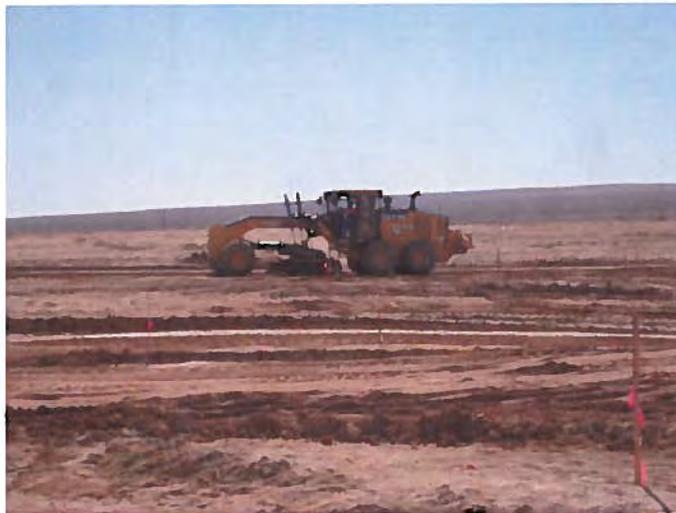
**Blade wind rolling material in East fill area**

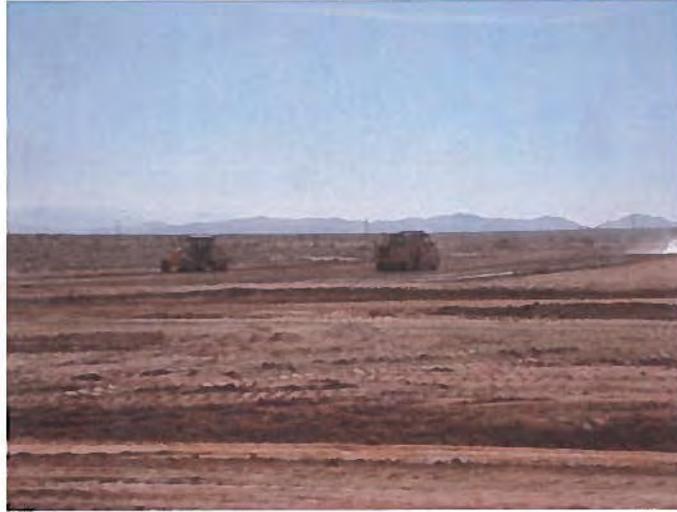
**Two 623 scrapers placing fill material on the East side**

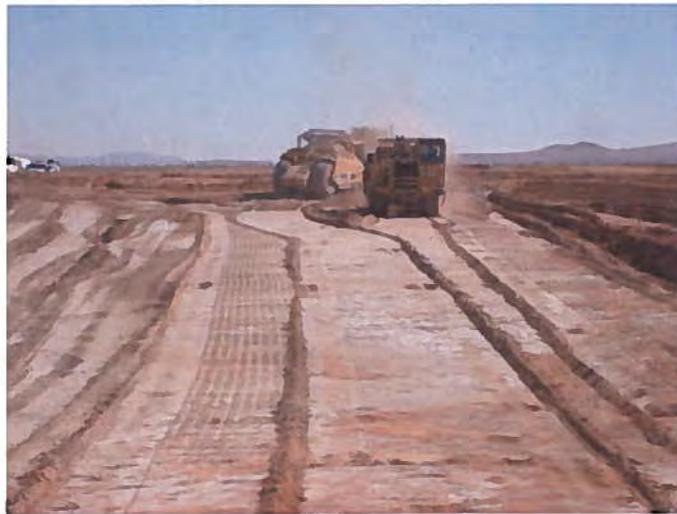
**623 scrapers removing material from pond B**

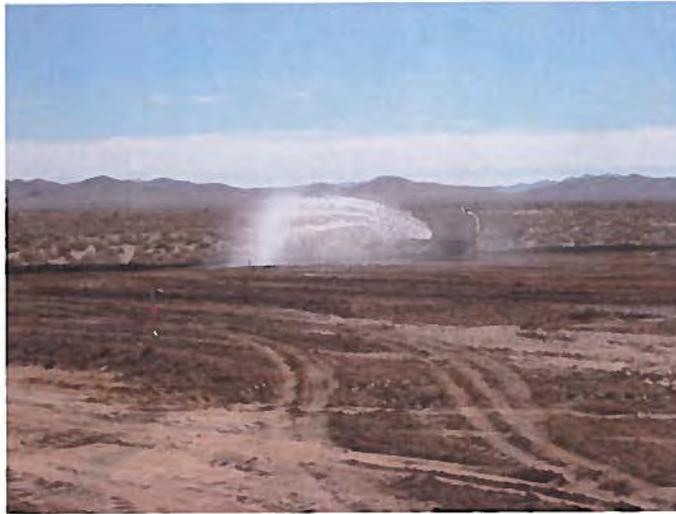
**Water truck moisture conditioning material placed on the east**

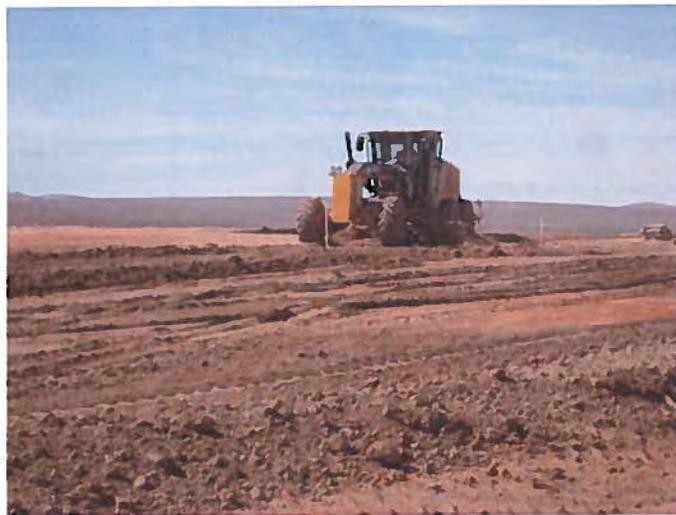
**Blade wind rolling material in East fill area**

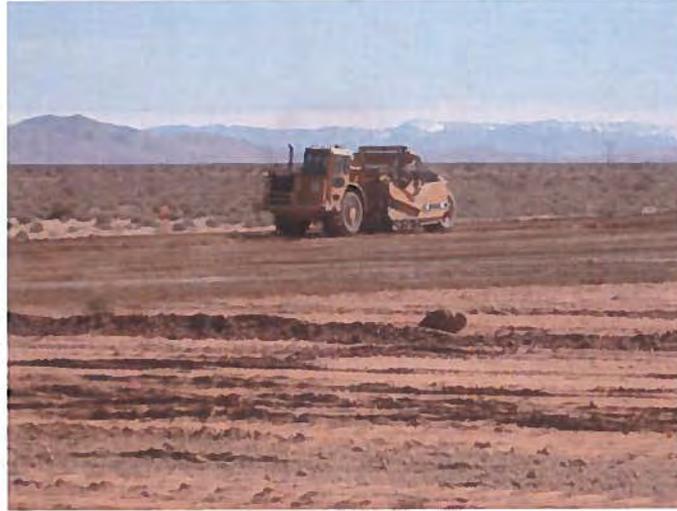
**Two 623 scrappers placing fill material on the East side**

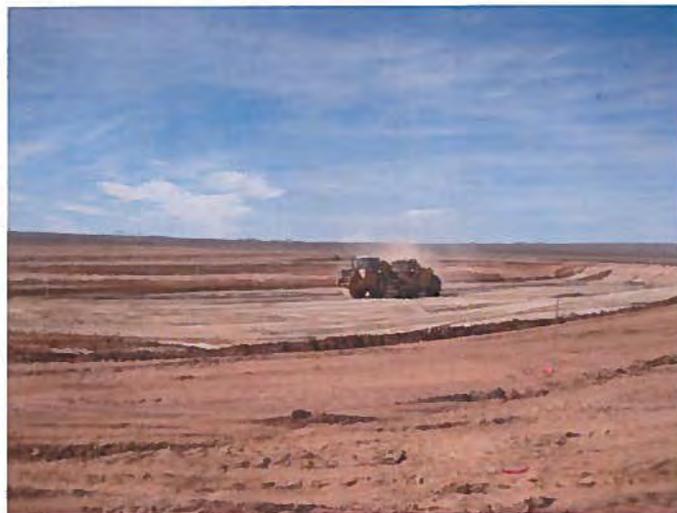
**623 scrappers removing material from pond B**

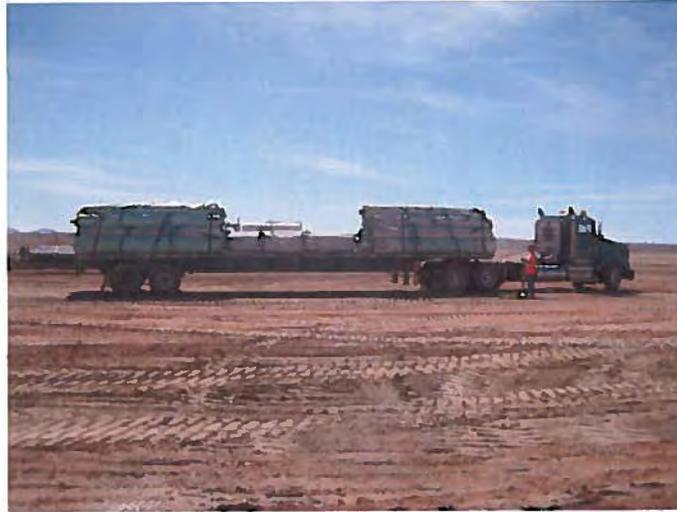
**Truck delivering GCL to site**

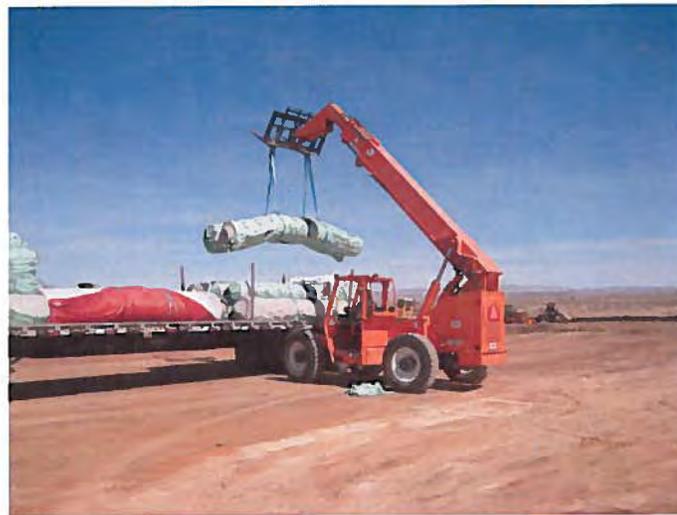
**Forklift unloading truck GCL**

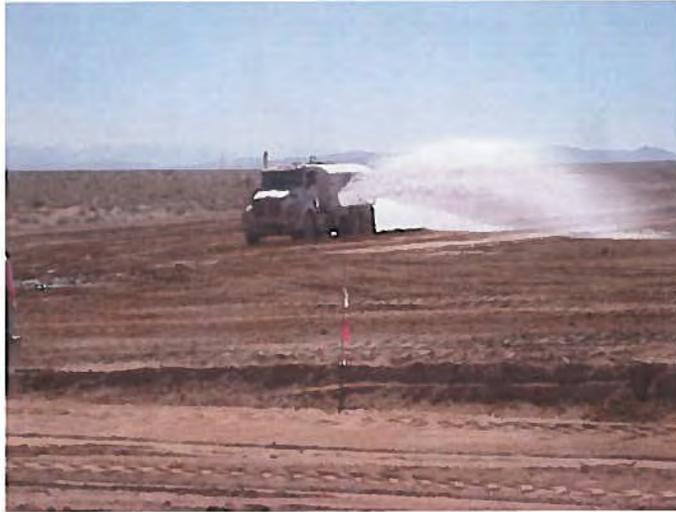
**Water truck moisture conditioning material placed on the east**

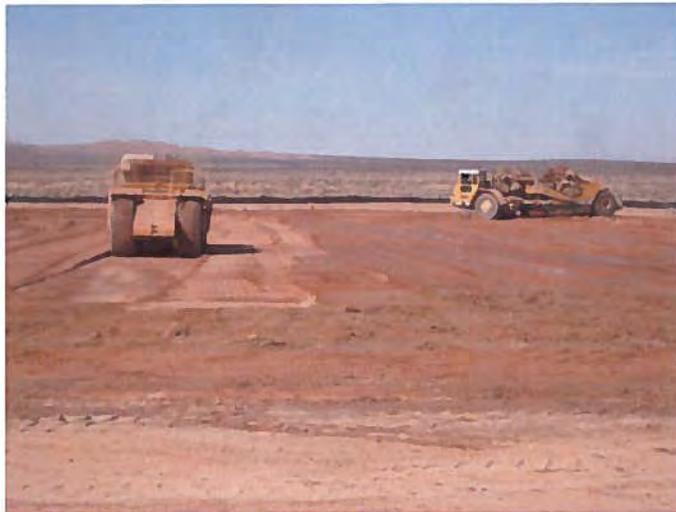
**623 scrapers removing material from pond A**

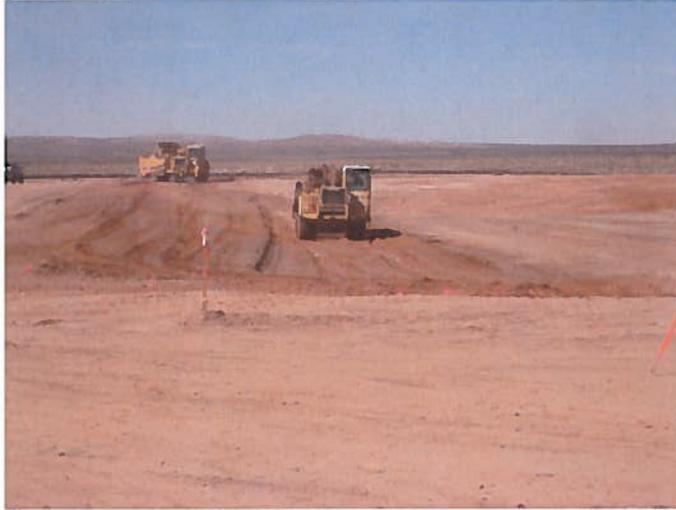
**Two 623 scrapers placing fill material on the East side**

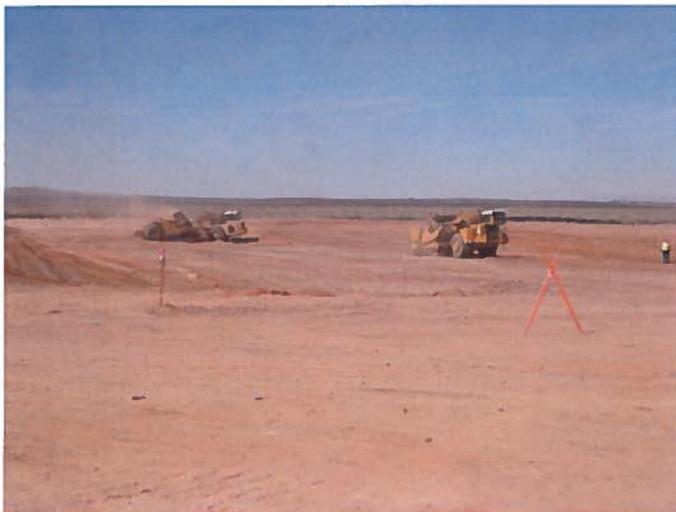
**623 scrapers removing material from pond B**

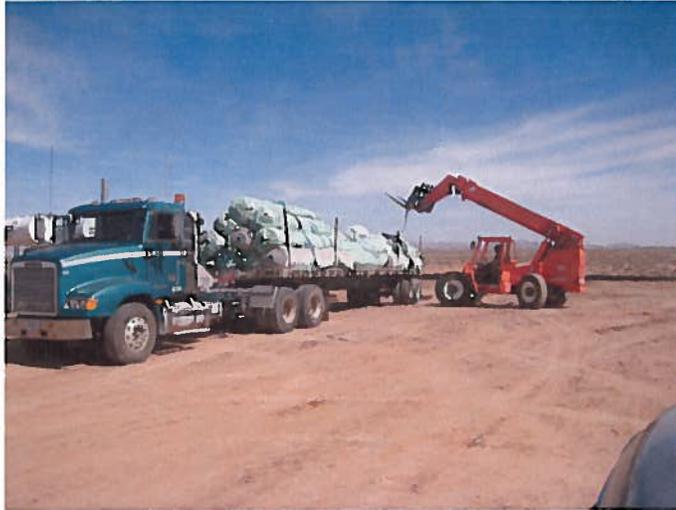
**Forklift unloading truck GCL**

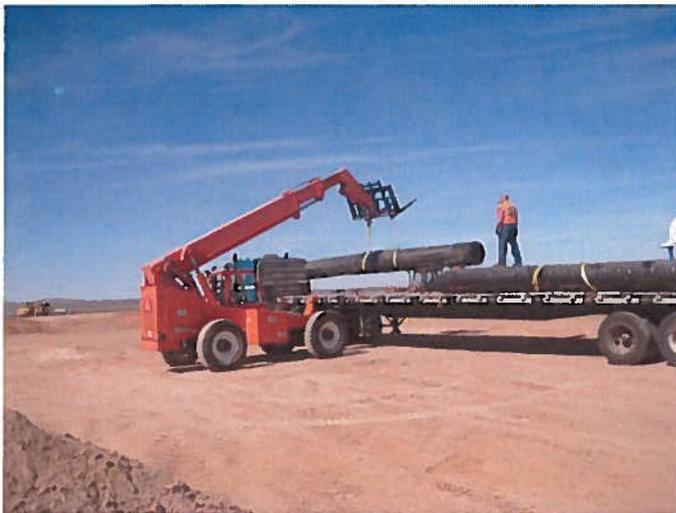
**Forklift unloading truck HDPE**

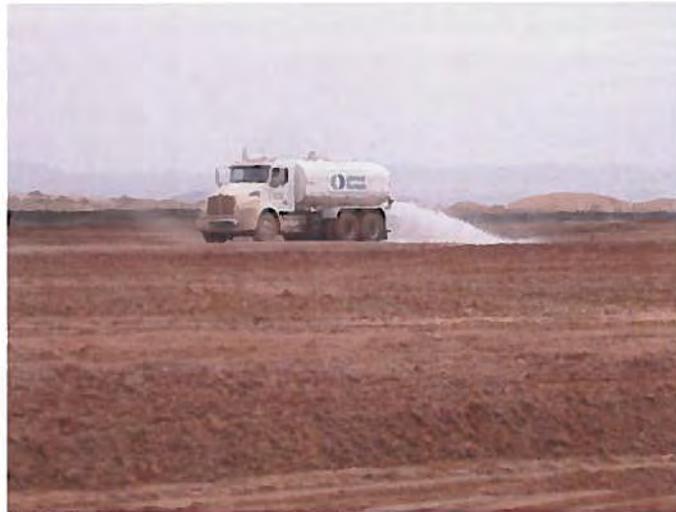
**Water truck moisture conditioning material placed on the east**

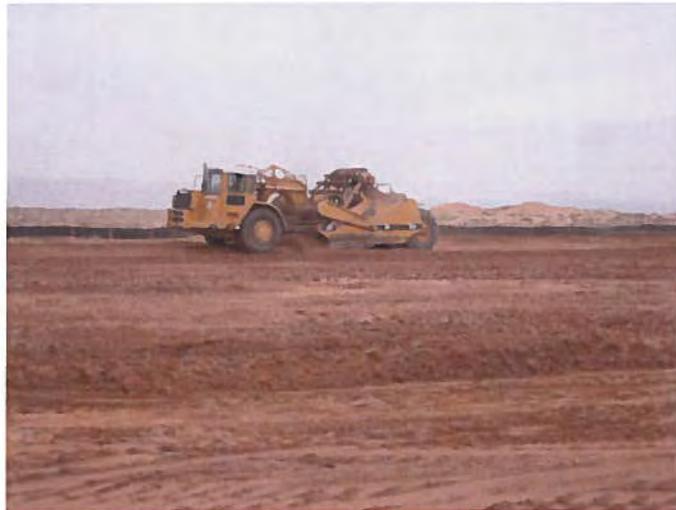
**623 scrapper removing material from pond A**

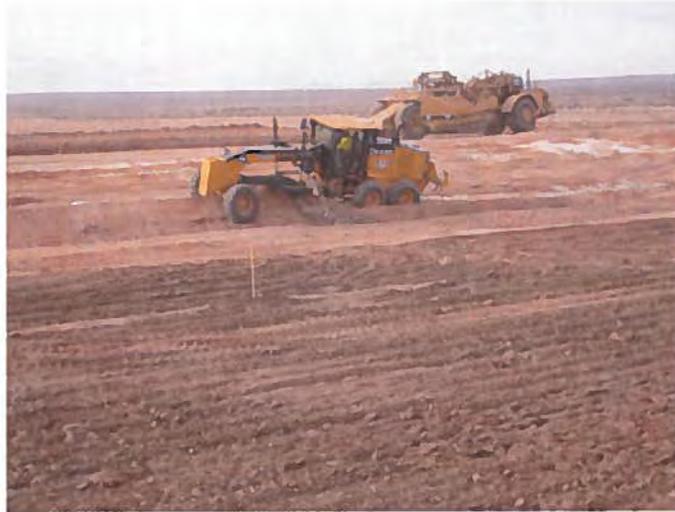
**Removing soil from slope of pond B**

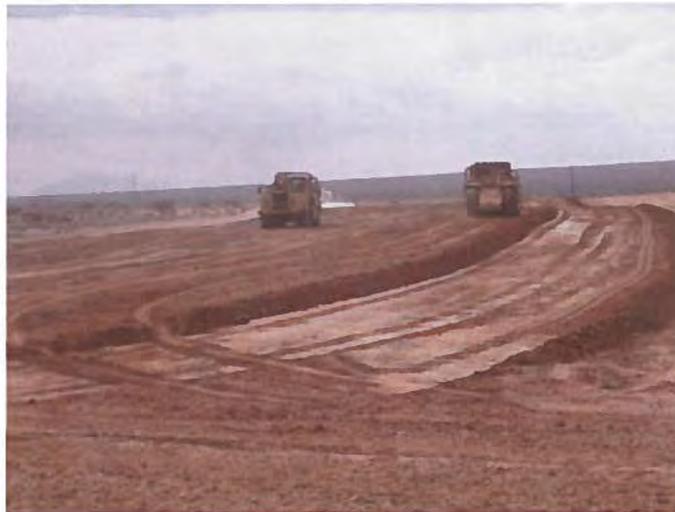
**Two 623 scrapers placing fill material on the East side**

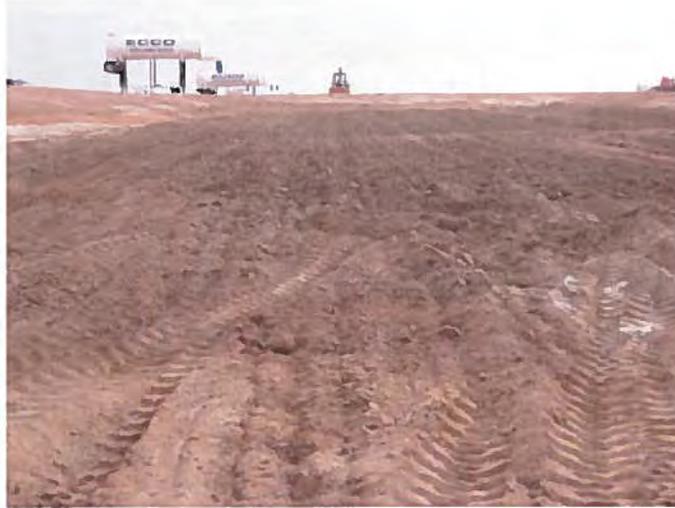
**Ripping cell floor of pond B**

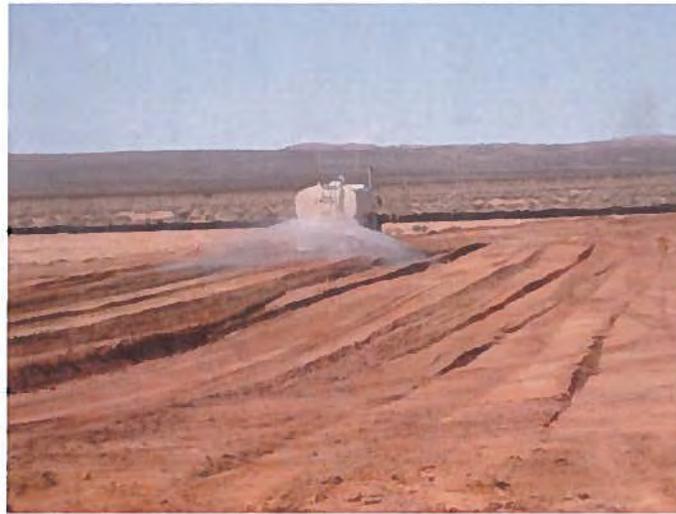
**Water truck moisture conditioning material in pond A**

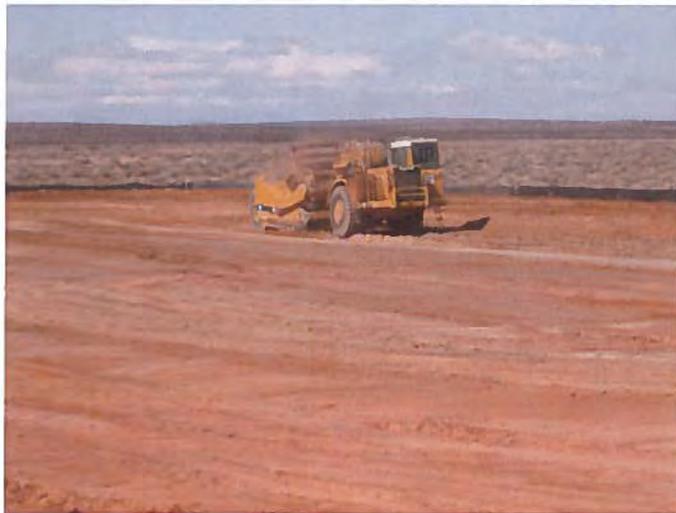
**623 scrapper removing material from pond A**

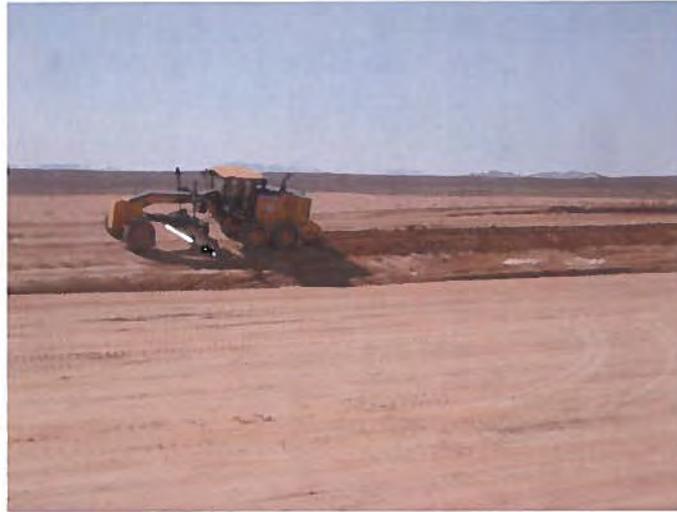
**Ripping slopes of pond B**

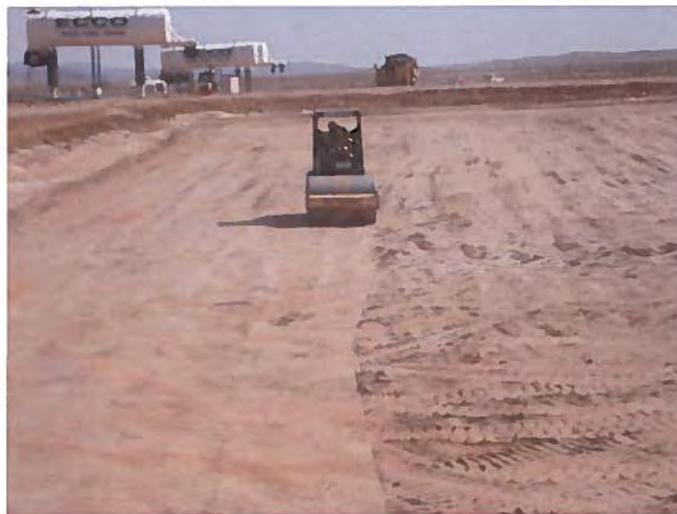
**Smooth drum rolling cell floor of pond B**

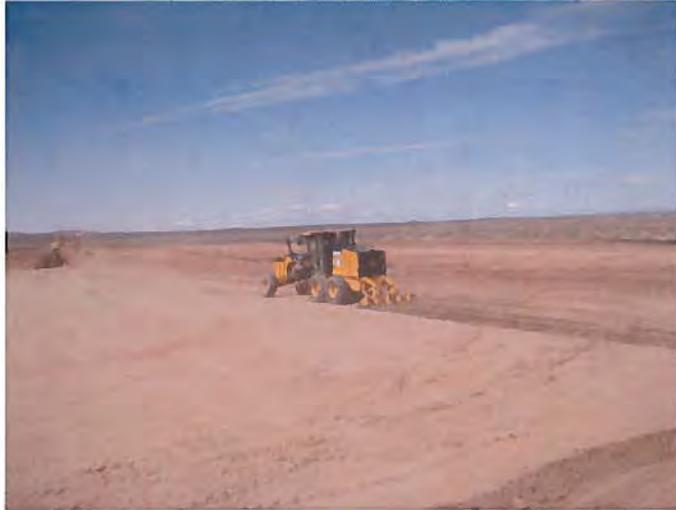
**Ripping cell floor of pond B**

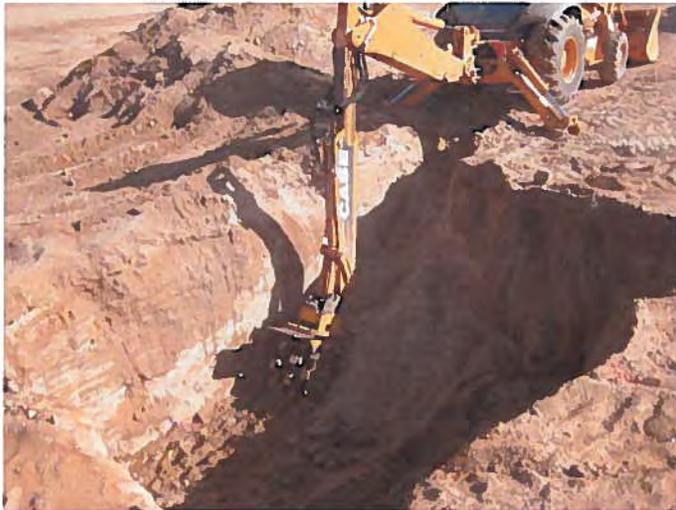
**Compacting soil under Lysimeter Sump in pond B**

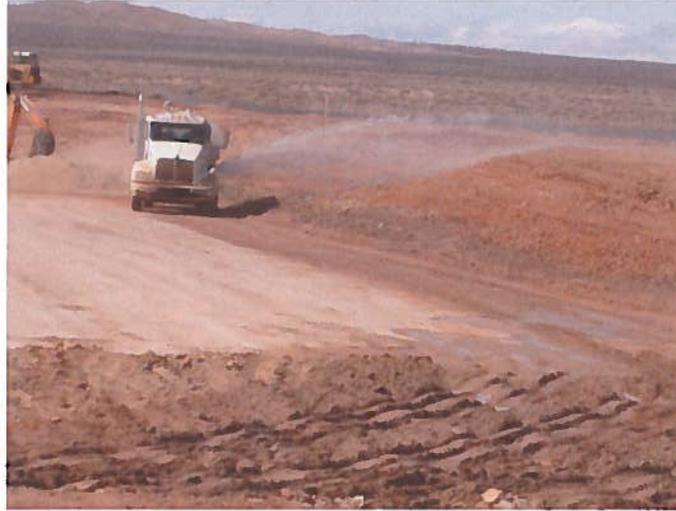
**Moisture conditioning slopes of pond B**

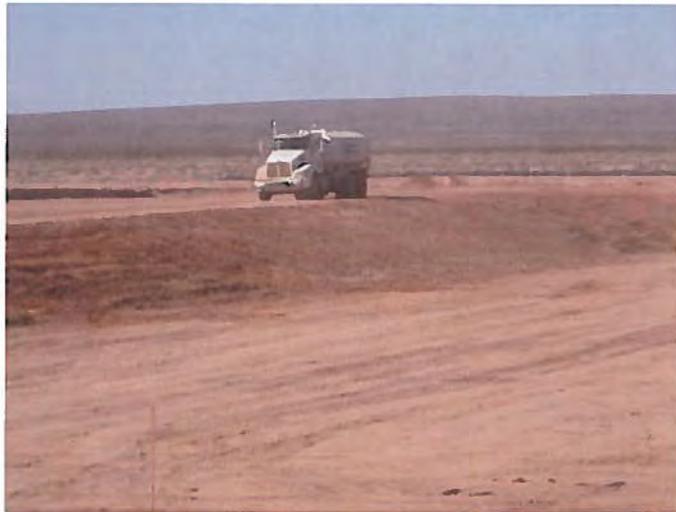
**Water truck moisture conditioning slopes of pond B**

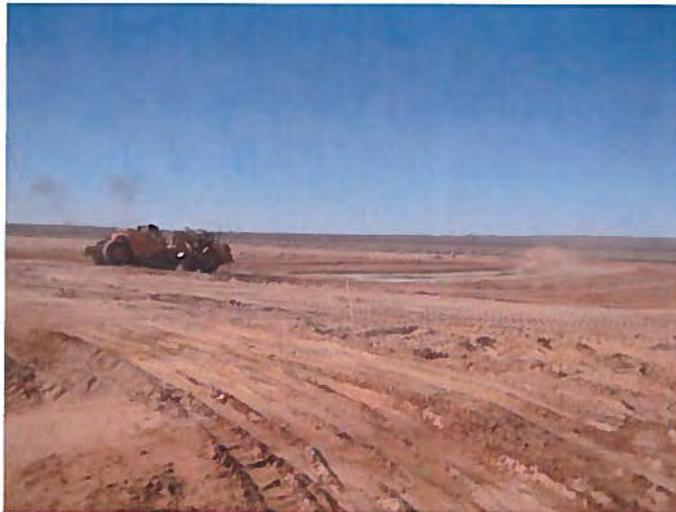
**623 scrapper removing material from pond A**

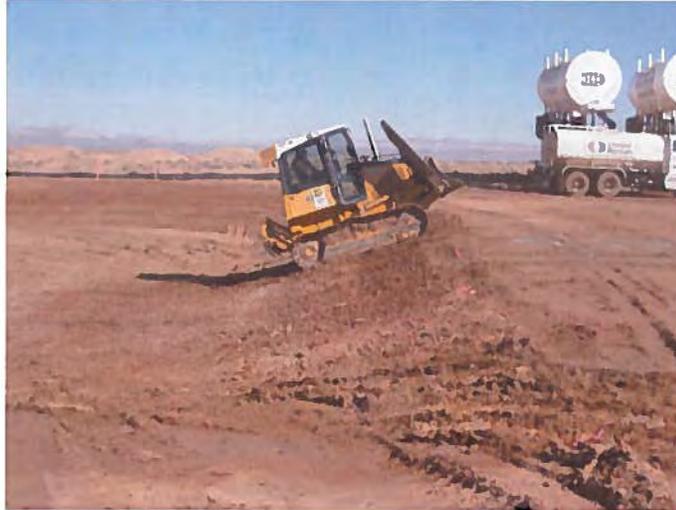
**Compacting slopes of pond B with D4 dozer**

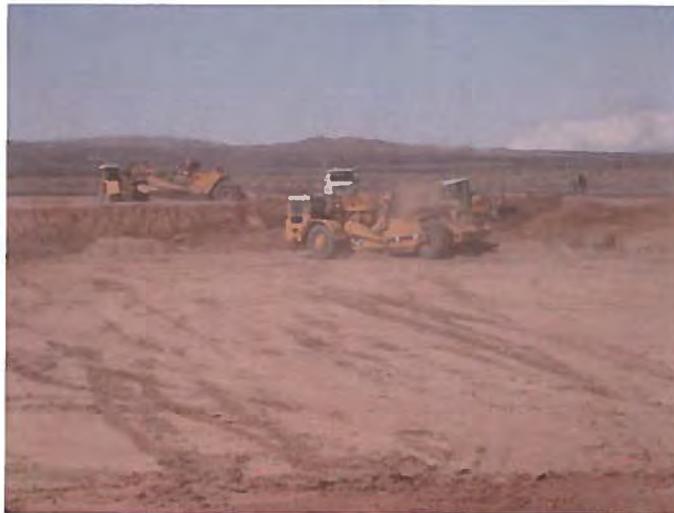
**Removing soil from Lysimeter sump in pond B**

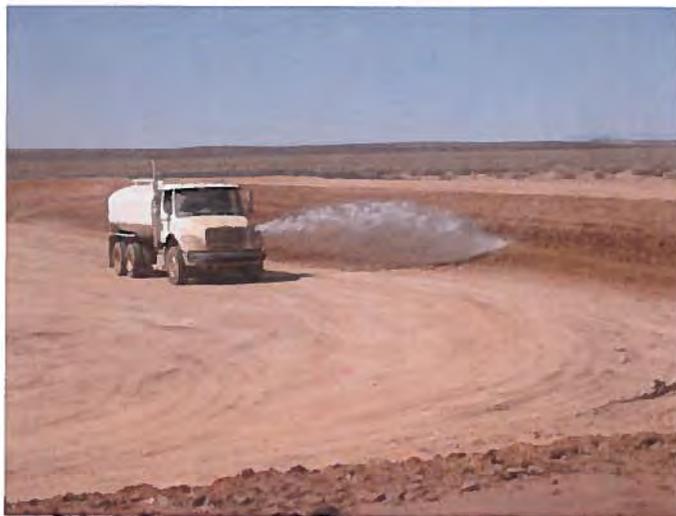
**Water truck moisture conditioning slopes of pond B**

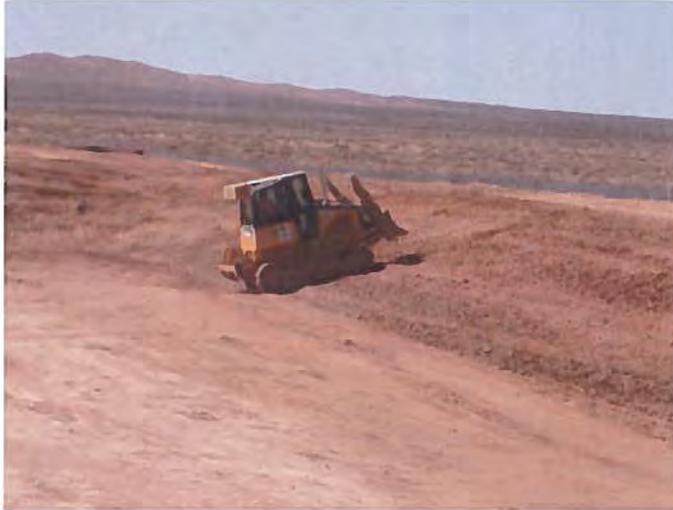
**Compacting slopes of pond B with D4 dozer**

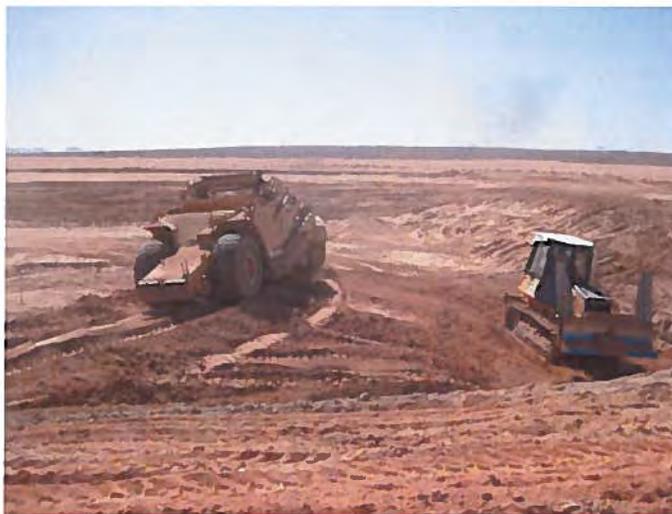
**Placing soil for Lysimeter sump back fill in pond B**

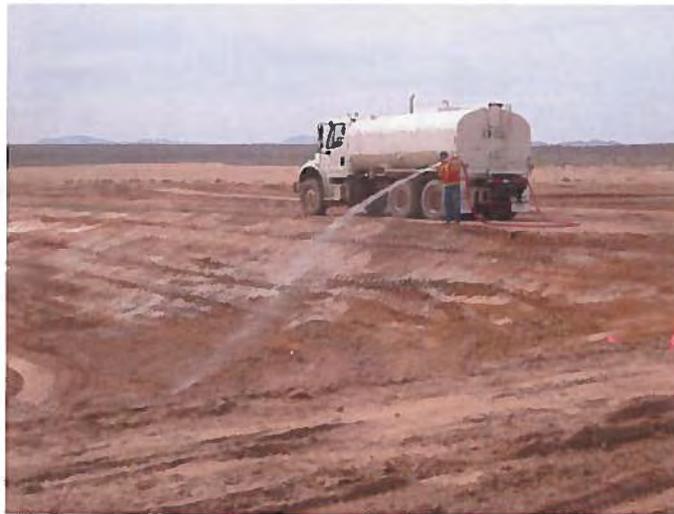
**Water truck moisture conditioning slopes of pond B**

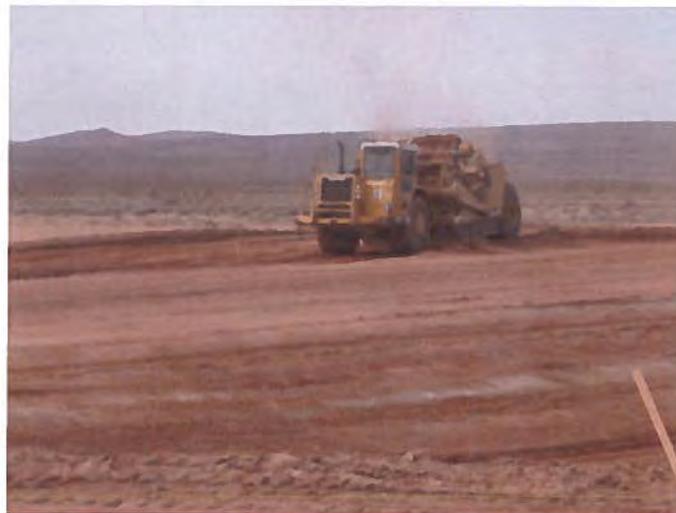
**623 scrapper removing material from pond A**

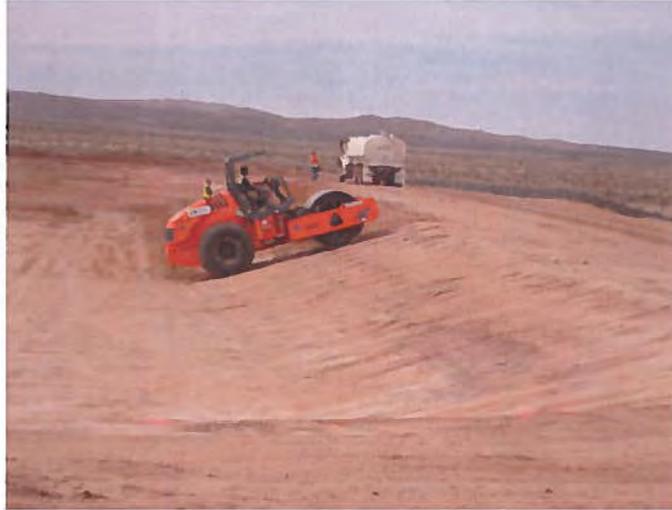
**Smooth drum rolling slopes of pond B**

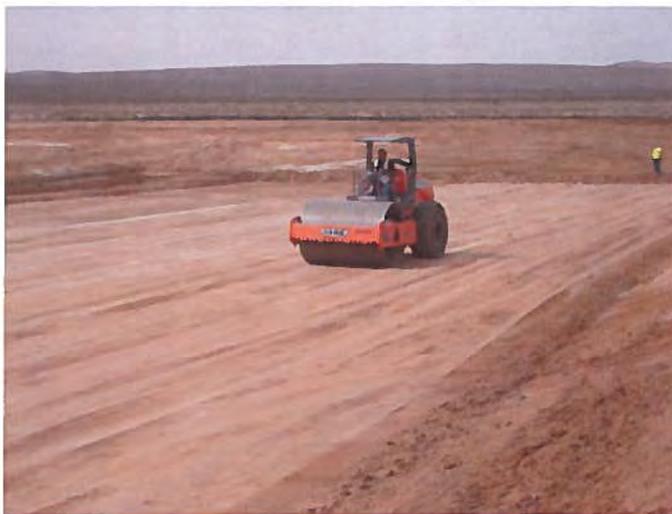
**Smooth drum rolling cell floor of pond B**

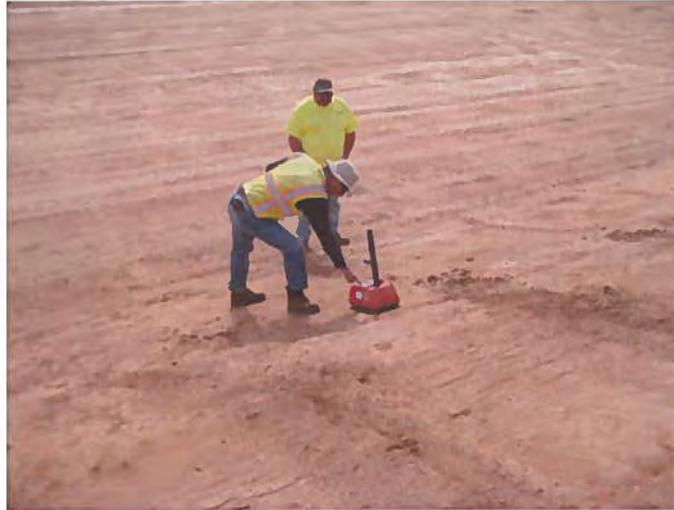
**Nuclear density testing slope of pond B**

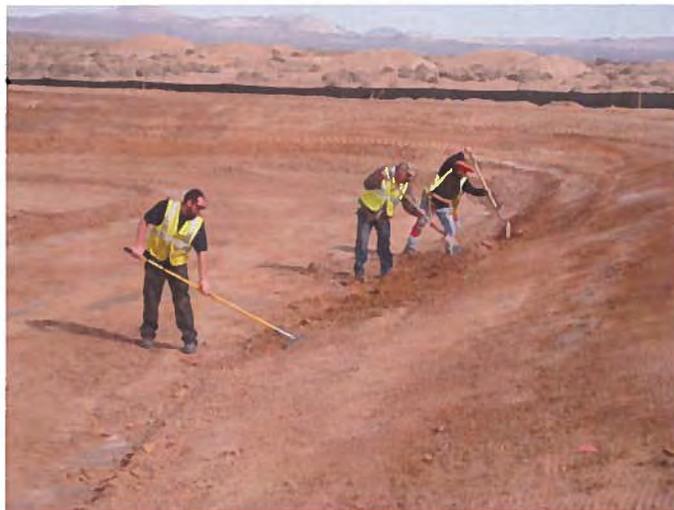
**Racking sub grade of pond B**

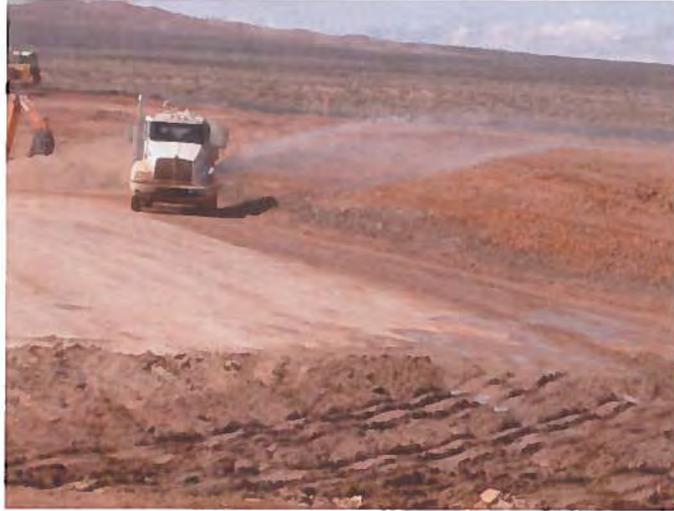
**Moisture conditioning slopes of pond B**

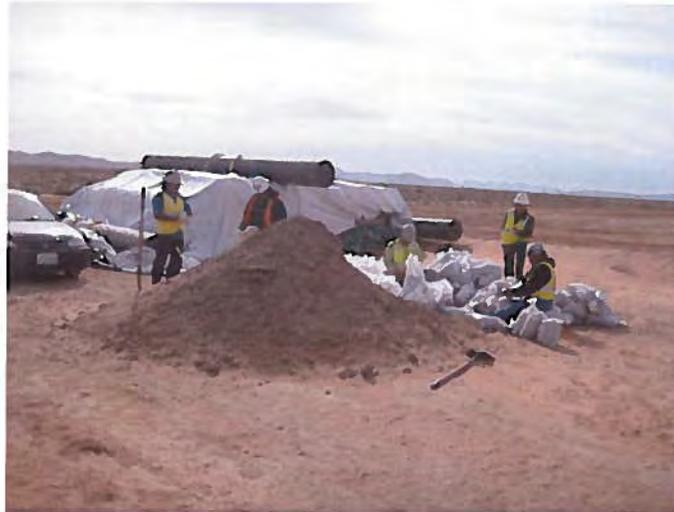
**Filling sandbags for HDPE deployment**

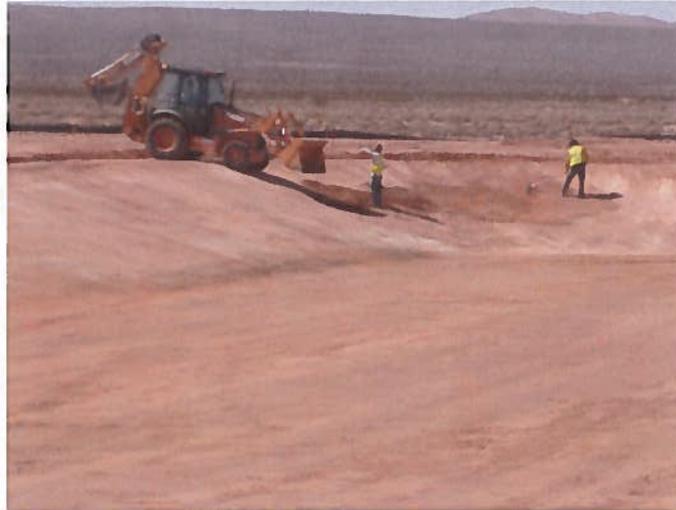
**Preparing sub grade of pond B**

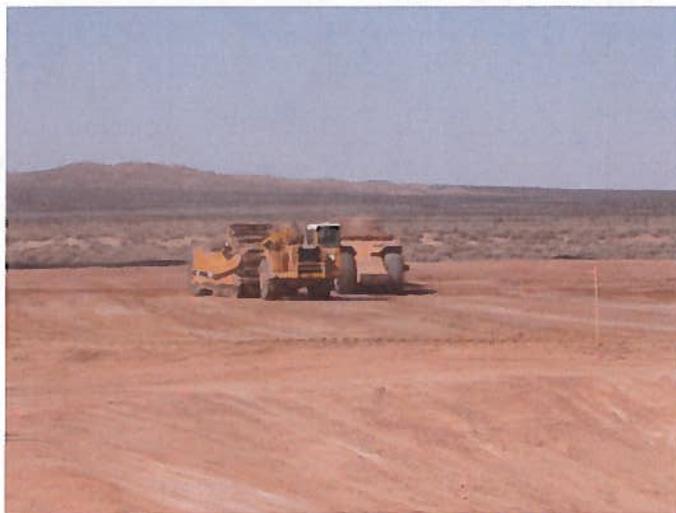
**623 scrapers removing material from pond A**

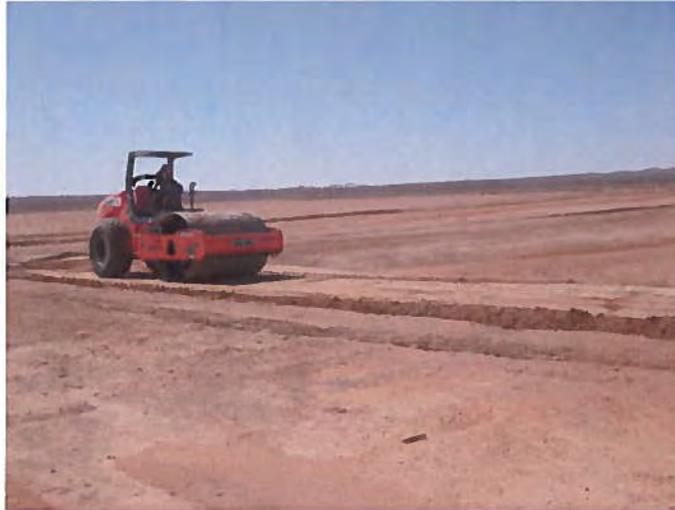
**Smooth drum rolling anchor trench of pond B**

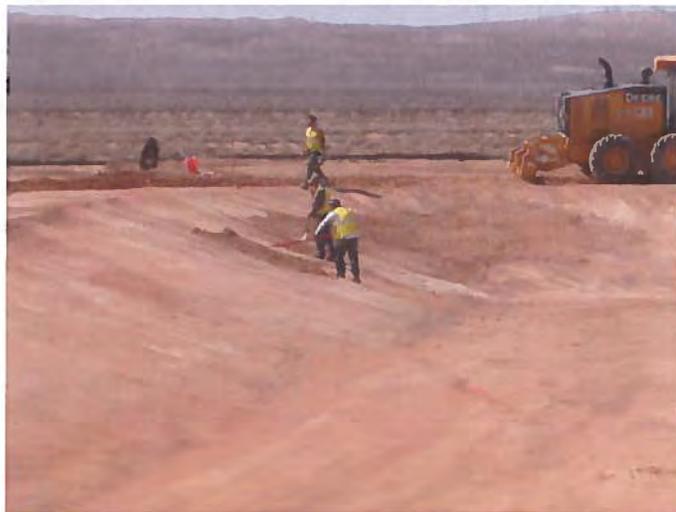
**Racking sub grade of pond B**

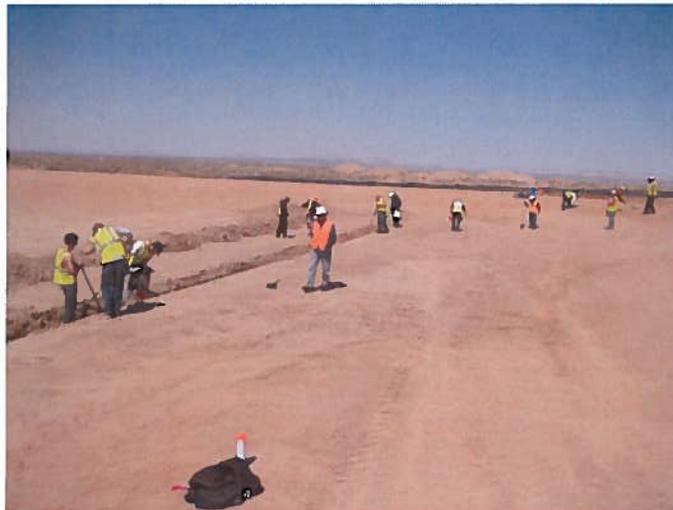
**Preparing sub grade of pond B**

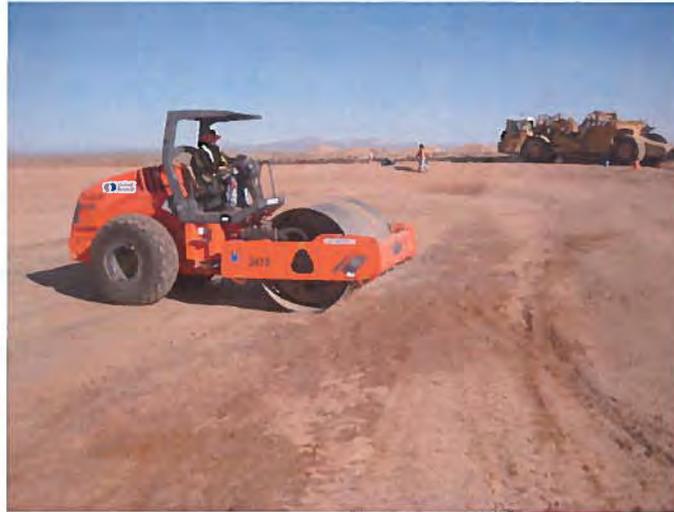
**Smooth drum rolling anchor trench of pond B**
