Nursery Products, LLC.  
12277 Apple Valley Road, Suite 131  
Apple Valley, California 92308

**FINAL CONSTRUCTION  
QUALITY ASSURANCE REPORT  
EAST WASTE PILE COMPOSTING PAD and  
SURFACE IMPOUNDMENT A and B**

**HAWES COMPOSTING FACILITY**

May 2012

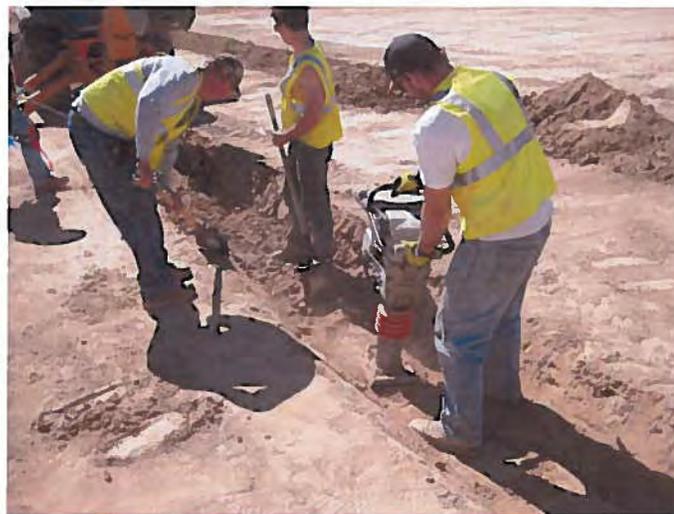
**Compacting bottom of anchor trench #1 in pond B**

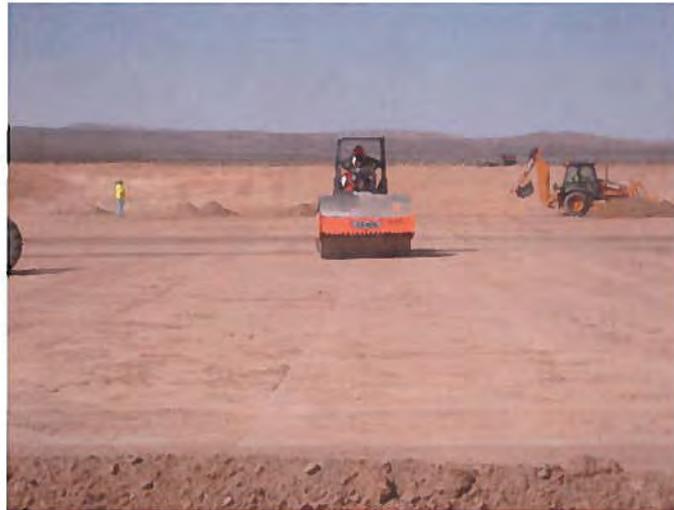
**Smooth drum rolling subgrade of pond B**

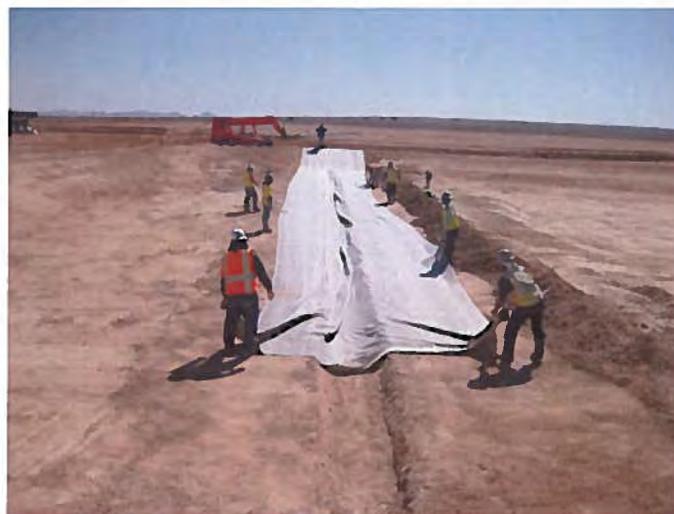
**Placing GCL in anchor trench #1 in pond B**

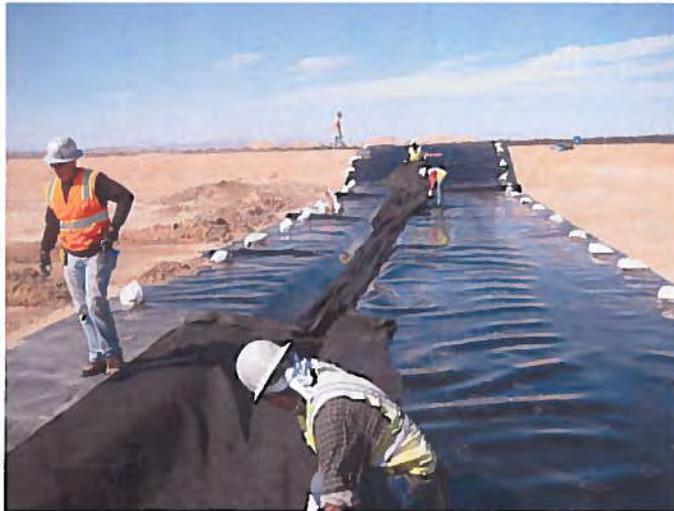
**Placing Geomembrane in anchor trench #1 in pond B**

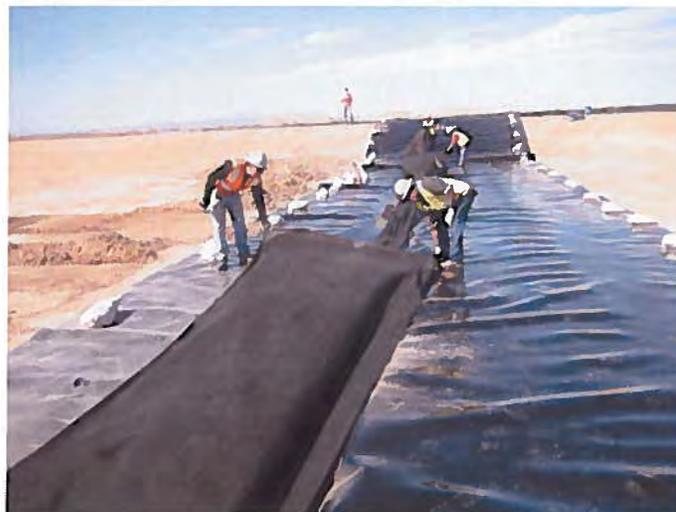
**Placing 12 oz Geotextile in anchor trench # 1 in pond B**

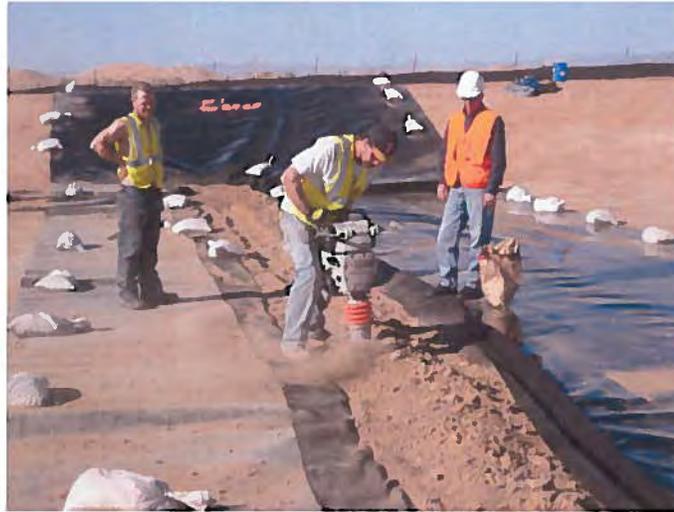
**Compacting back fill material in anchor trench #1 in pond B**

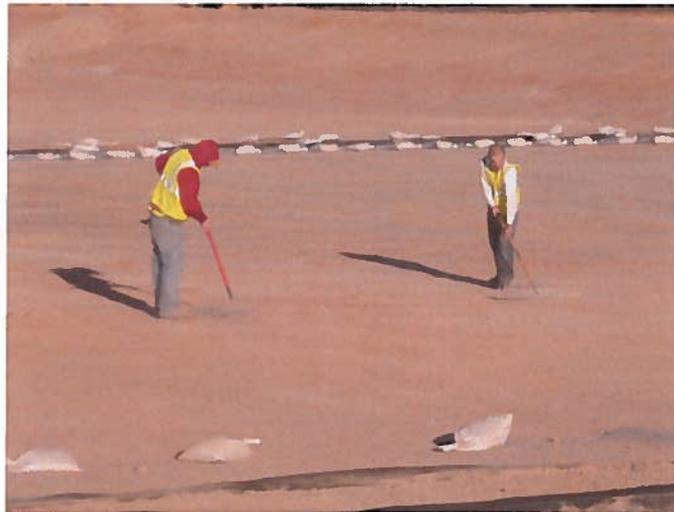
**Preparing sub grade of pond B**

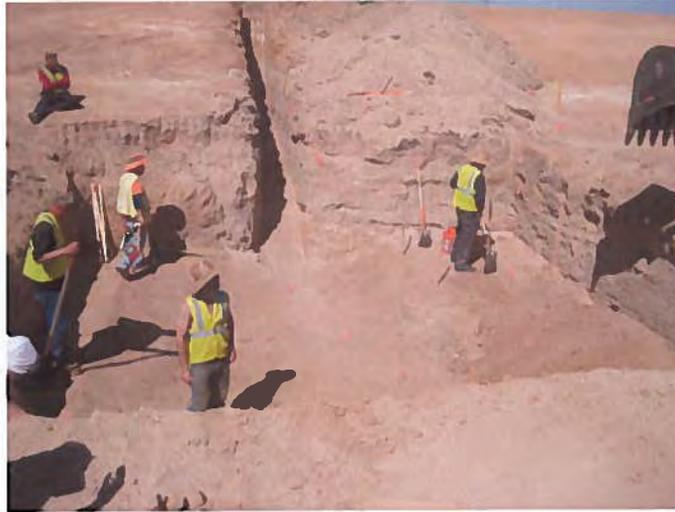
**Preparing subgrade of Lysimeter sump in pond B**

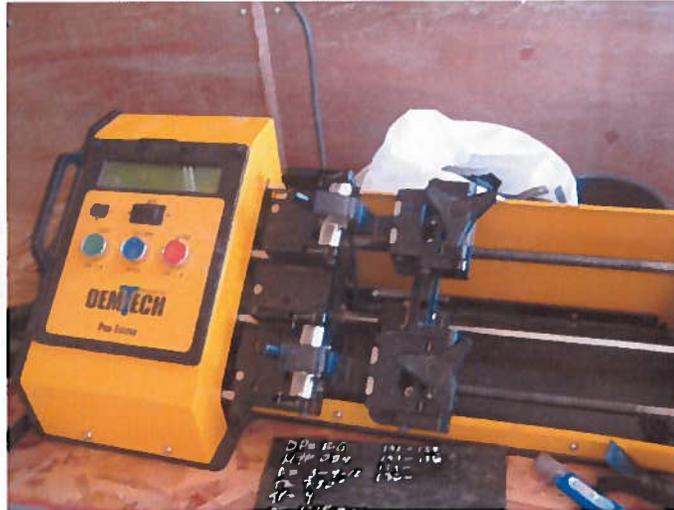
**Trial weld being pulled for fusion weld**

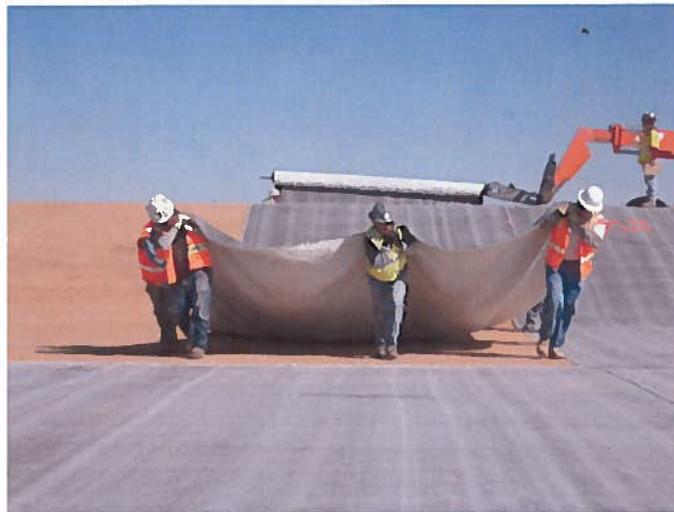
**Placing GCL on the east slope and cell floor in pond B**

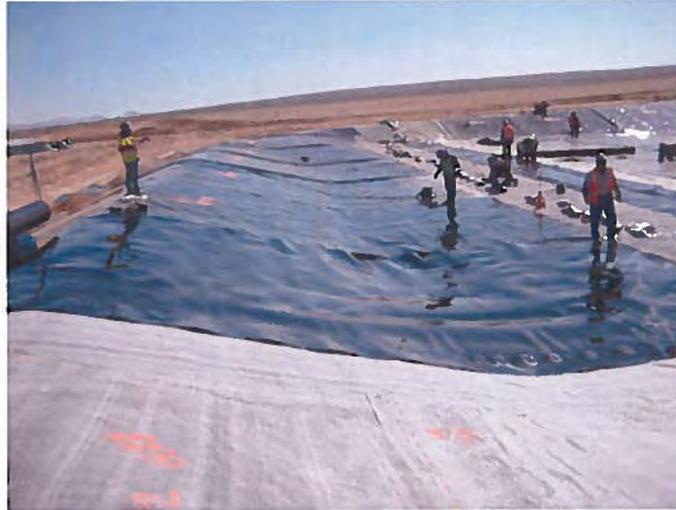
**Placing HDPE liner on top of GCL on the east slope and cell floor in pond B**

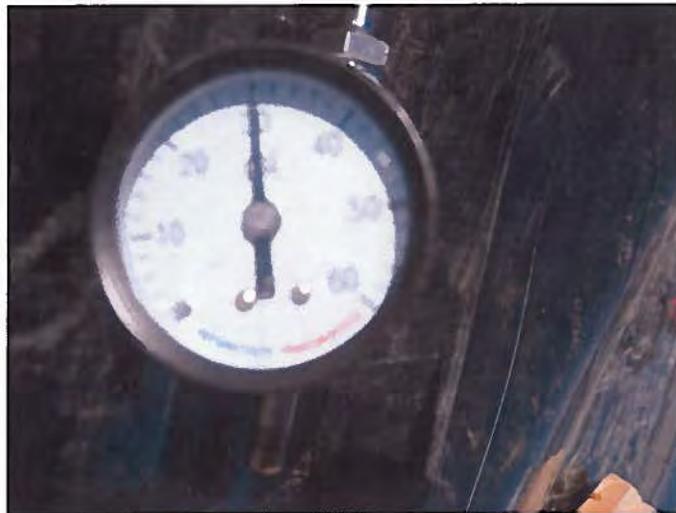
**Air pressure testing fusion welded seam of HDPE liner in pond B**

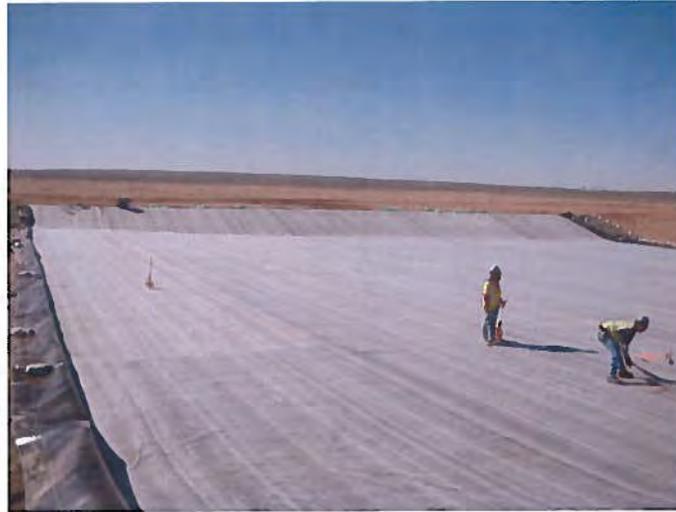
**Placing GCL on the North to South slope and cell floor between 1<sup>st</sup> and 2<sup>nd</sup> anchor trench in pond B**

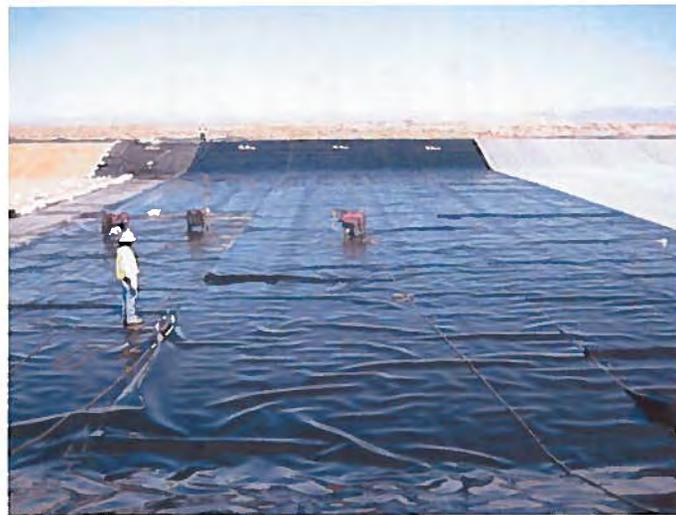
**Placing HDPE liner on top of GCL on the North to South slope and cell floor between 1<sup>st</sup> and 2<sup>nd</sup> anchor trench in pond B**

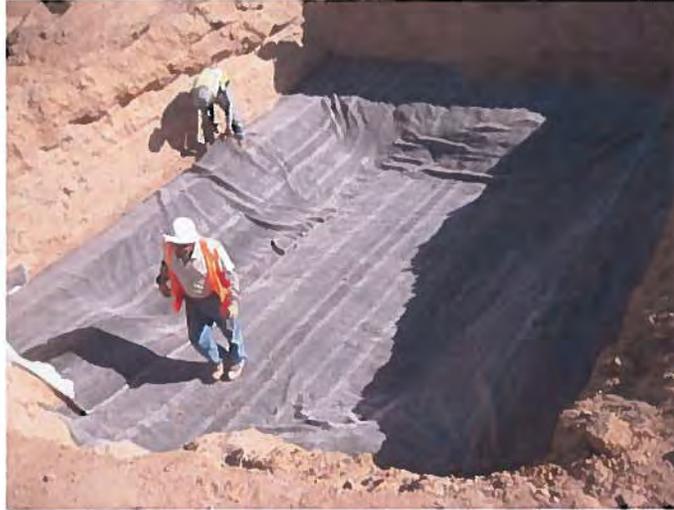
**Placing GCL in Lysimeter sump in pond B**

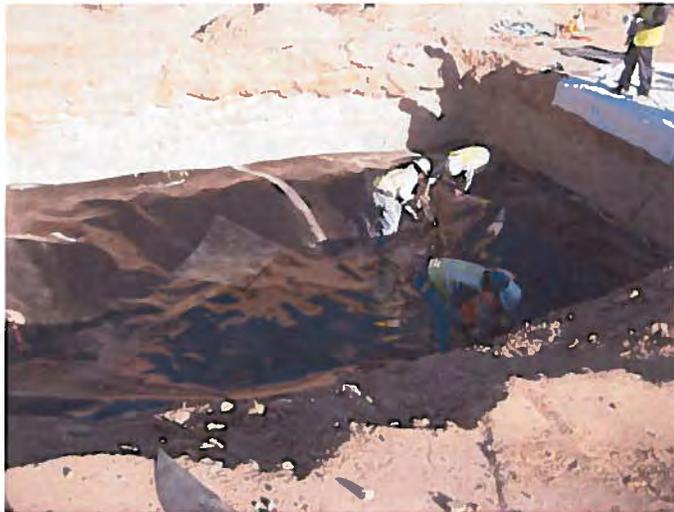
**Placing HDPE liner on top of GCL in Lysimeter sump in pond B**

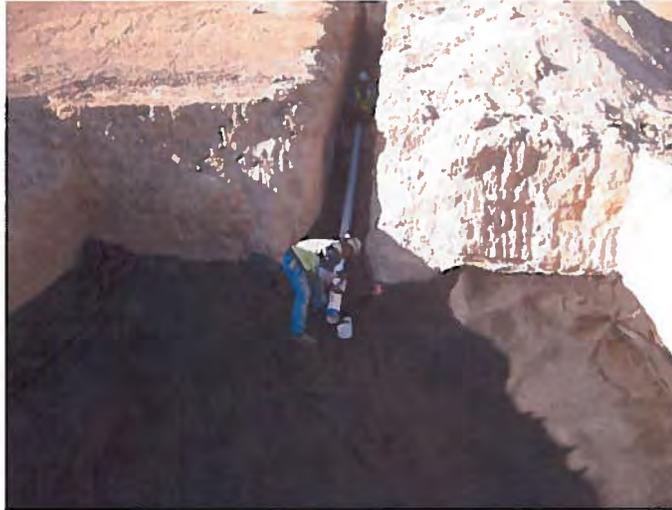
**Placing geotextile and pipe in Lysimeter sump in pond B**

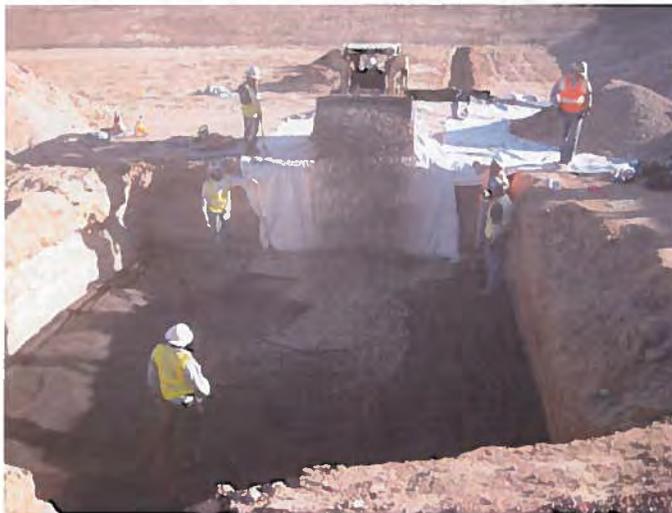
**Placing rock back fill on top of 12oz geotextile in Lysimeter sump in pond B**

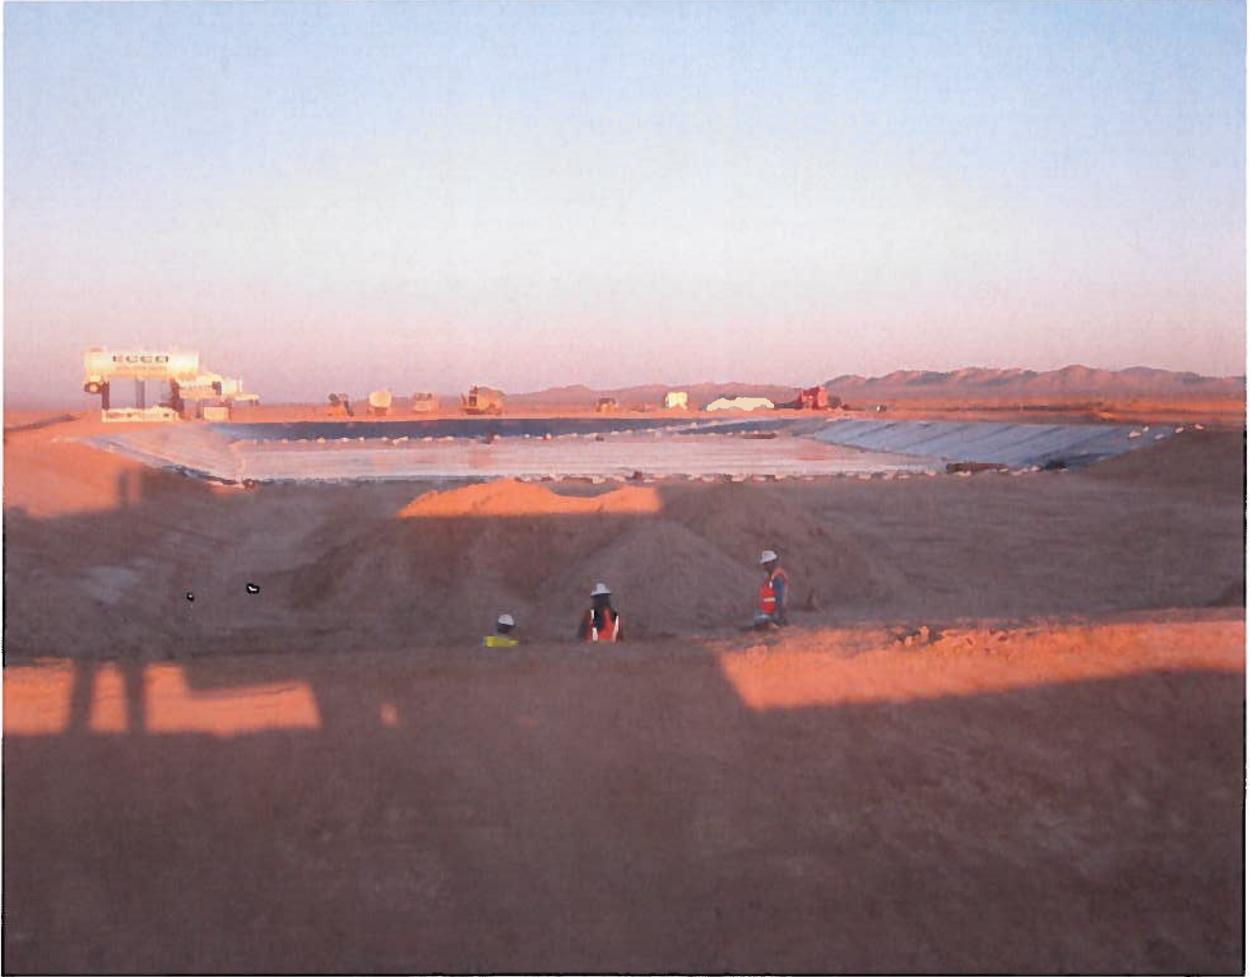
**Pond B picture from the West side looking to the East side.**

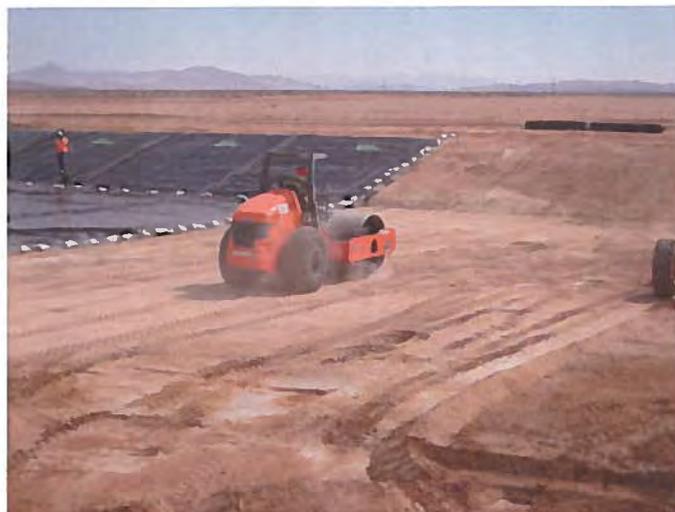
**Preparing sub grade of pond B**

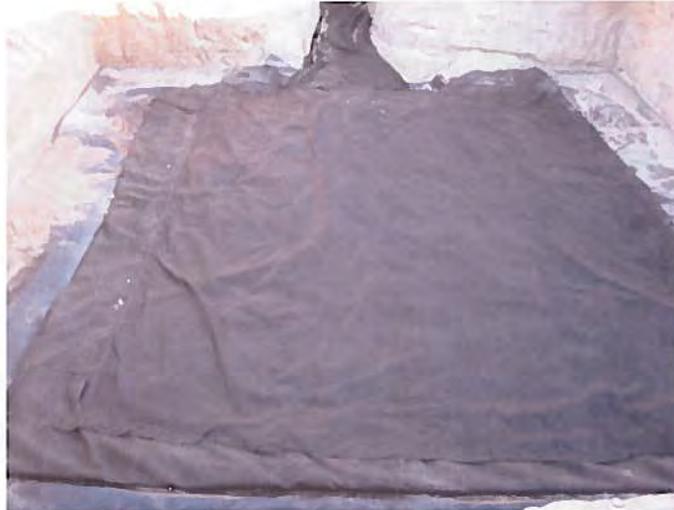
**Geotextile placed in Lysimeter sump in pond B**

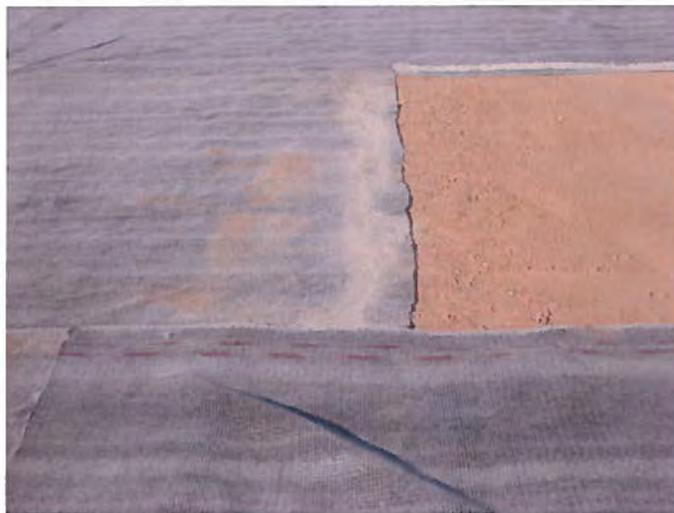
**Placing bentonite in butt seams of GCL placed in pond B**

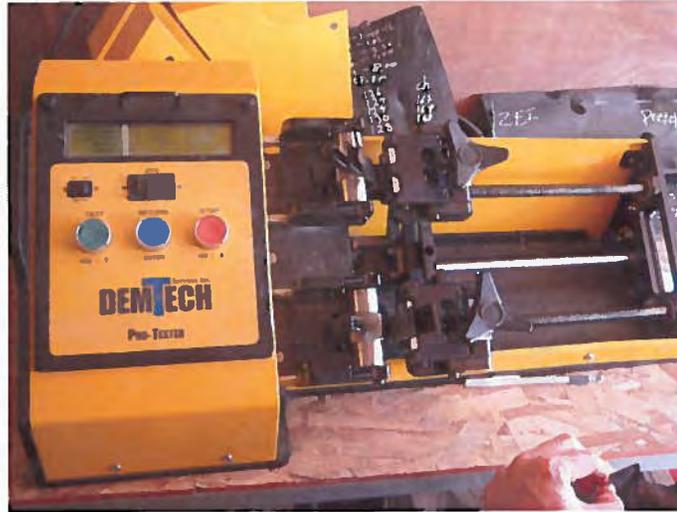
**Trial weld being pulled for fusion weld**

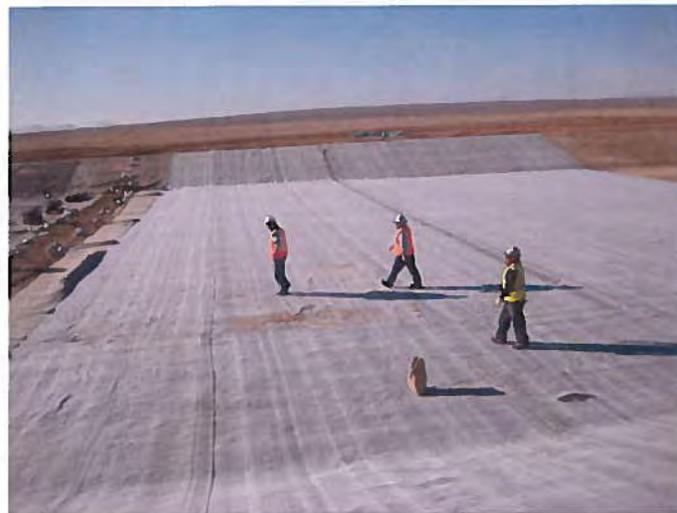
**Placing GCL on the North slope, South slope, cell floor between 2<sup>nd</sup> and 3<sup>rd</sup> anchor trench in pond B**

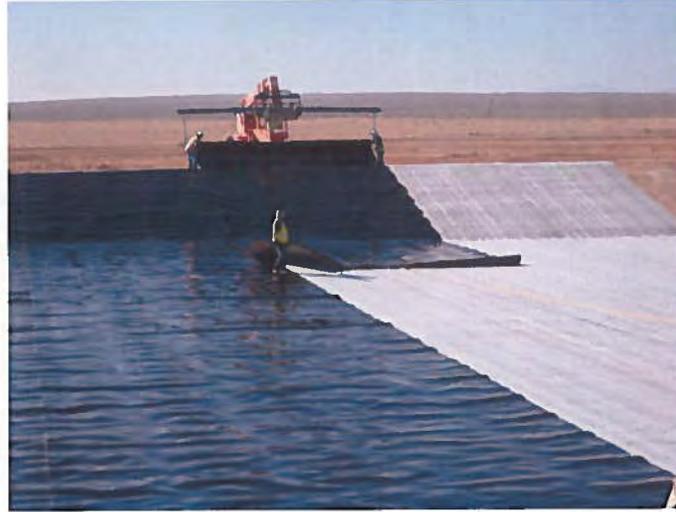
**Placing HDPE liner on the North slope, South slope, cell floor between 2<sup>nd</sup> and 3<sup>rd</sup> anchor trench in pond B**

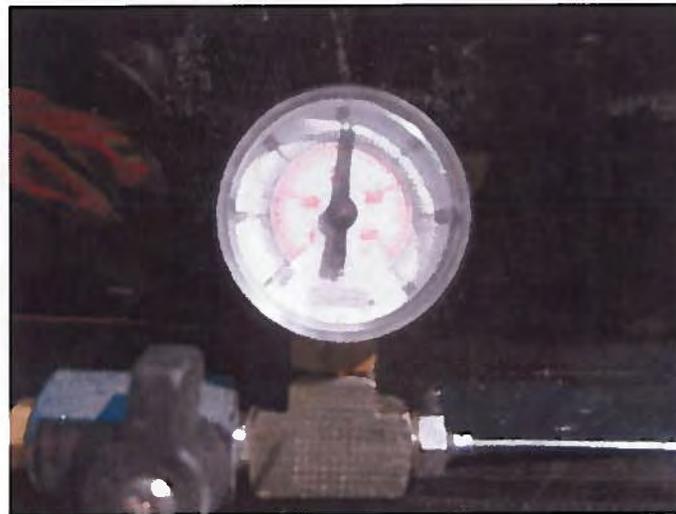
**Air pressure testing fusion welded seam of HDPE liner in pond B**

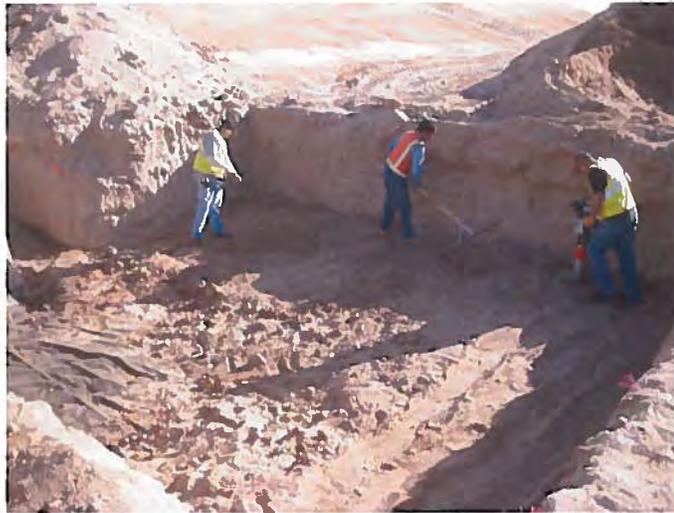
**Compacting material placed on top of geotextile in Lysimeter sump in pond B**

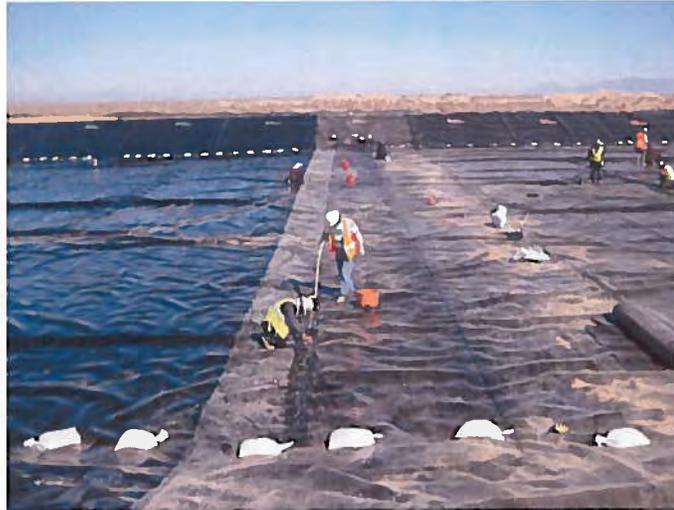
**Cap over anchor trench in pond B**

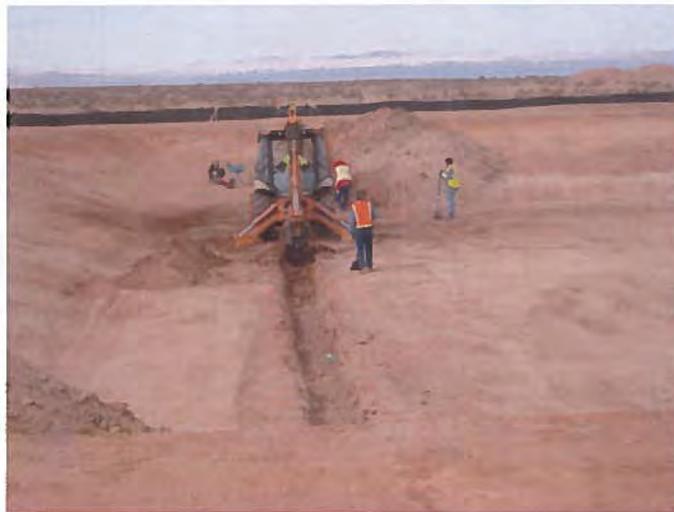
**Digging 3<sup>rd</sup> anchor trench in pond B**

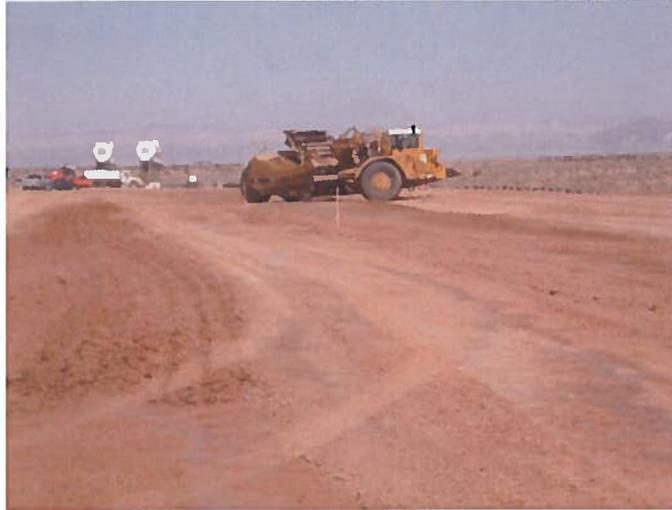
**623 scrapper placing fill material on the East side of compost area**

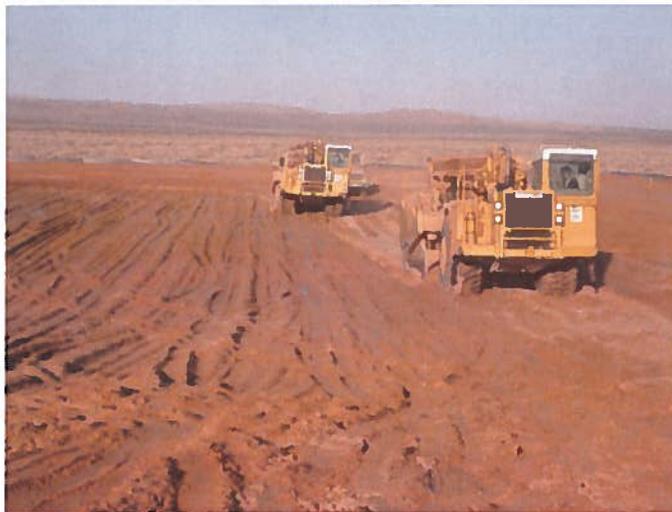
**Two 623 scrapper removing material from pond A**

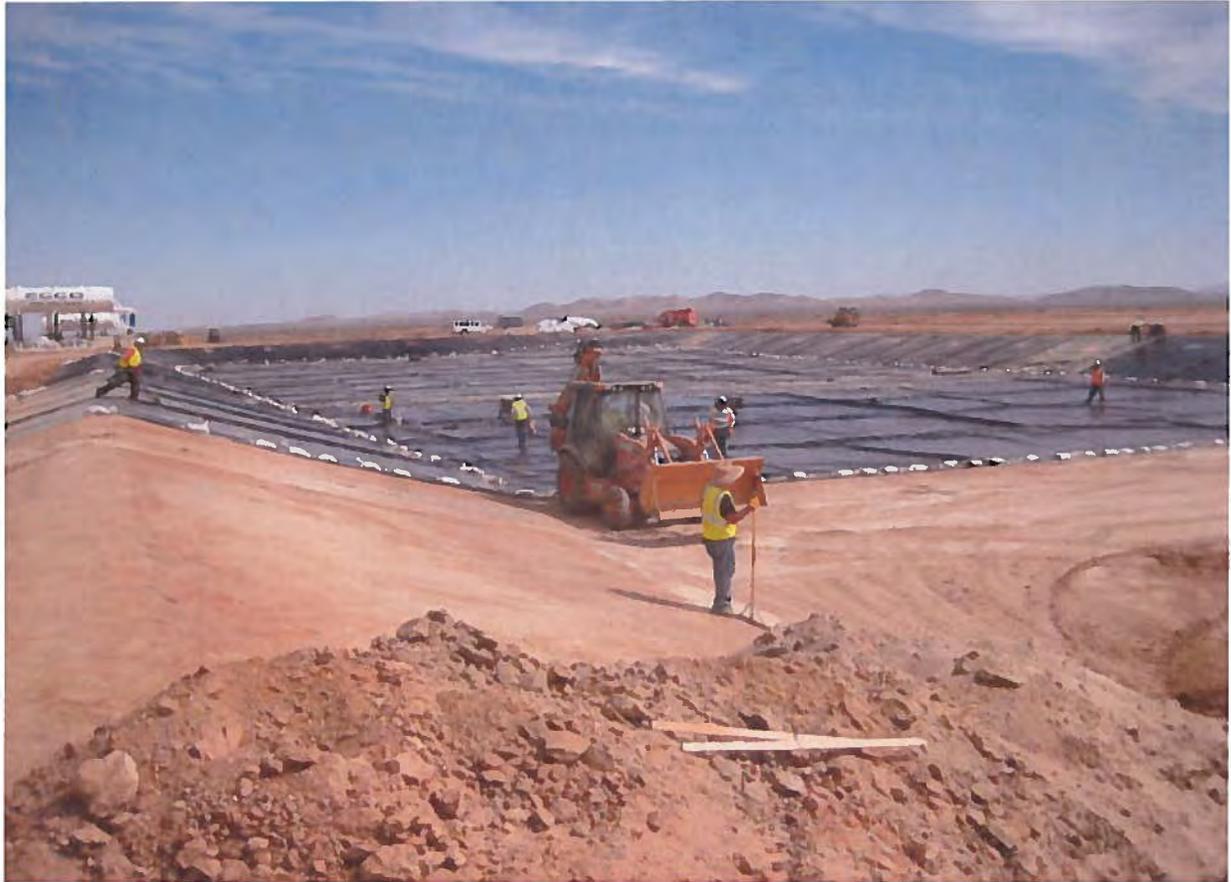
**Pond B picture from the West side looking to the East side.**

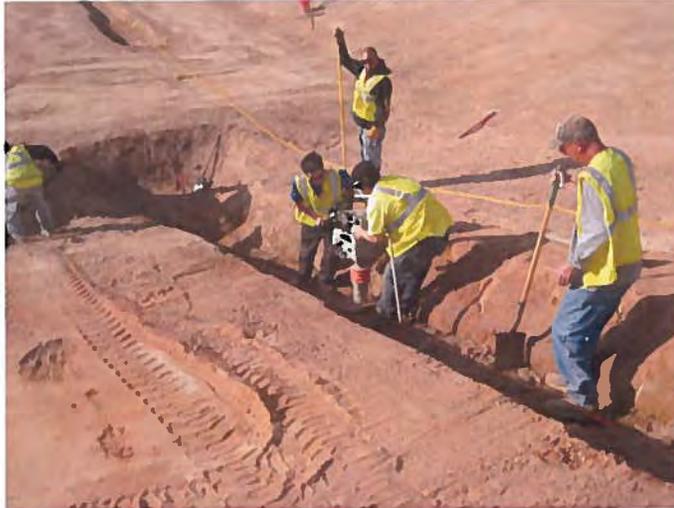
**Compacting and preparing subgrade of sump in pond B**

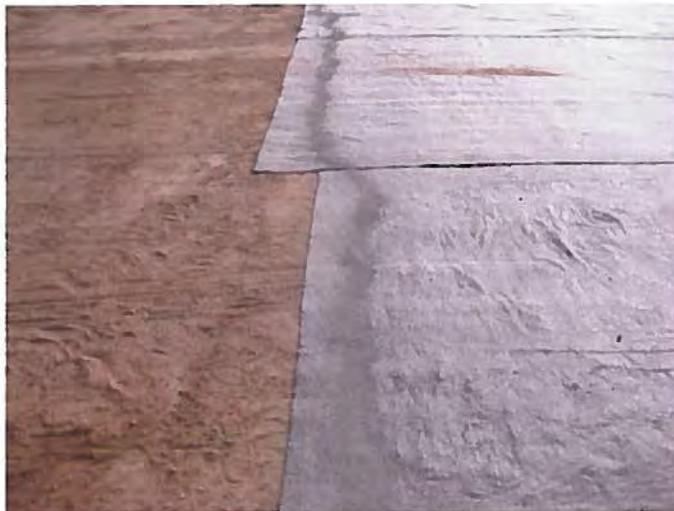
**Placing bentonite in butt seams of GCL placed in pond B**

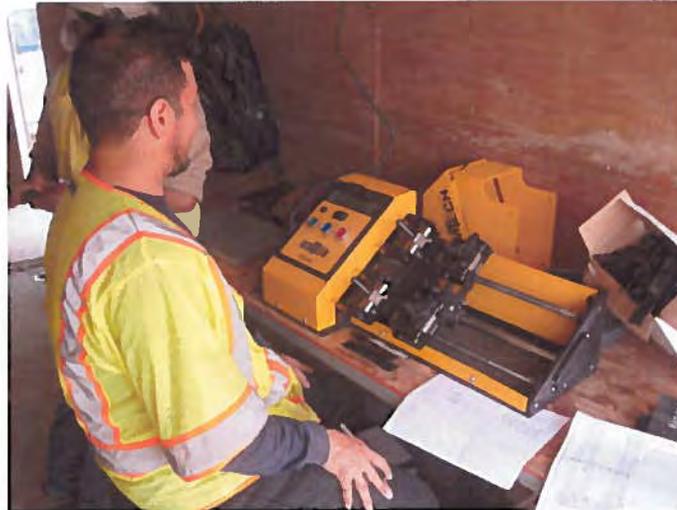
**Trial weld being pulled for fusion weld**

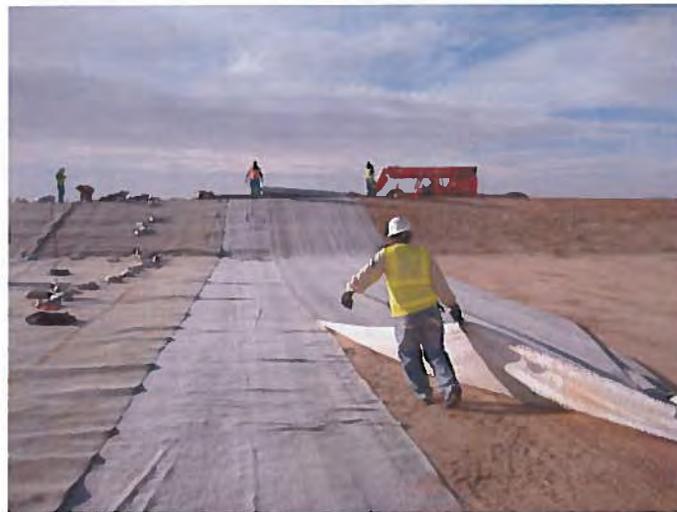
**Placing GCL on the North slope, South slope, cell floor between 2<sup>nd</sup> and 3<sup>rd</sup> anchor trench in pond B**

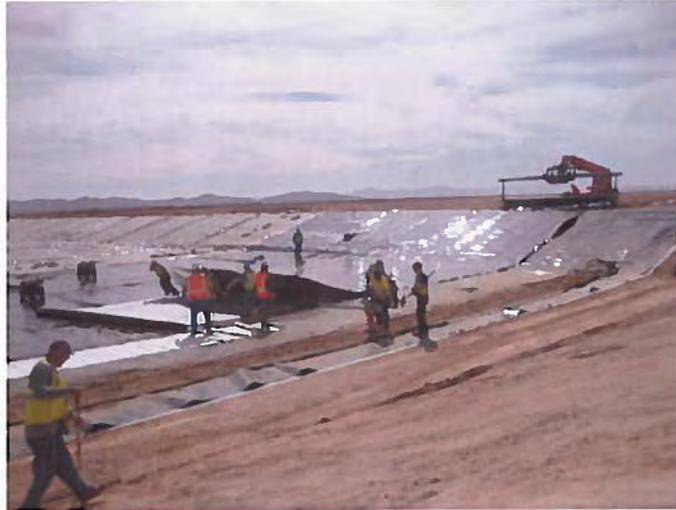
**Placing HDPE liner on the North slope, South slope, cell floor between 2<sup>nd</sup> and 3<sup>rd</sup> anchor trench in pond B**

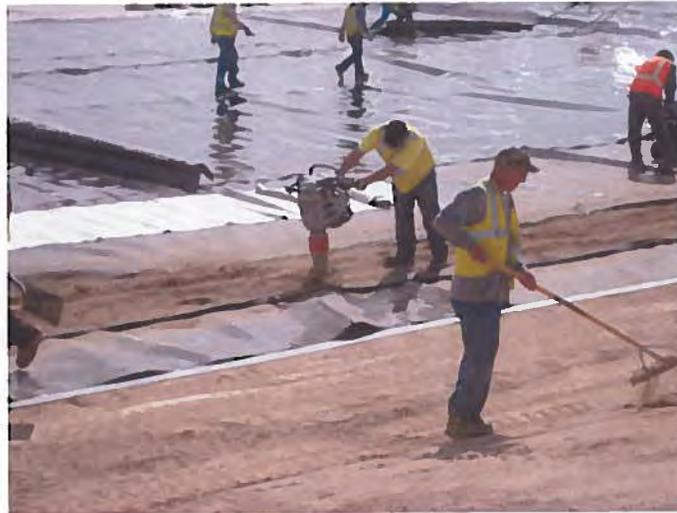
**Compacting back fill material in anchor trench # 3 in pond B**

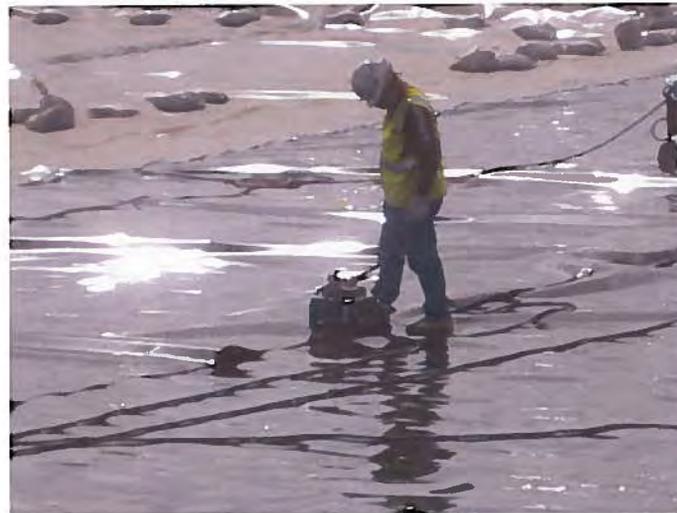
**Fusion welding seam of HDPE liner in pond B**

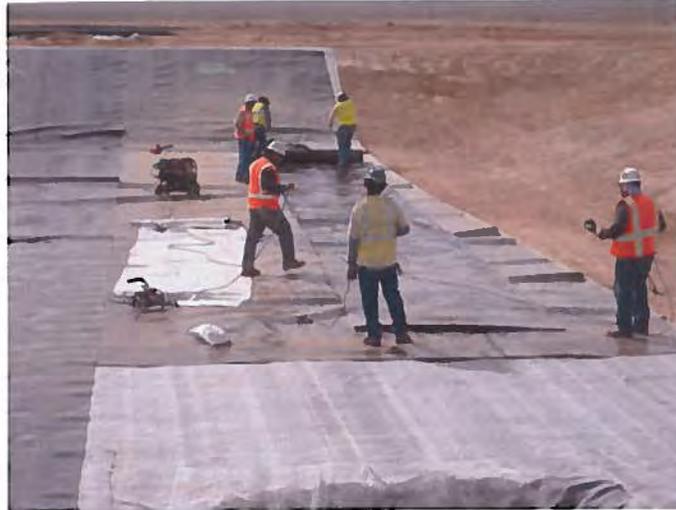
**Cap over anchor trench # 3 in pond B**

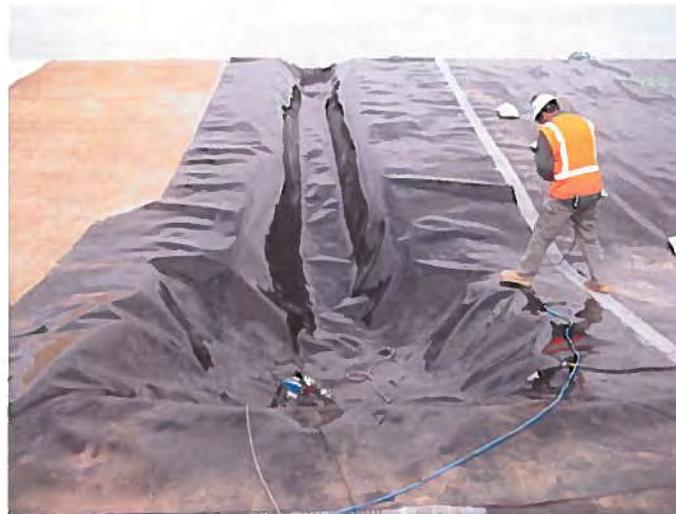
**HDPE liner placed in sump in pond B**

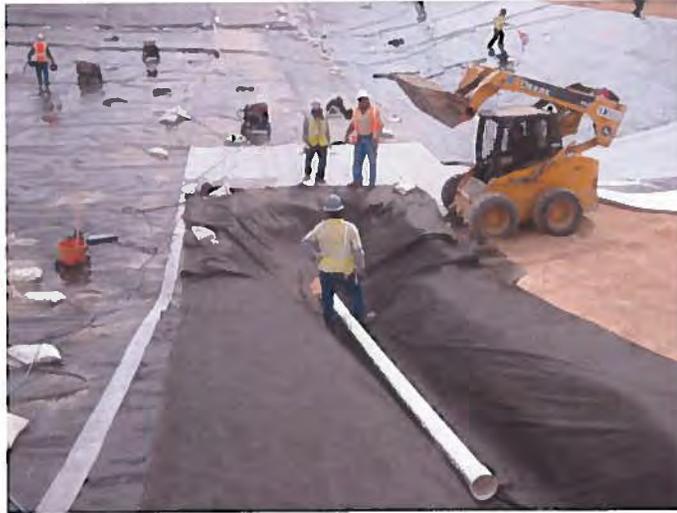
**Geotextile and pipe placed in sump in pond B**

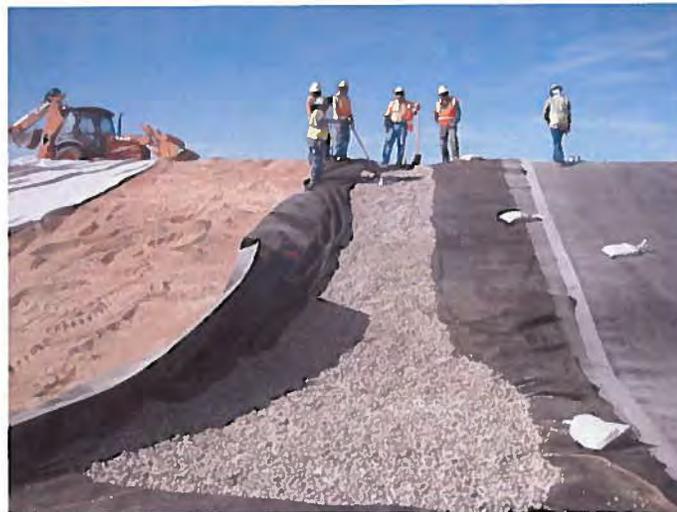
**Rock placed in sump in pond B**

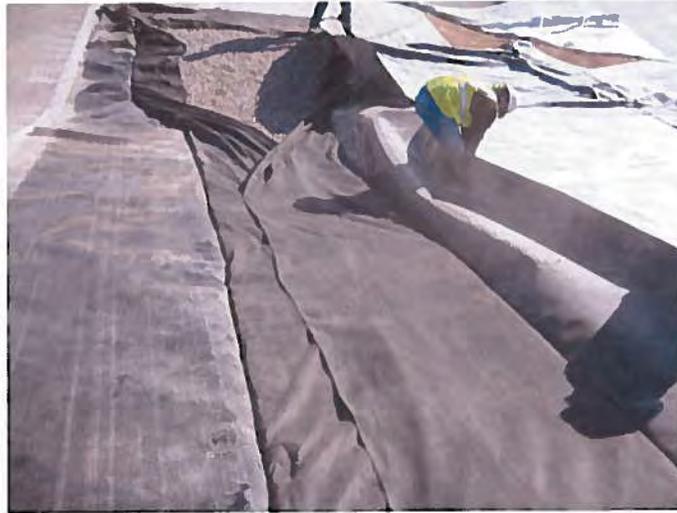
**Geotextile placed on top of rock in sump in pond B**

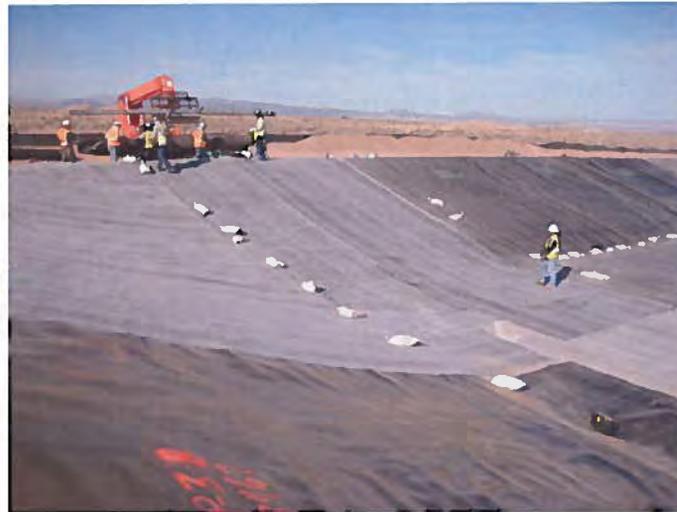
**GCL placed on top of geotextile in sump in pond B**

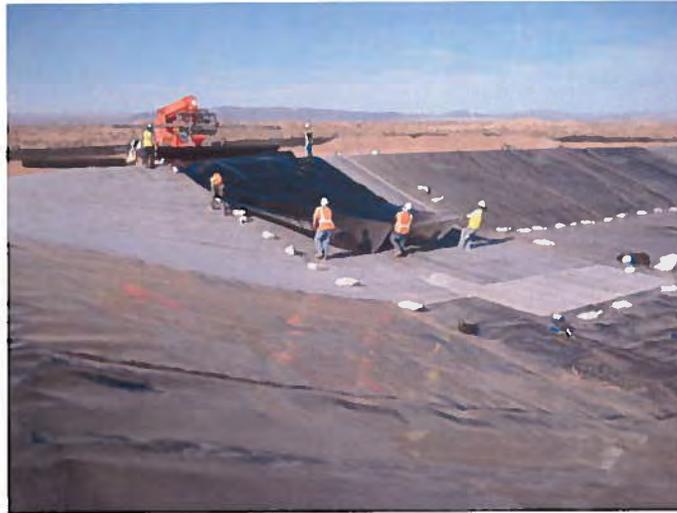
**HDPE liner placed on top of GCL in sump in pond B**

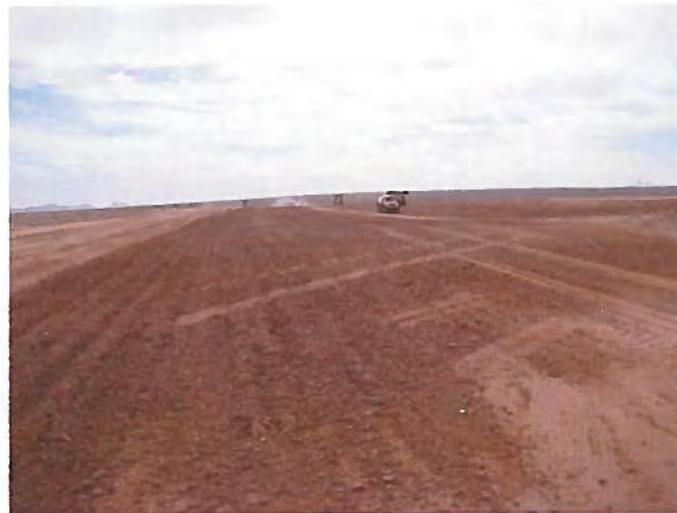
**Ripping subgrade material on the West side of compost area**

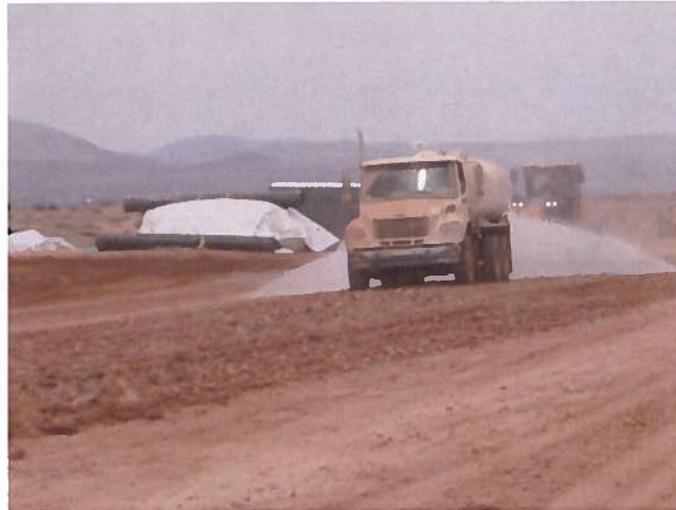
**Moisture conditioning subgrade material on the West side of compost area**

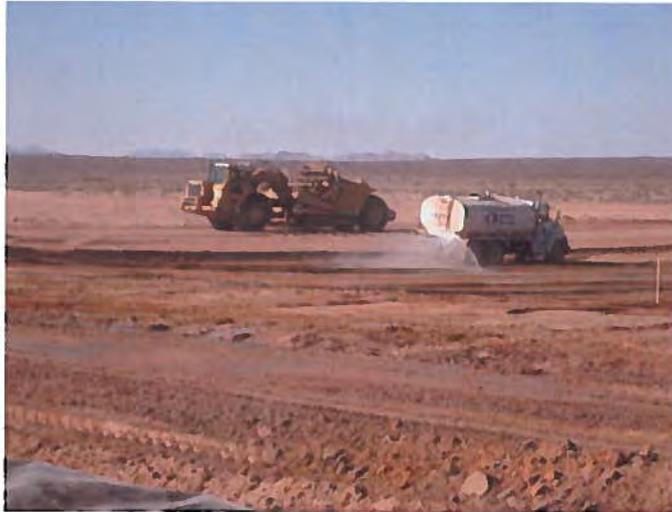
**623 scrapper removing material from pond A**

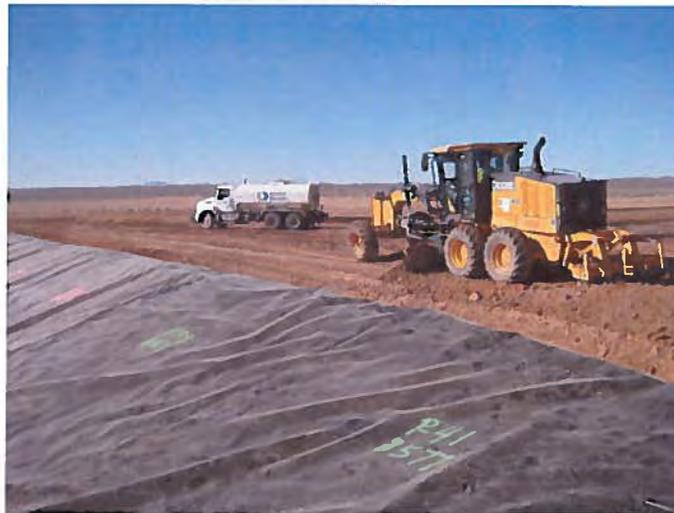
**Blade back filling anchor trench around pond B**

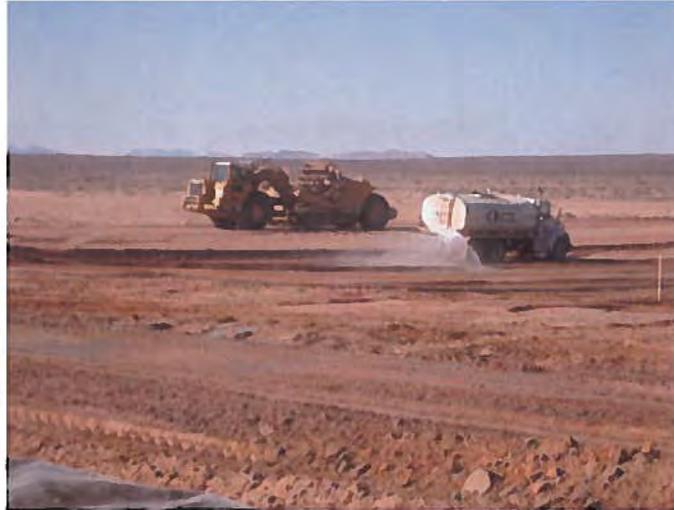
**623 scrapper removing material from pond A**

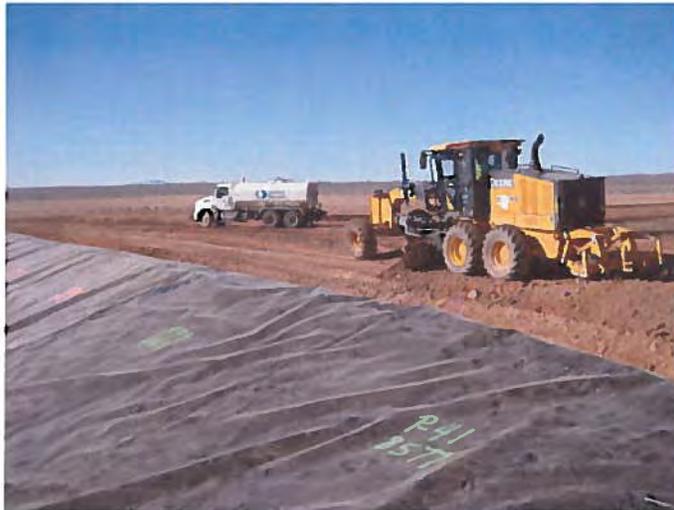
**Blade back filling anchor trench around pond B**

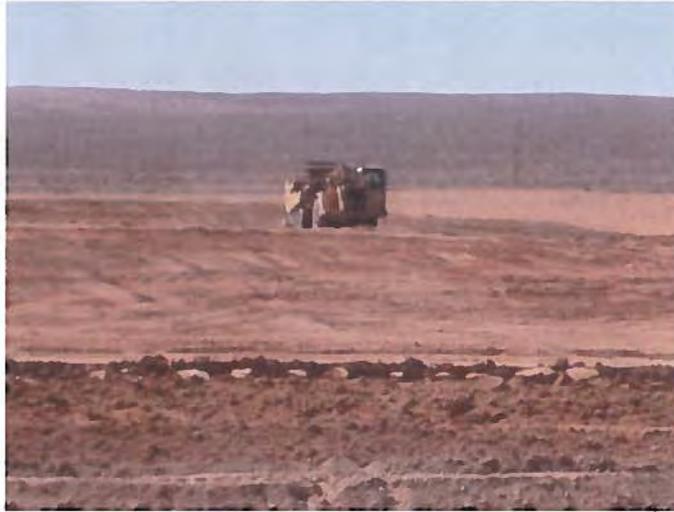
**623 scrapper placing fill material on the West side of compost area**

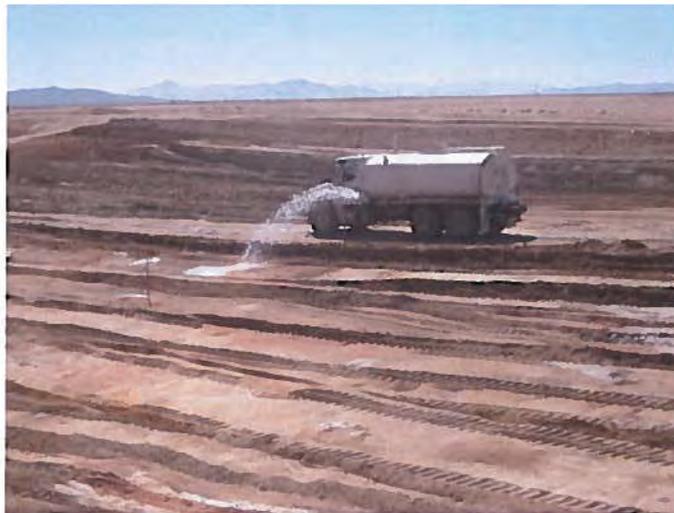
**Moisture condition material in pond A**

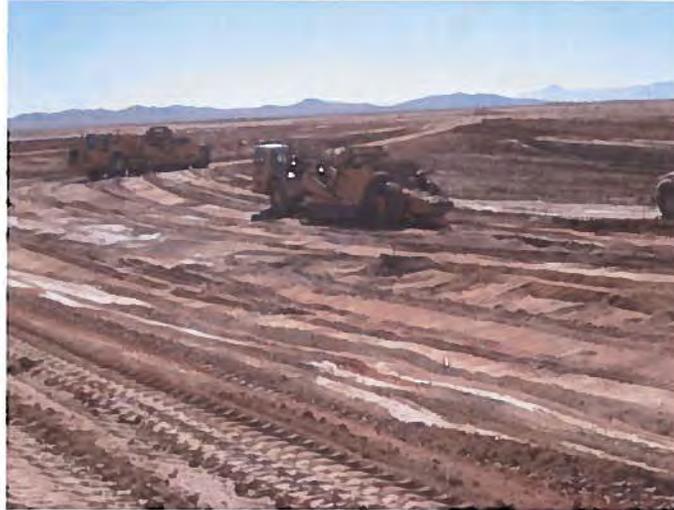
**Two 623 scrapers removing material from pond A**

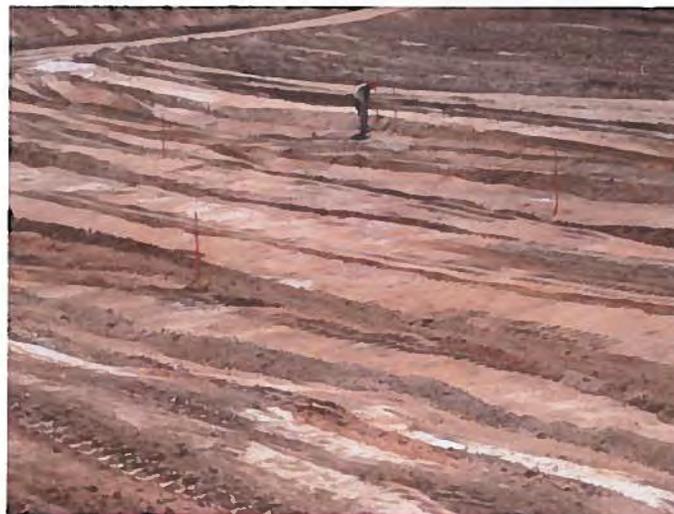
**Subgrade of pond A**

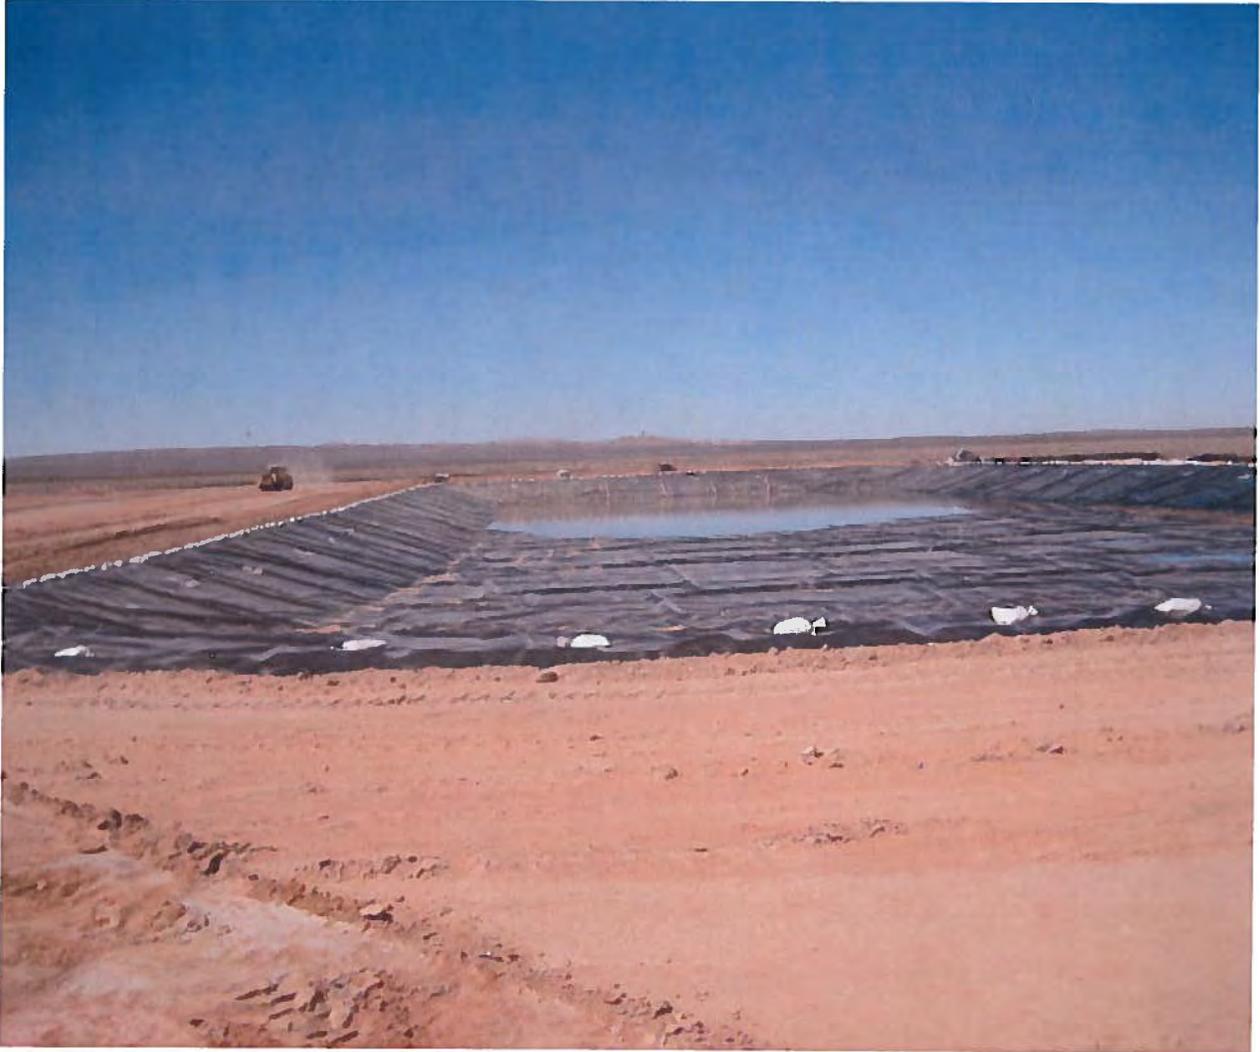
**Pond B picture from the East side looking to the West side.**
