Nursery Products, LLC.  
12277 Apple Valley Road, Suite 131  
Apple Valley, California 92308

**FINAL CONSTRUCTION  
QUALITY ASSURANCE REPORT  
EAST WASTE PILE COMPOSTING PAD and  
SURFACE IMPOUNDMENT A and B**

**HAWES COMPOSTING FACILITY**

May 2012

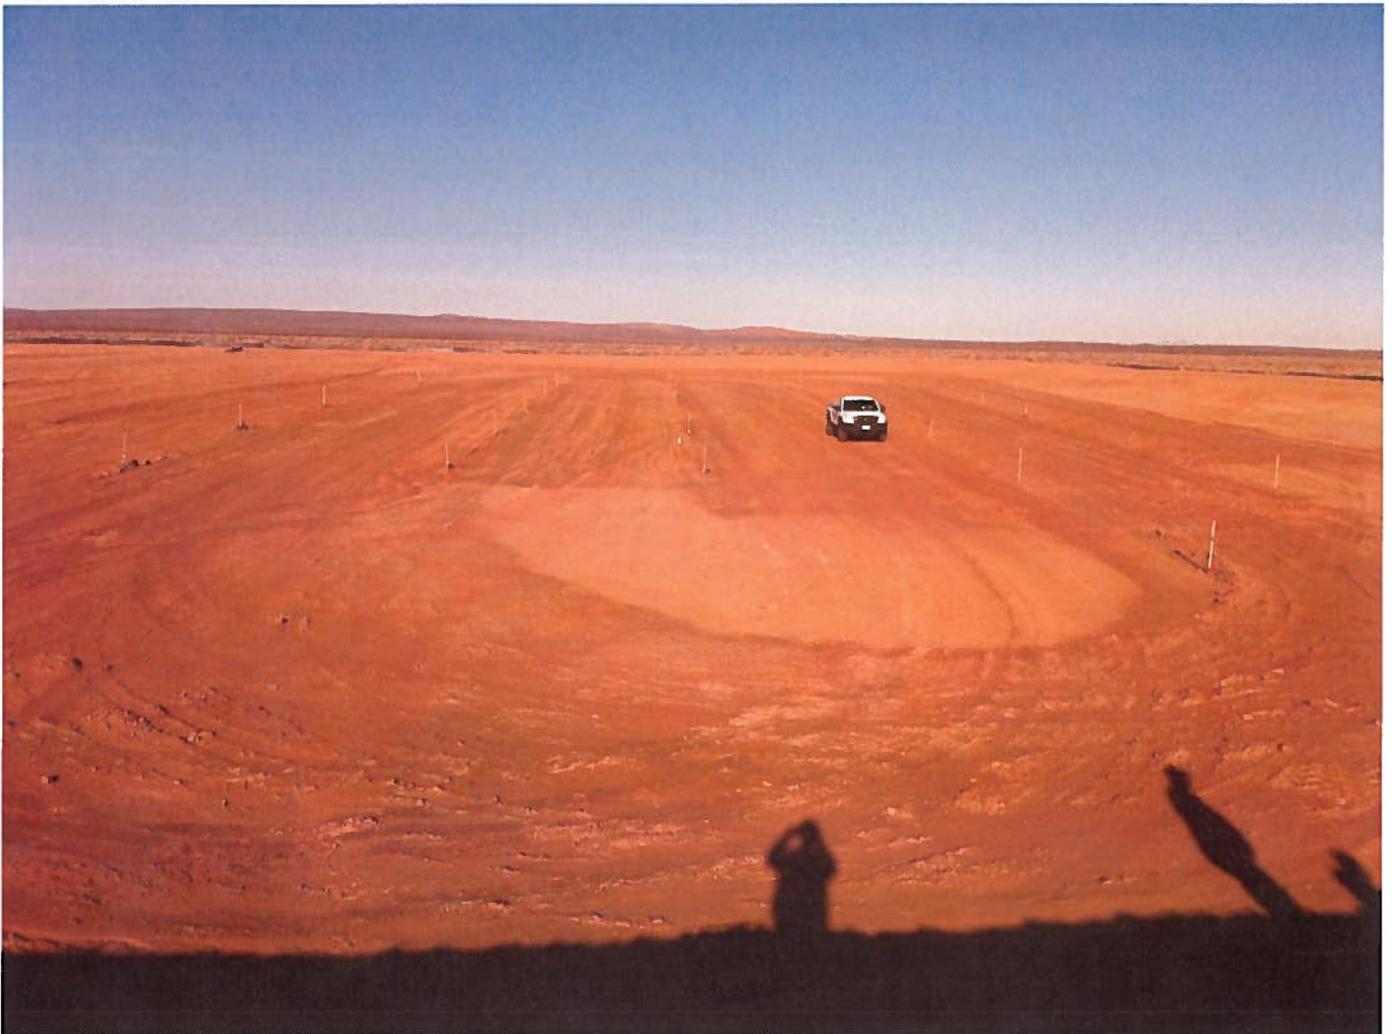
**Pond B rough grade**

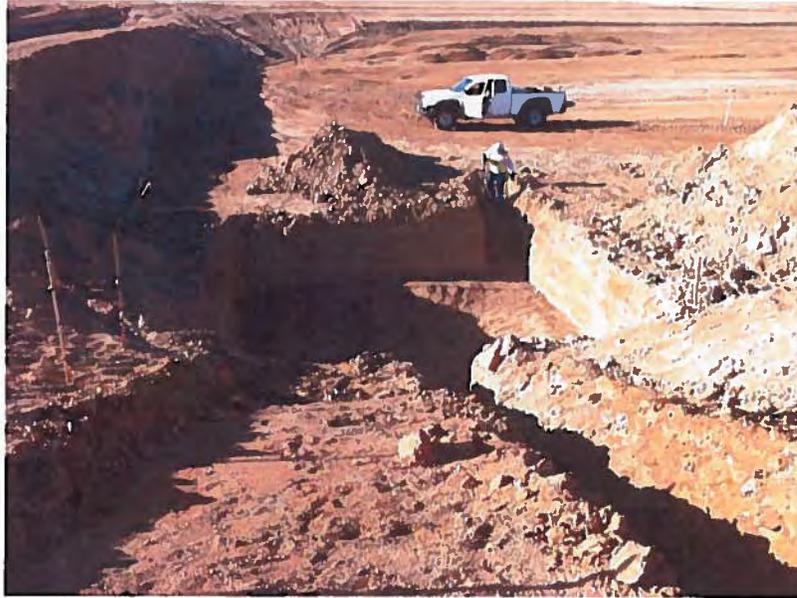
**Pond A bottom Lysimeter Excavation**

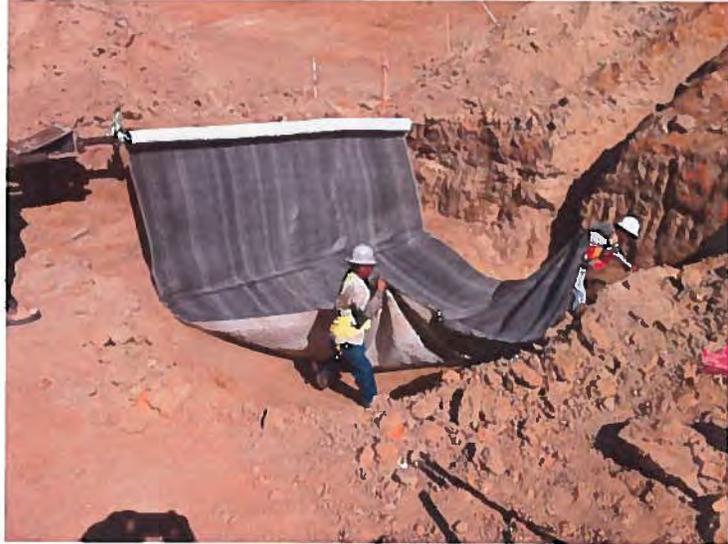
**GCL placed in Lysimeter subgrade Pond A**

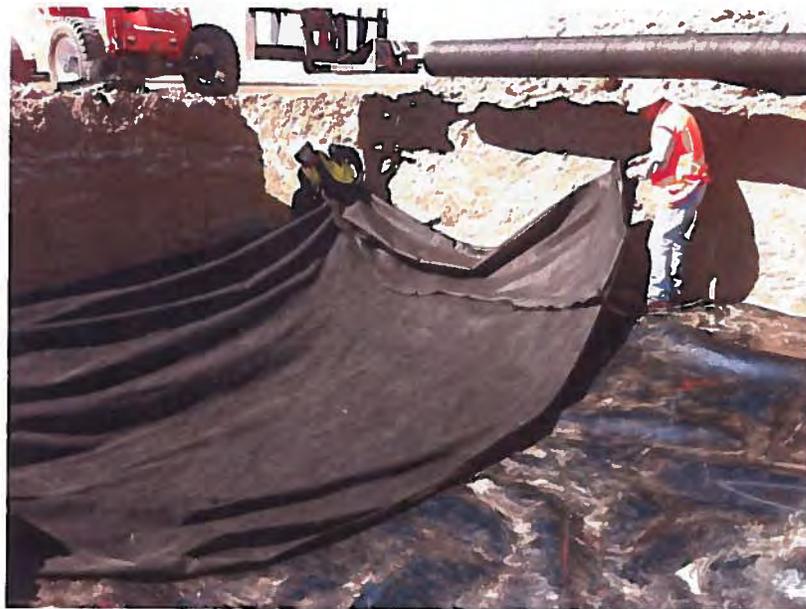
**Geotextile cushion fabric placed above 60-mil HDPE Liner**

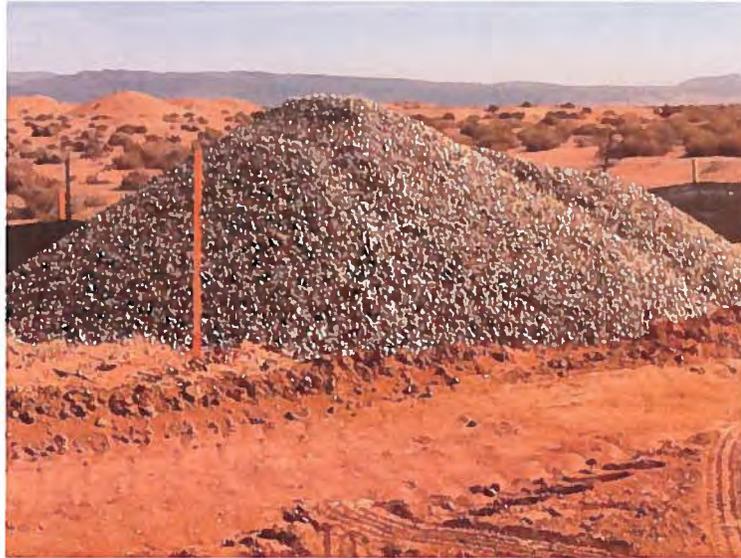
**Pre-Approved gravel for Lysimeter & Sump rock**

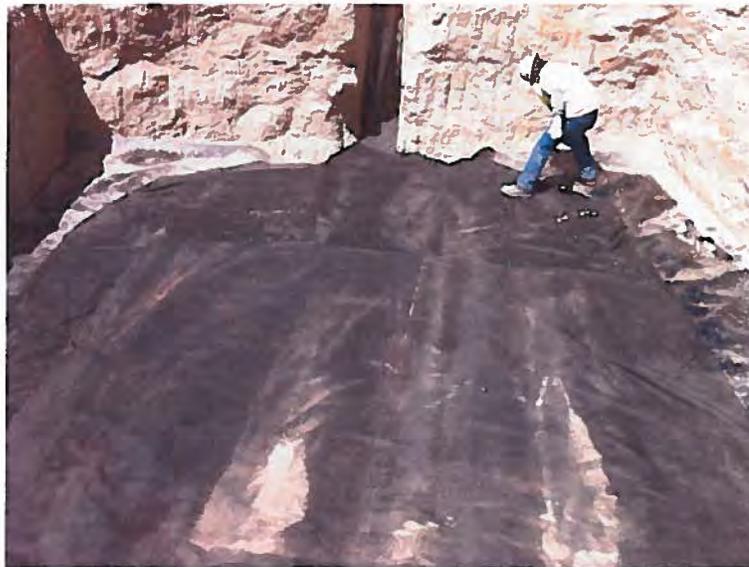
**Completed Lysimeter with gravel wrapped by geotextile**

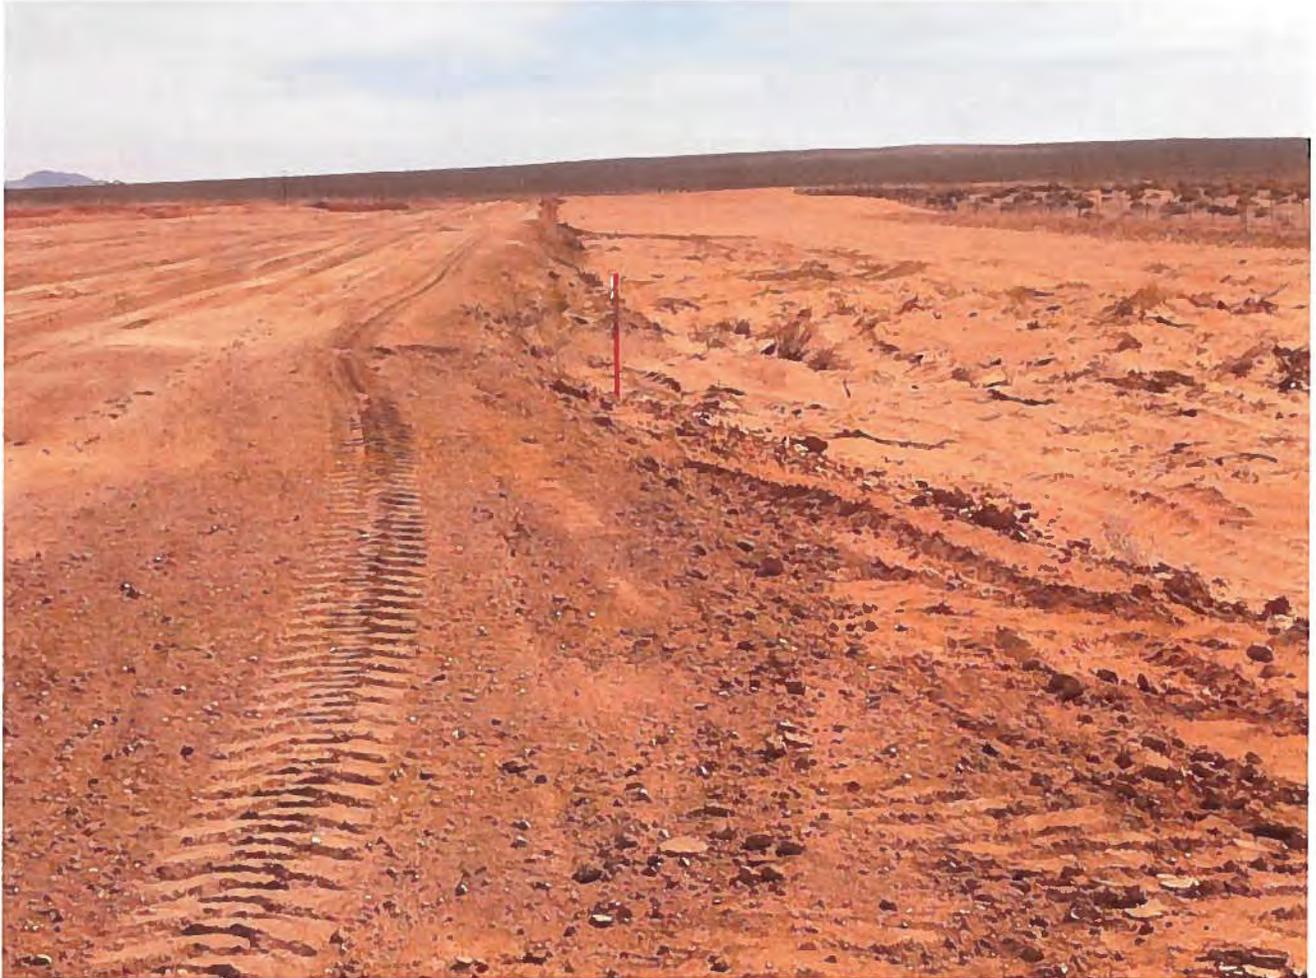
**Easterly Fill Limits (looking South)**

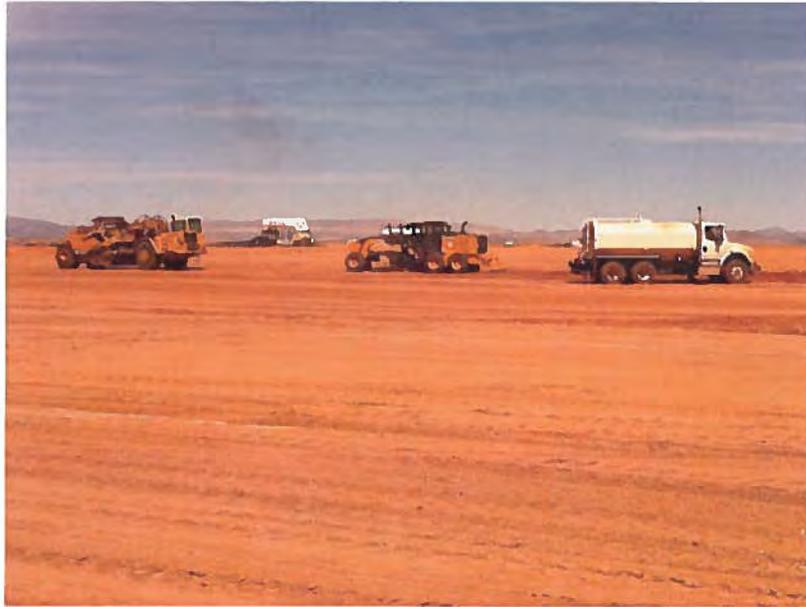
**Equipment working in Easterly Fill**

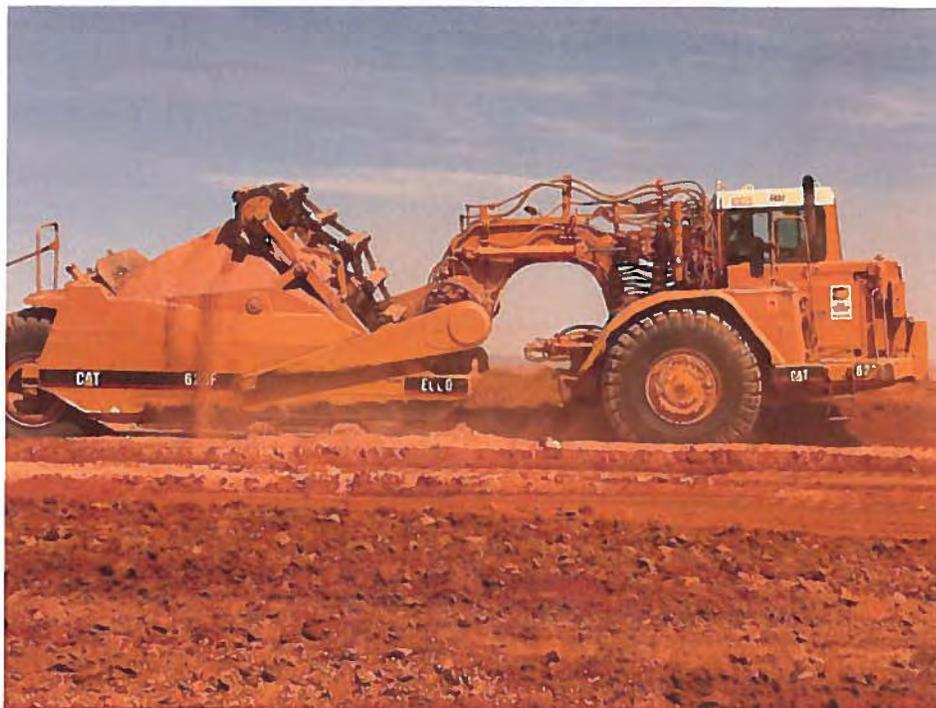
**Cat 623 Scrapper in center waste-pile cut area**

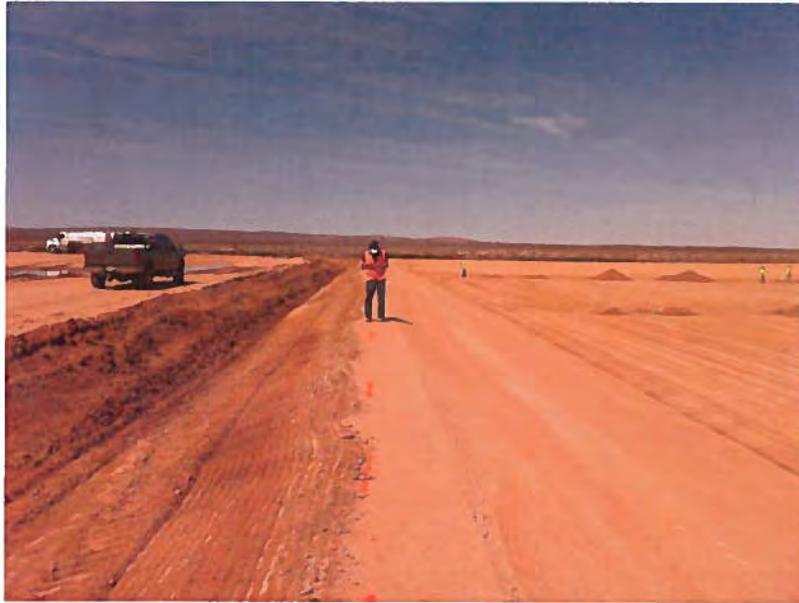
**Pond A Anchor Trench excavation**

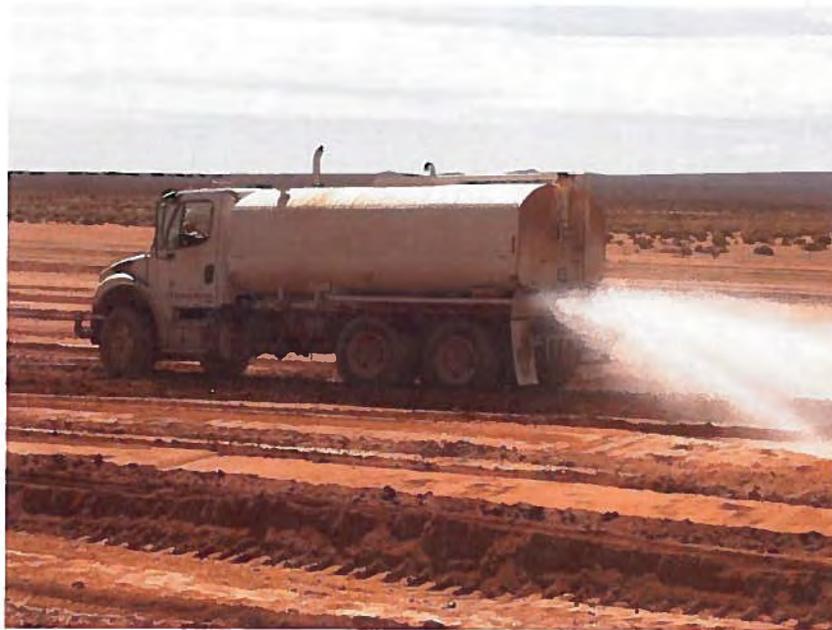
**Water Truck in Fill Area**

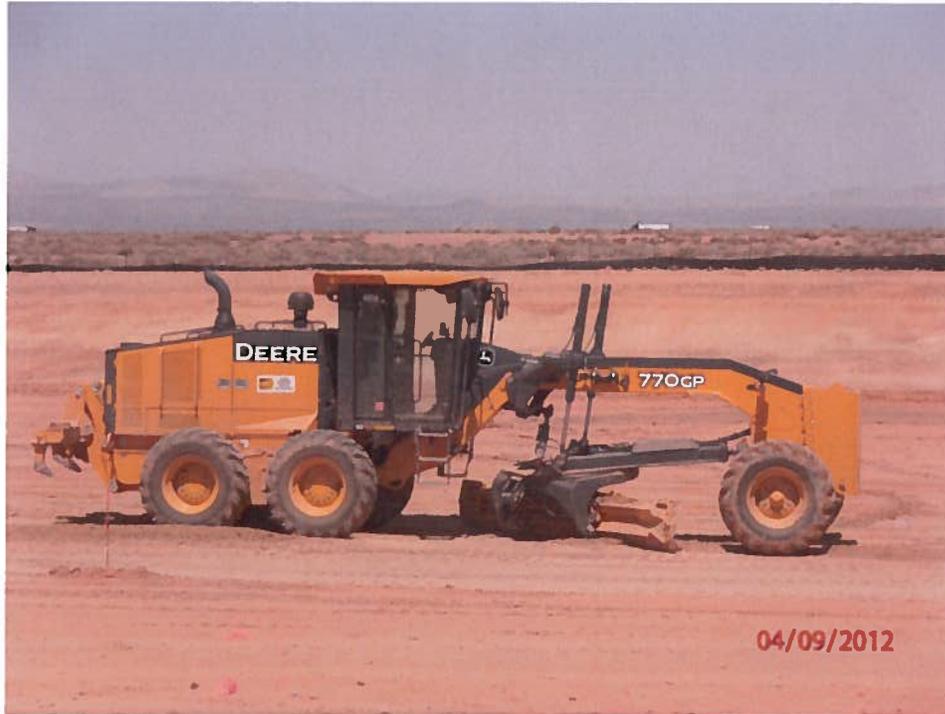
**Grader Fine Grades Pond A subgrade**

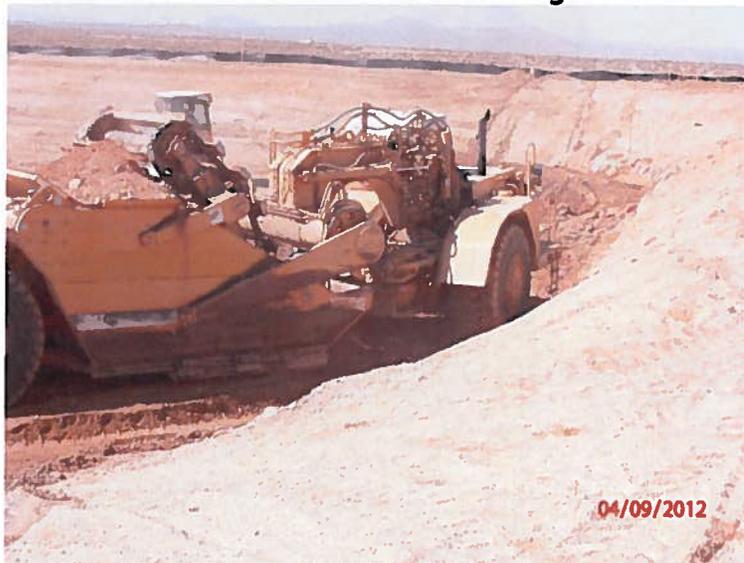
**Scrapper hauls fill soil to Pond A**

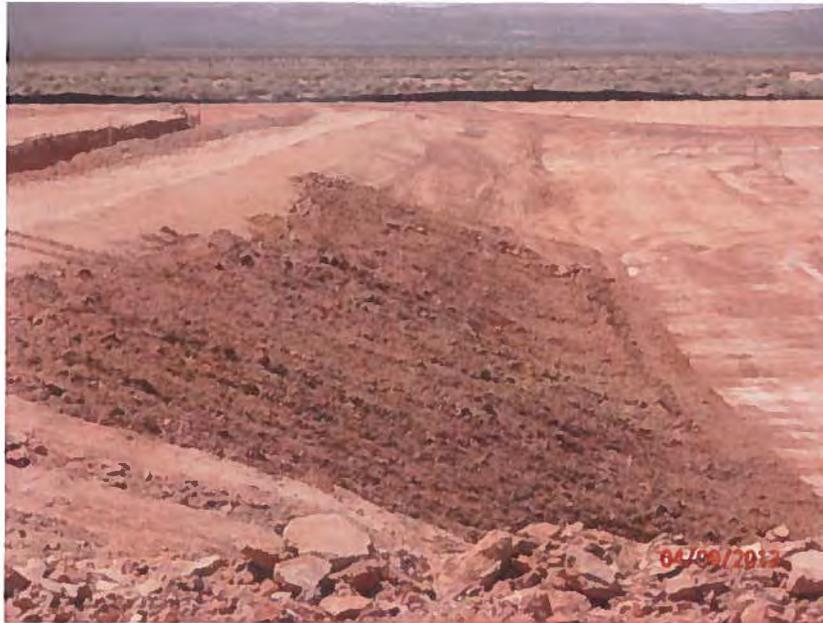
**Pond A South-Slope Scarified and watered**

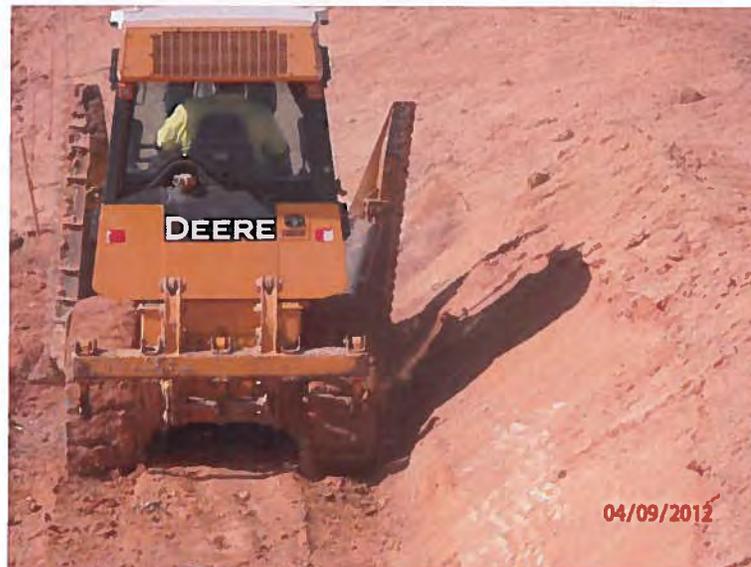
**Pond A side-slope grading**

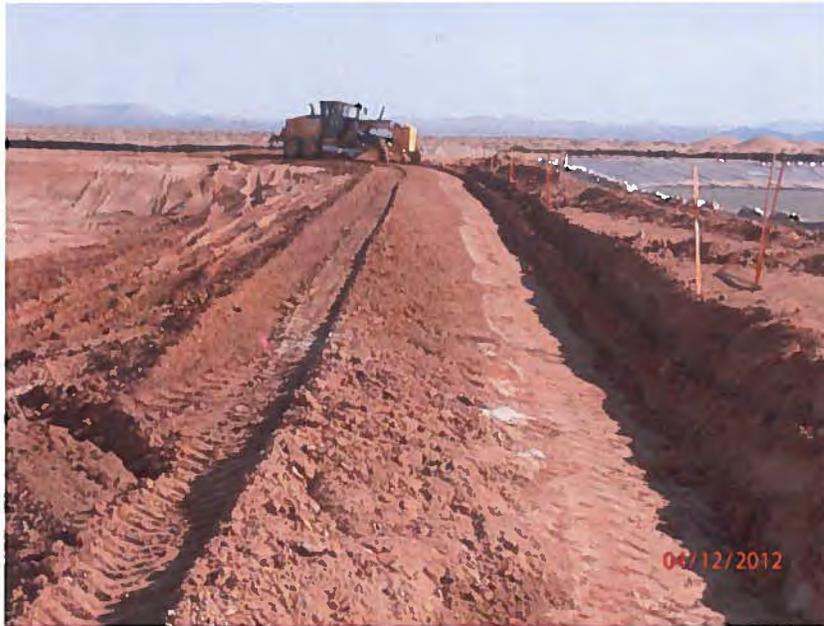
**Pond A Northerly Anchor Trench**

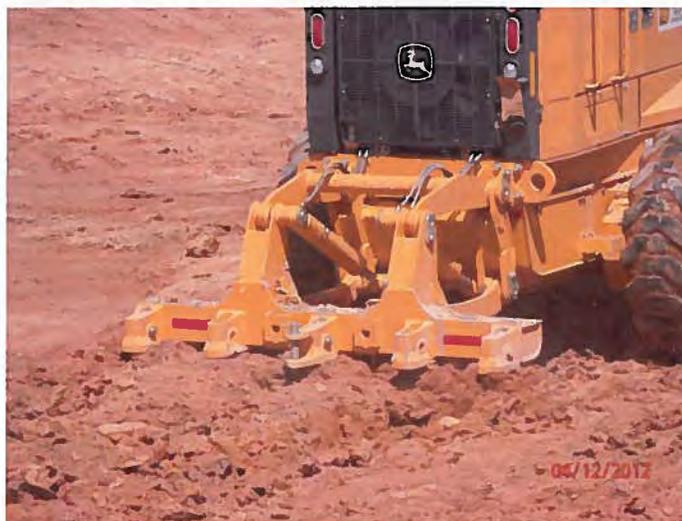
**Pond A ripping and scarifying subgrade**

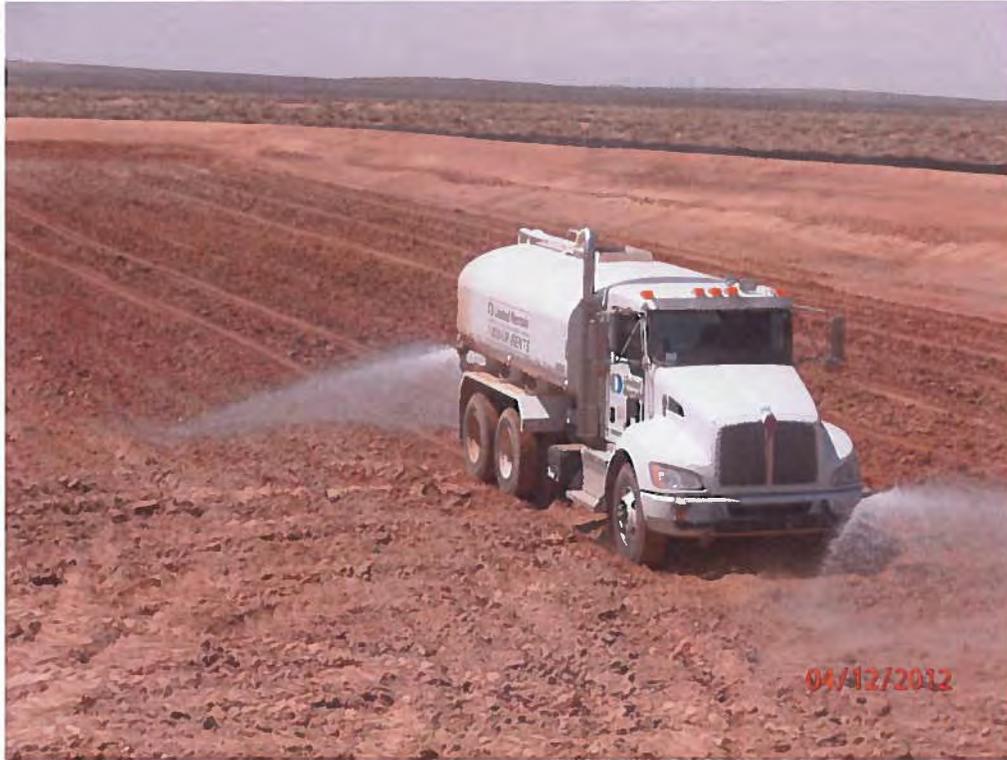
**Pond A Scarified and watered**

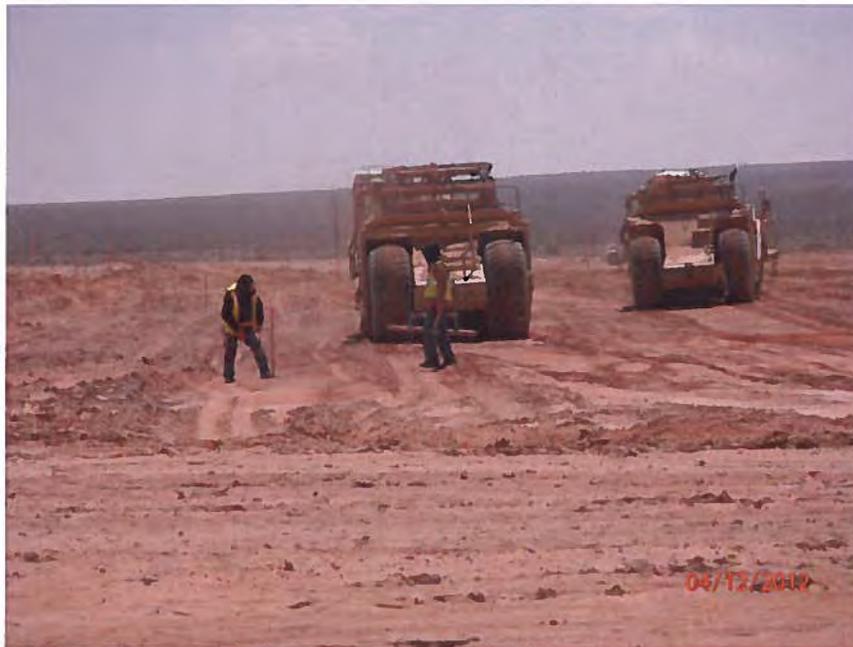
**Pond A Elevation Grade Check**

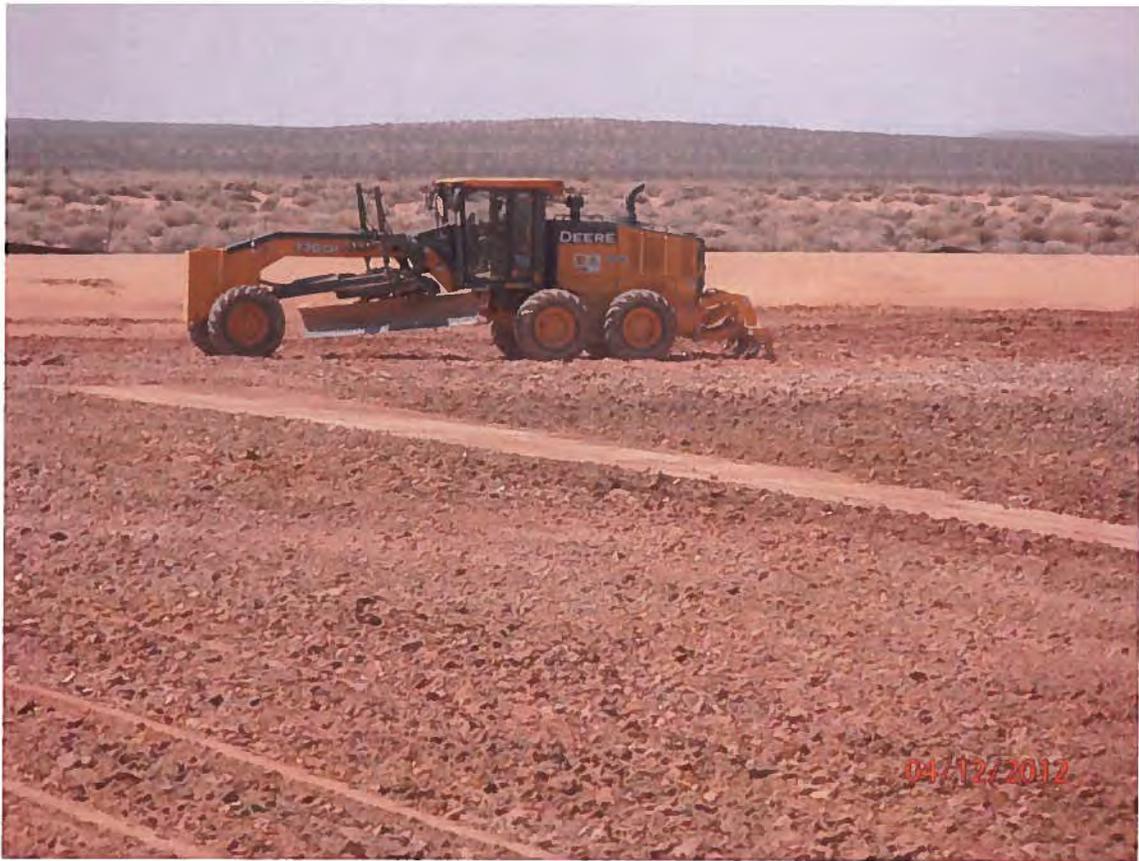
**Pond A Subgrade Preparation**

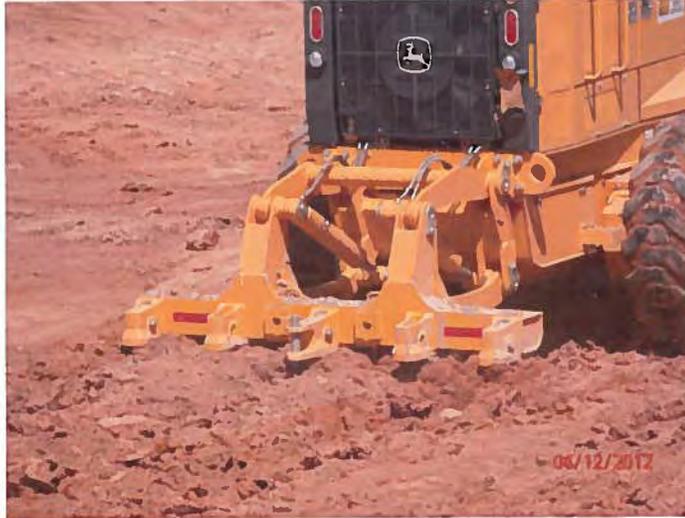
**Pond A ripping and scarifying subgrade**

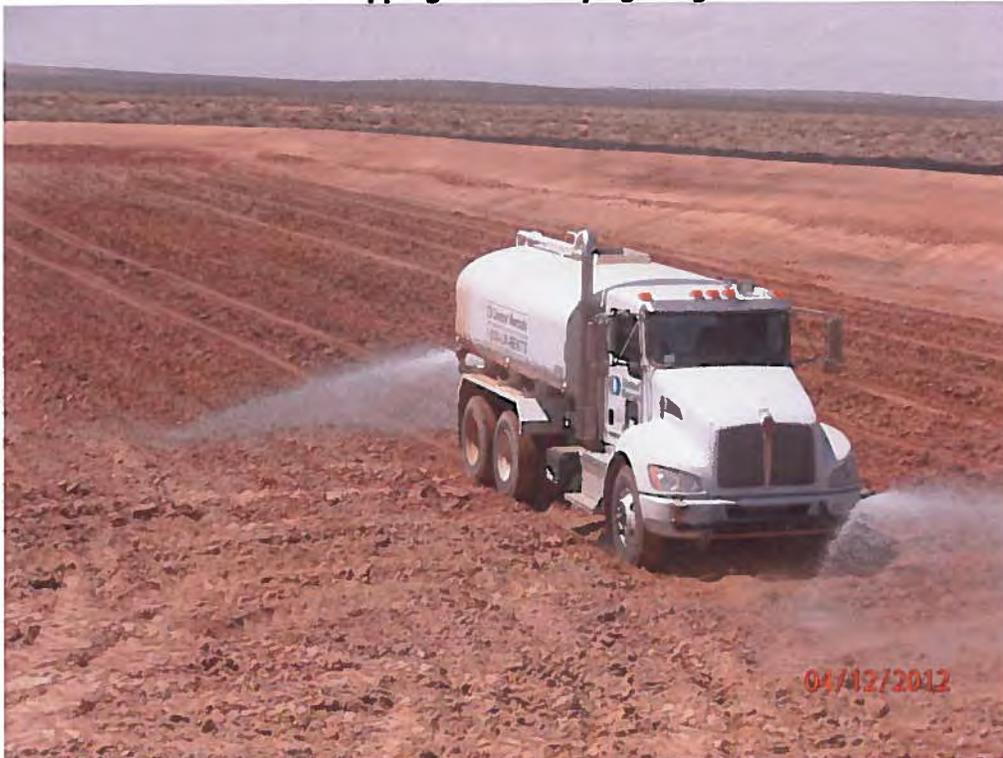
**Pond A Scarified and watered**

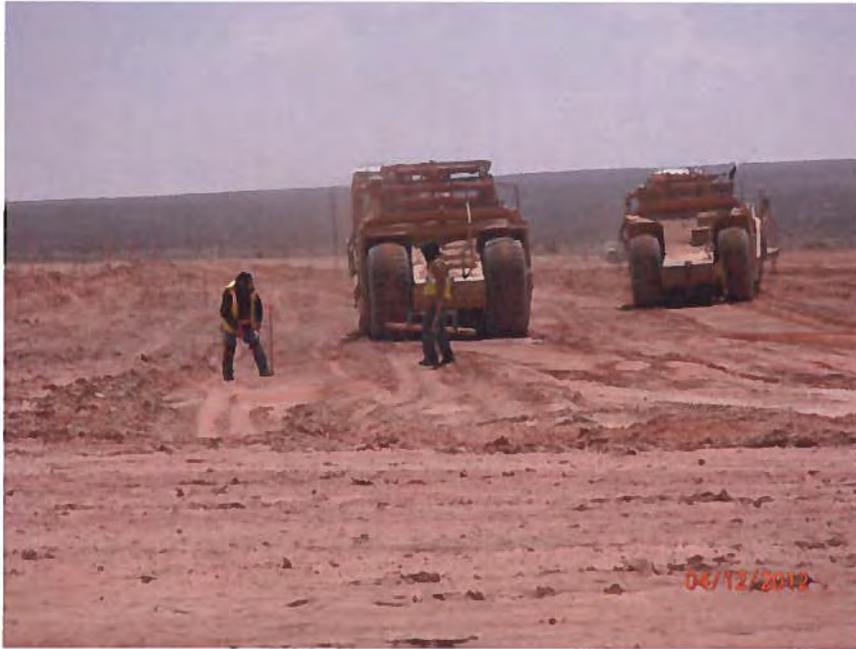
**Pond A Elevation Grade Check**

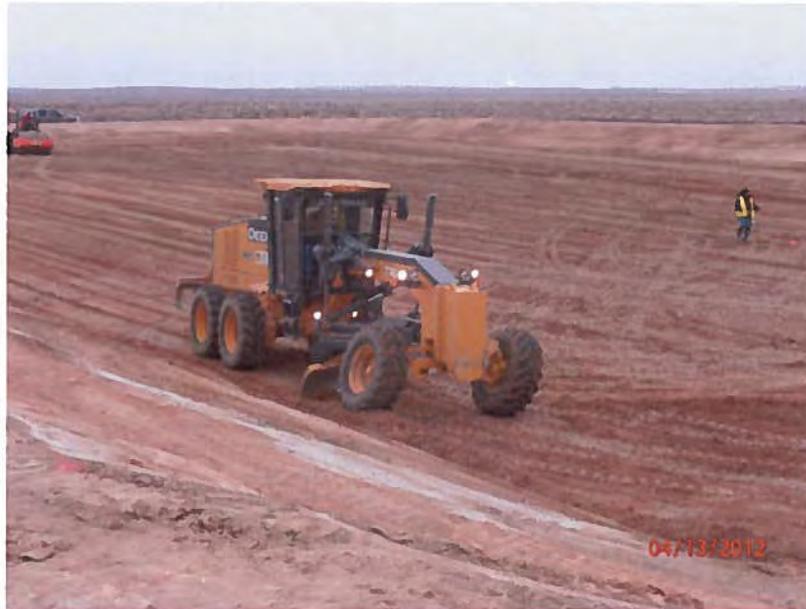
**Pond A Subgrade Preparation**

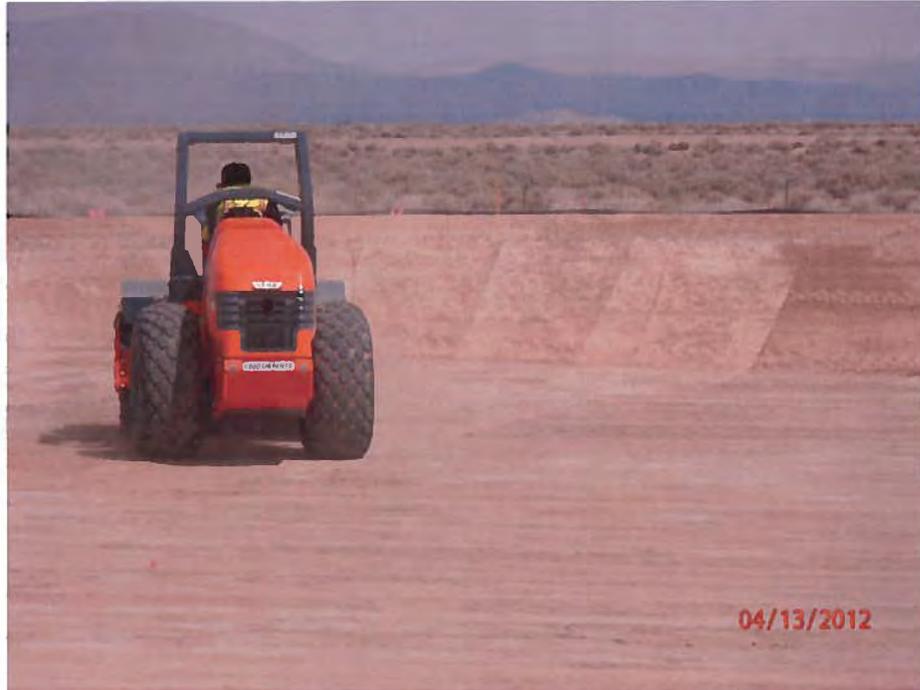
**Pond A Smooth Drum Rolled Surface**

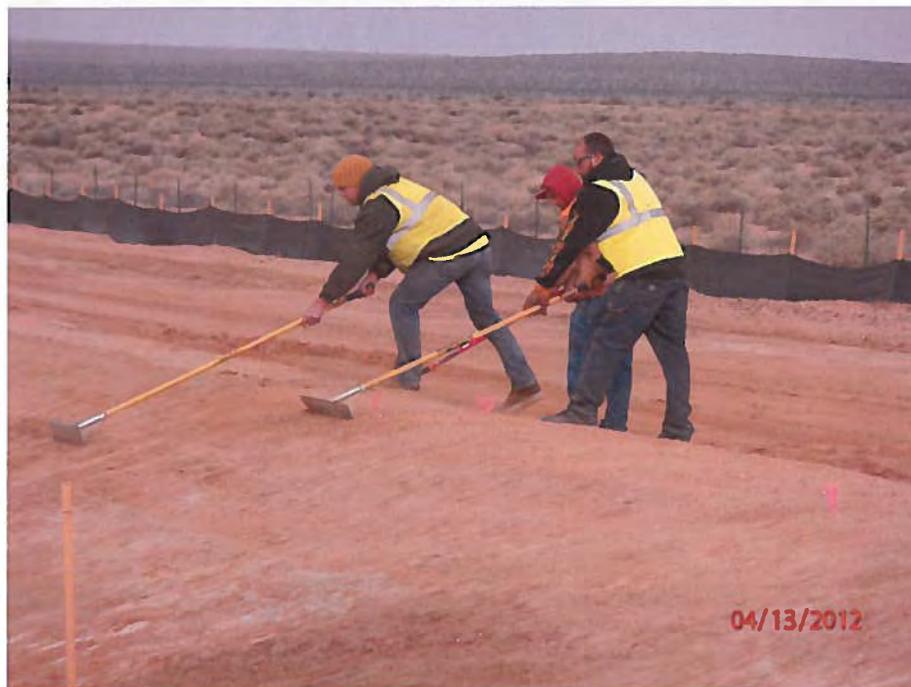
**Pond A Racked Smooth**

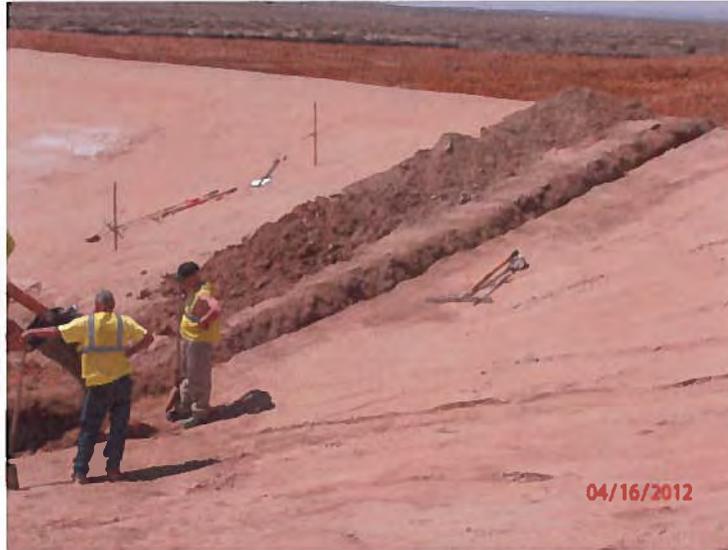
**Pond A Subgrade & Leak Detection Sump up Slope**

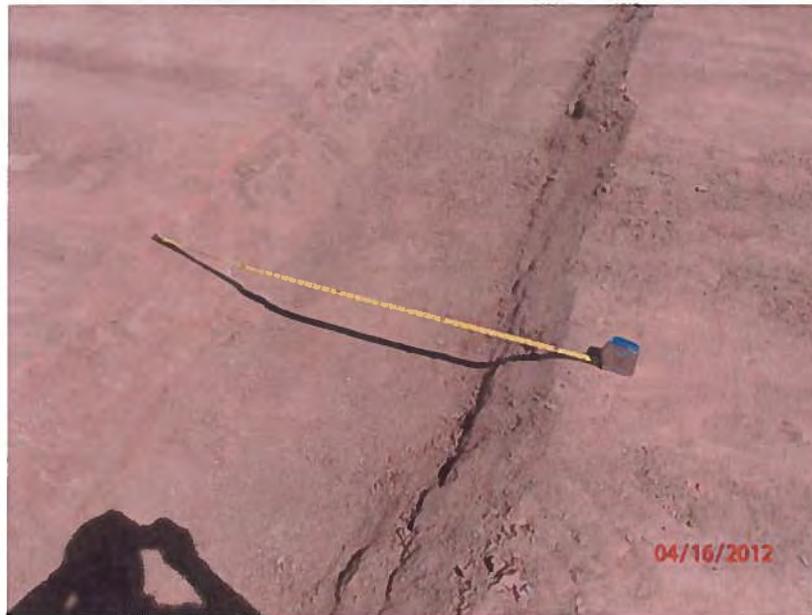
**Floor Ballast Anchor Trench**

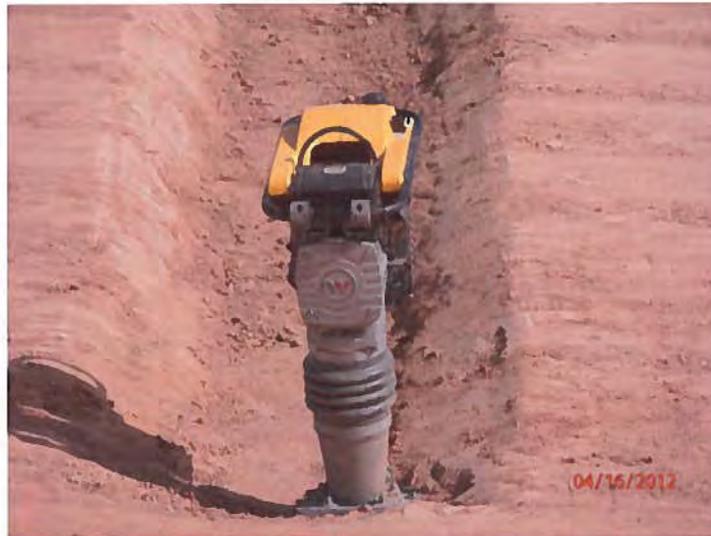
**Pond A Floor Ballast Trench Compacted Bottom**

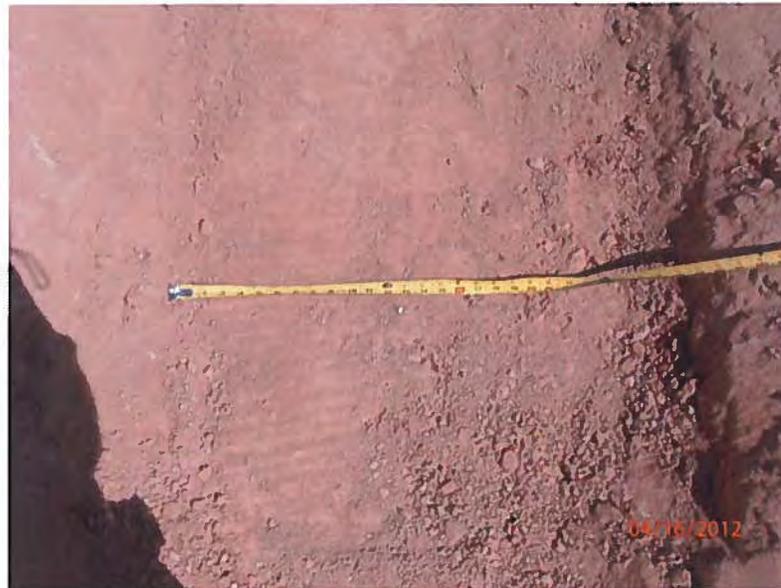
**Pond A Ballast System per plan**

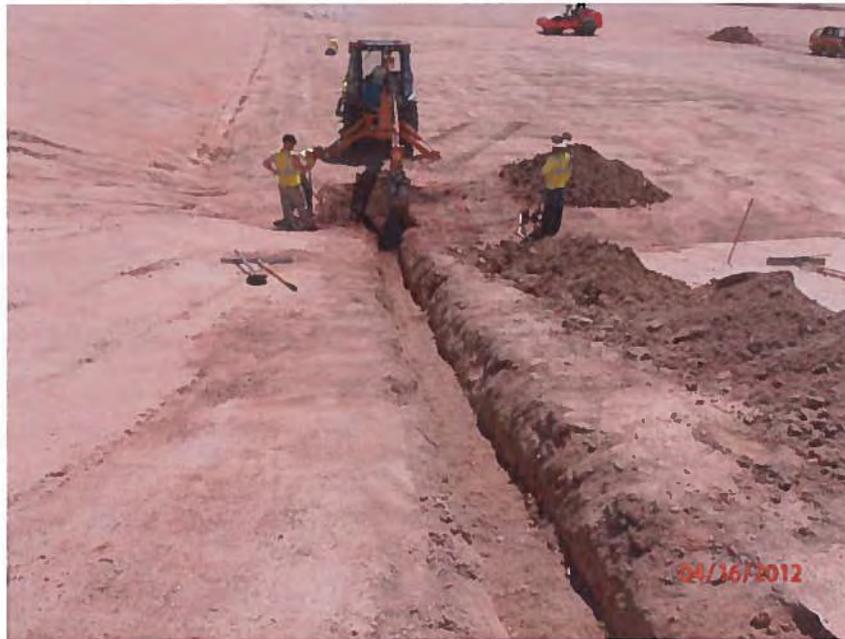
**Leak Detention Collection Trench Pond A**

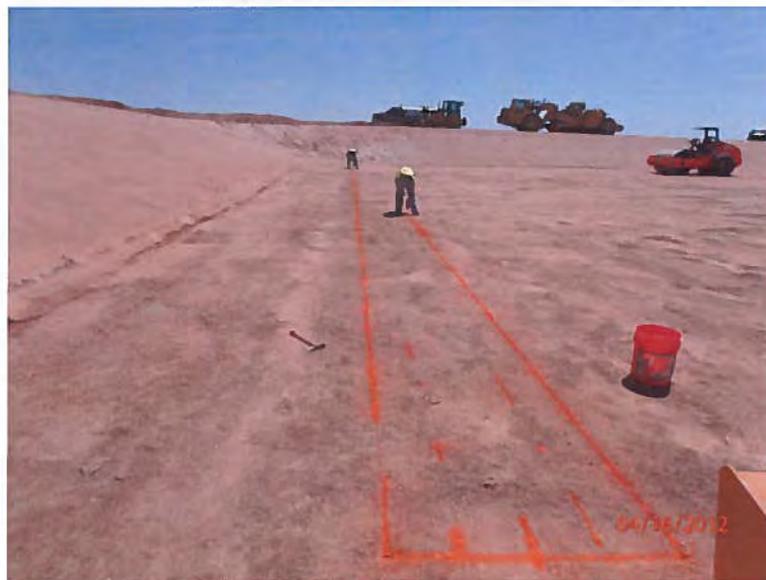
**Most Westerly Ballast Trench Pond A**

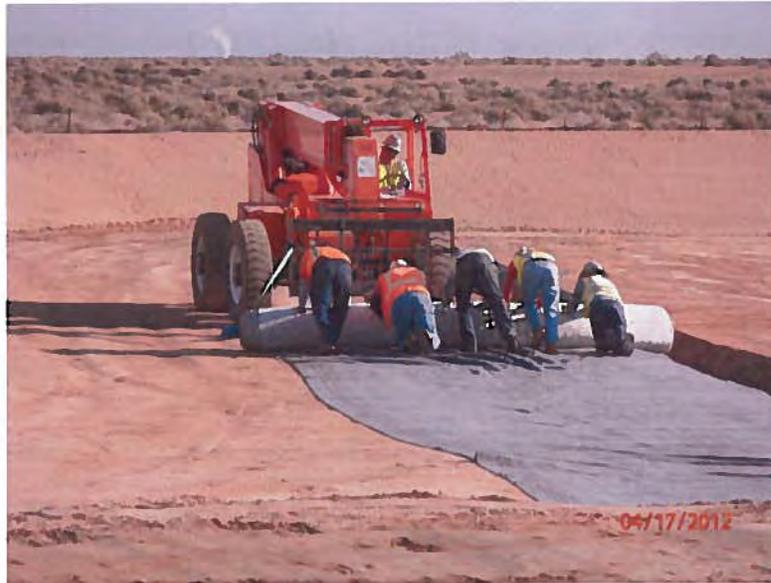
**Pond A GCL deployed at Ballast Trench**

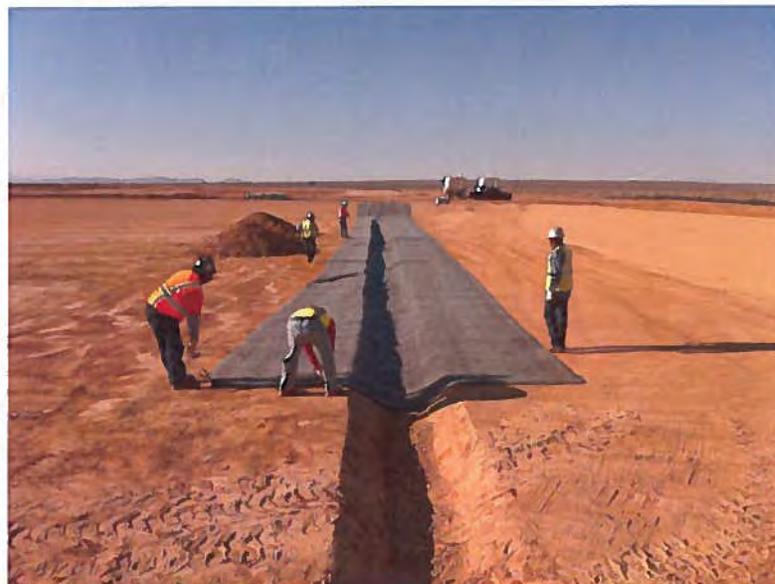
**Pond A Floor Ballast Anchor Trench GCL (looking south) most westerly trench**

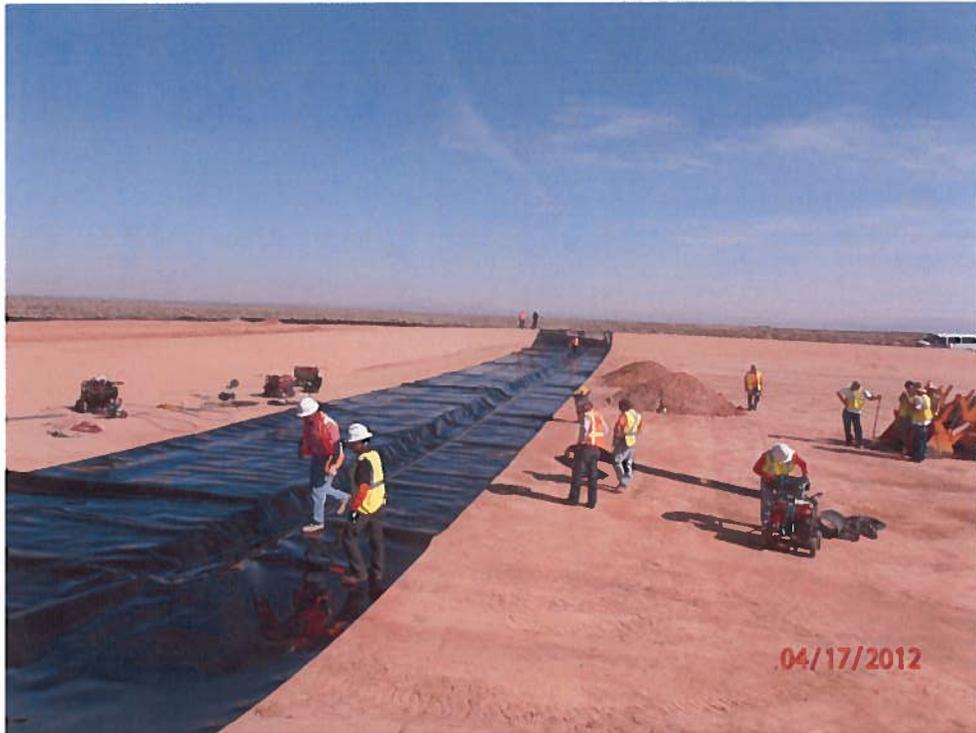
**Pond A Floor Ballast Trench 60-mil HDPE Liner above GCL (no exposed GCL)**

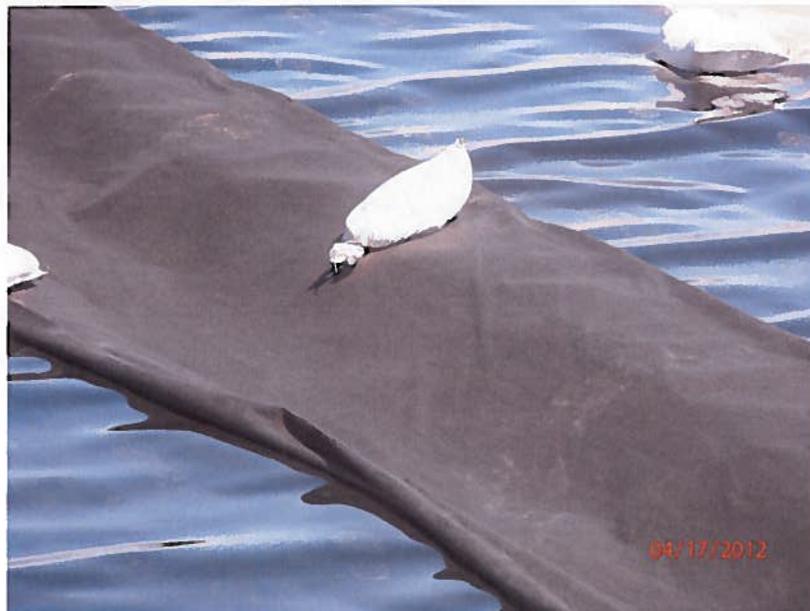
**Pond A Ballast System Geotextile above the HDPE for cushion and protection**

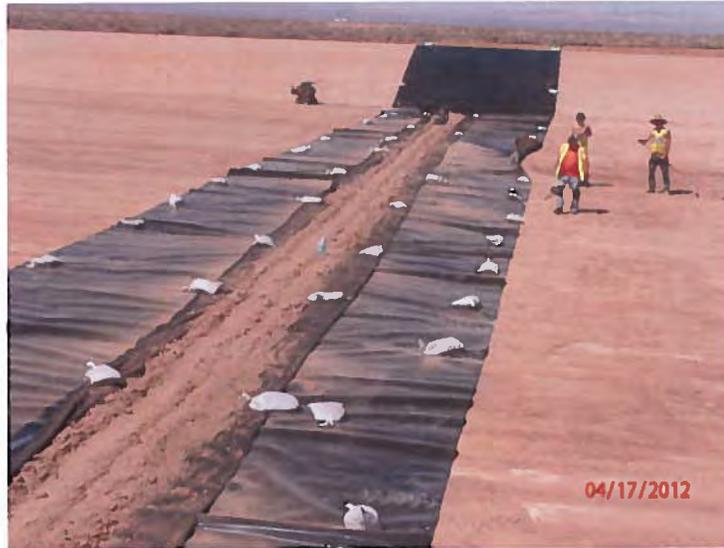
**Ballast fill above liner system**

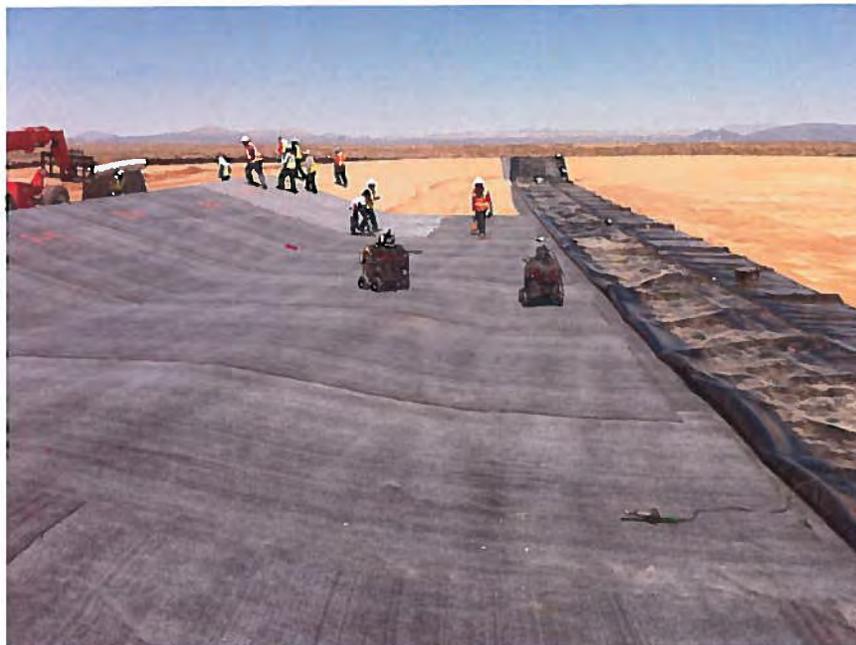
**Most Westerly Ballast Trench and Ramp area GCL Pond A**

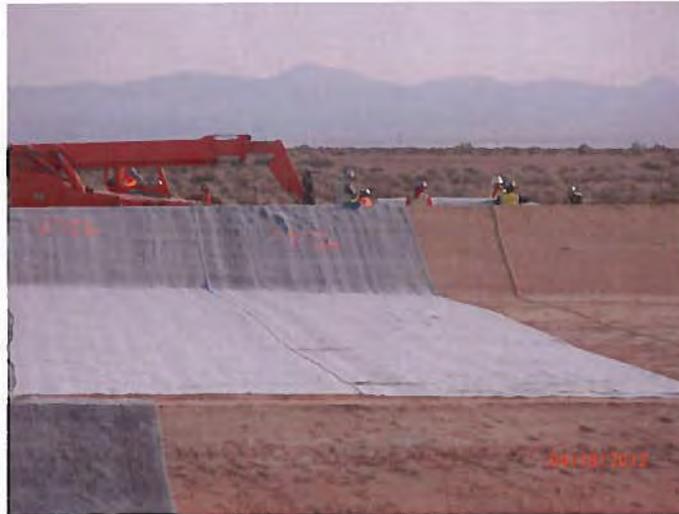
**Pond A GCL deployed north slope**

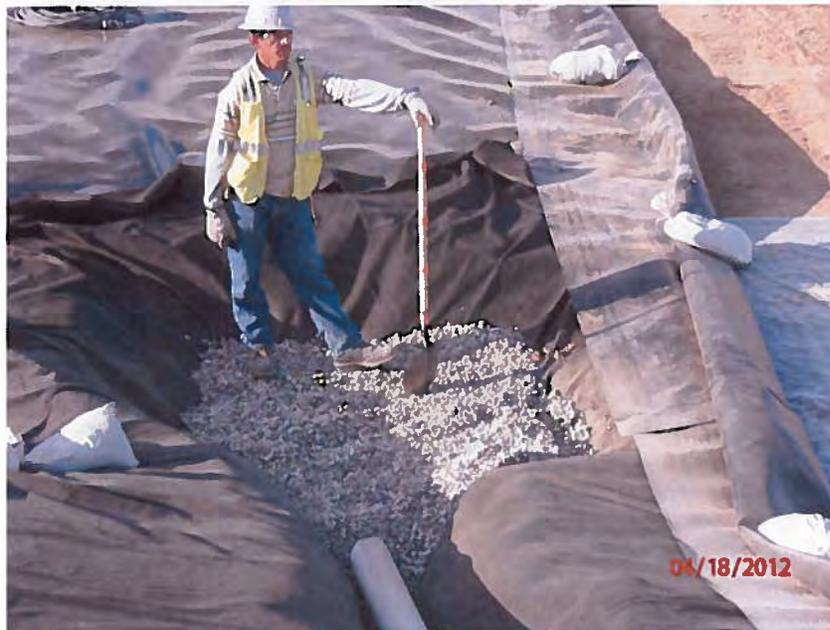
**Pond A Leak Detection Sump**

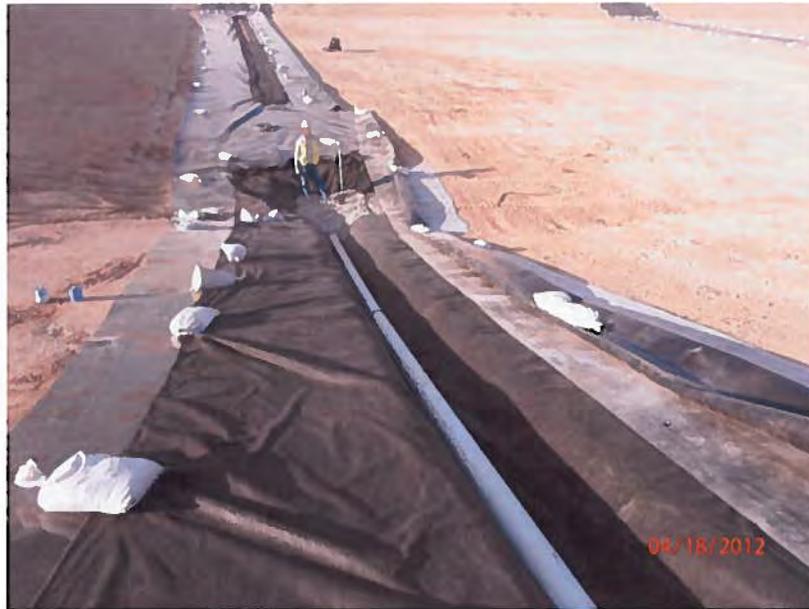
**Pond A Floor leak detection sump and riser pipe**
