Nursery Products, LLC.  
12277 Apple Valley Road, Suite 131  
Apple Valley, California 92308

**FINAL CONSTRUCTION  
QUALITY ASSURANCE REPORT  
EAST WASTE PILE COMPOSTING PAD and  
SURFACE IMPOUNDMENT A and B**

**HAWES COMPOSTING FACILITY**

May 2012

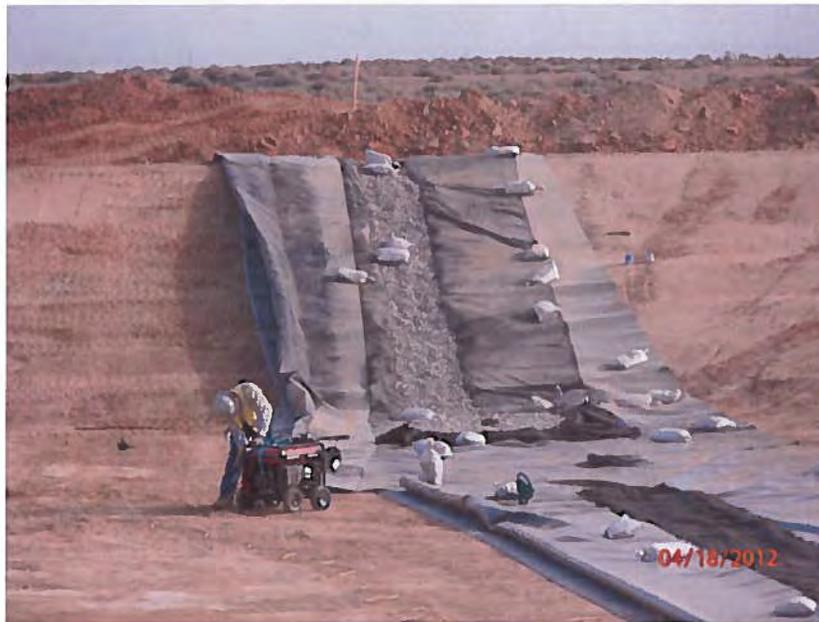
**Pond A leak detection sump system**

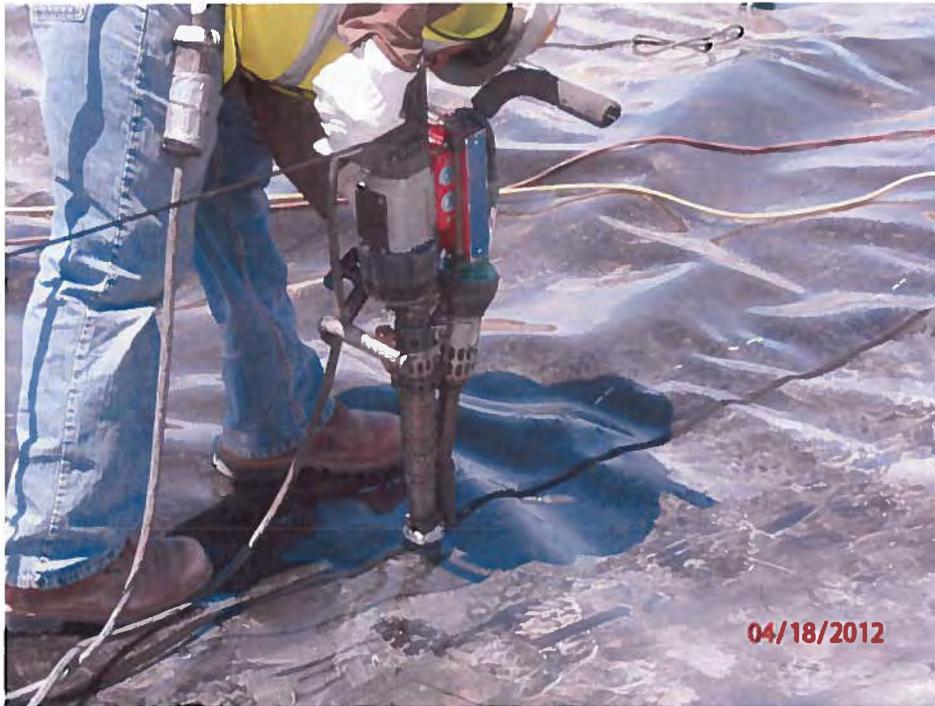
**Pond A Extrusion Weld Cap on Ballast Trench to Close System**

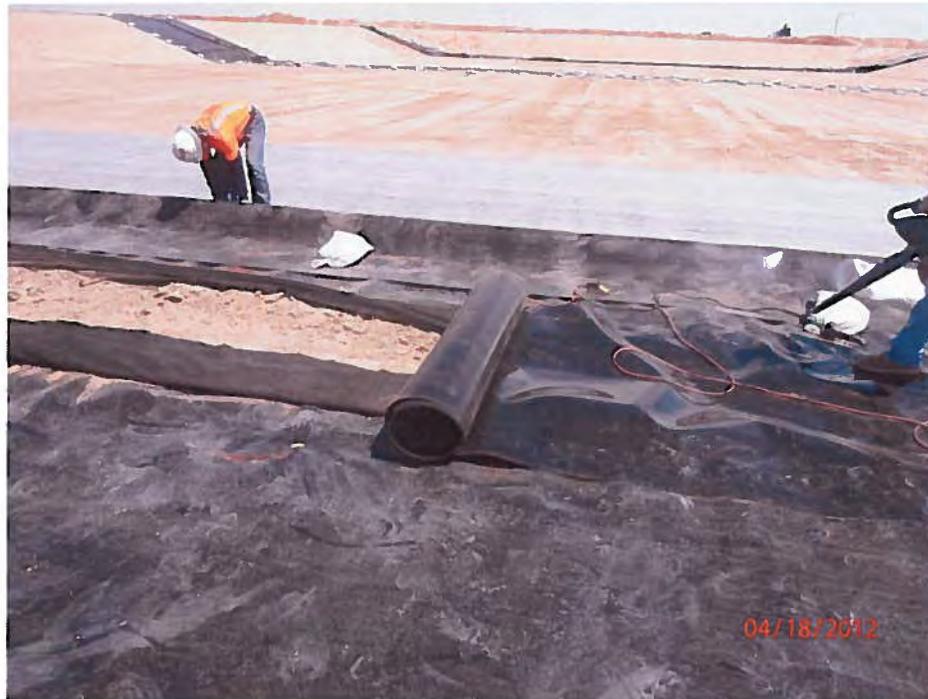
**Pond A ballast system closure**

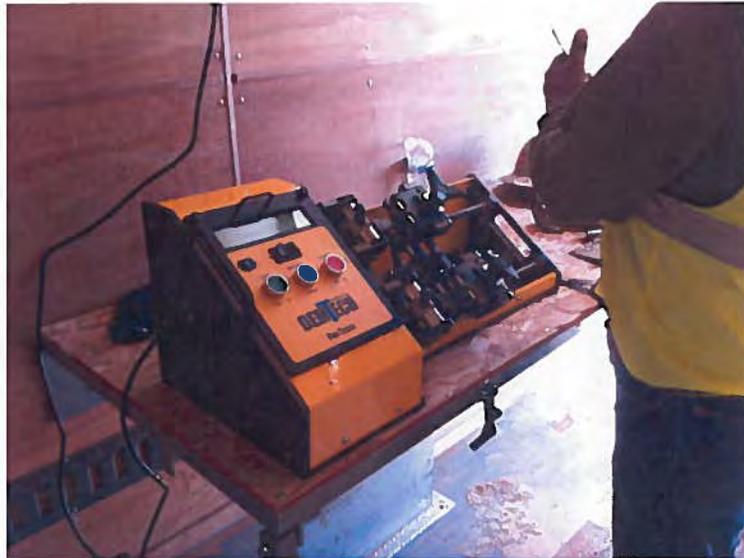
**ECA trial weld before production seaming**

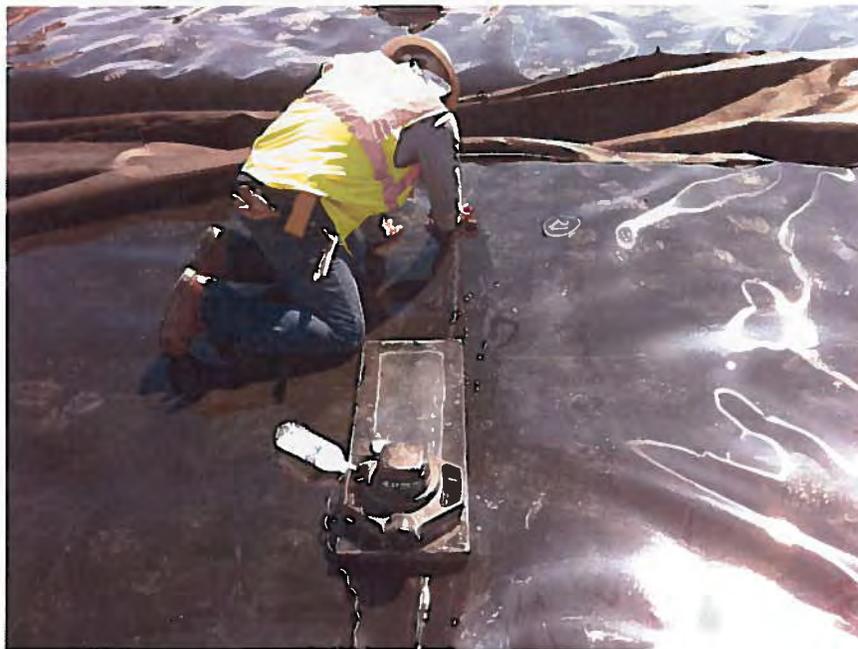
**Pond A Quality Control Vacuum Box Testing**

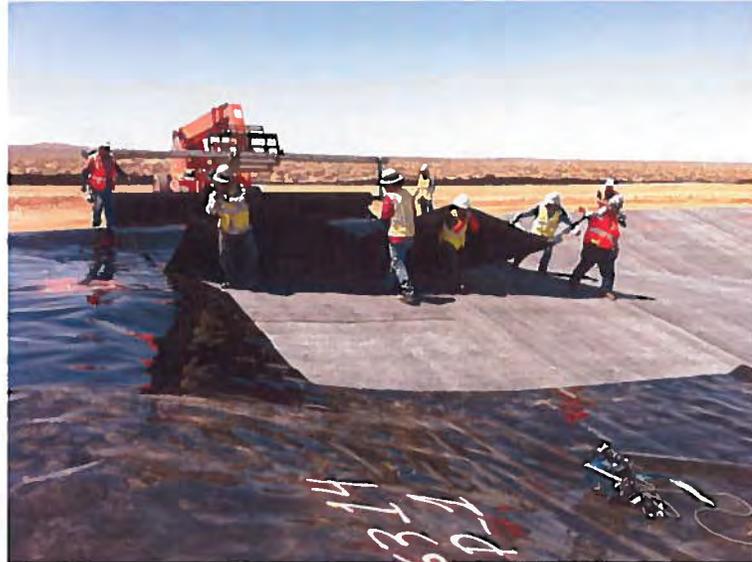
**Pond A HDPE Installation**

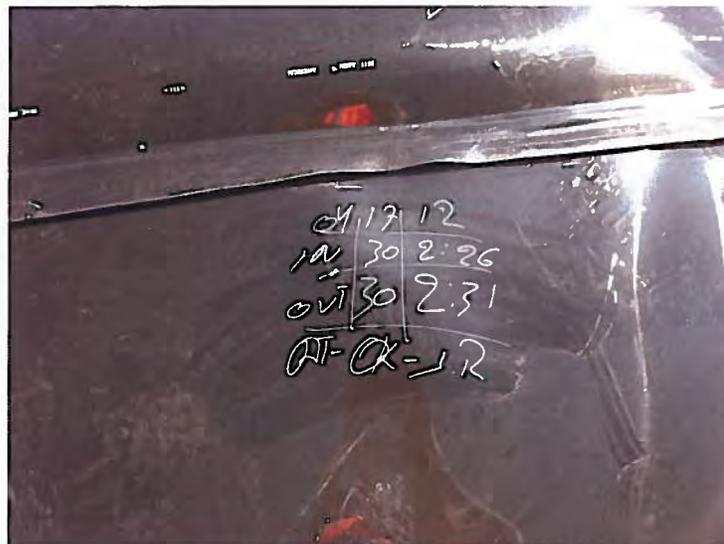
**Pond A Quality Control (QC) test documentation Air-Test**

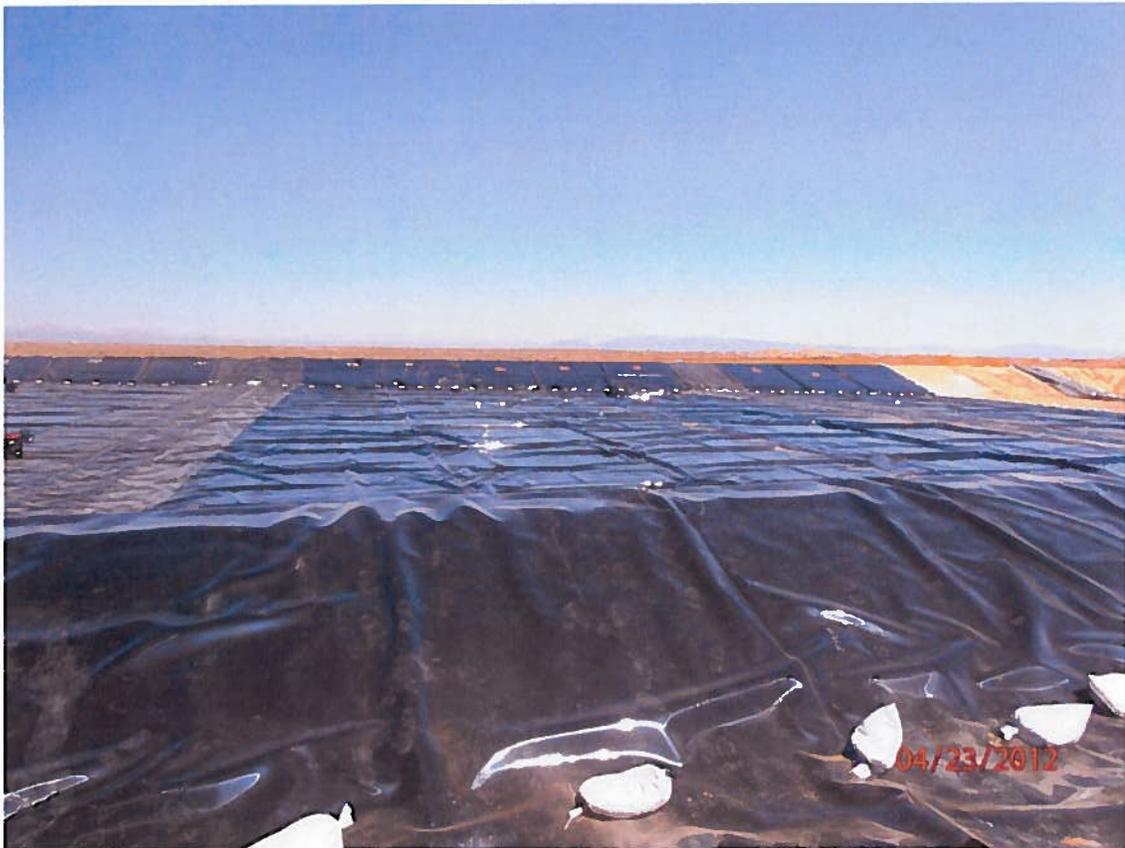
**Pond A 60 Mil HDPE anchor trench (looking North)**

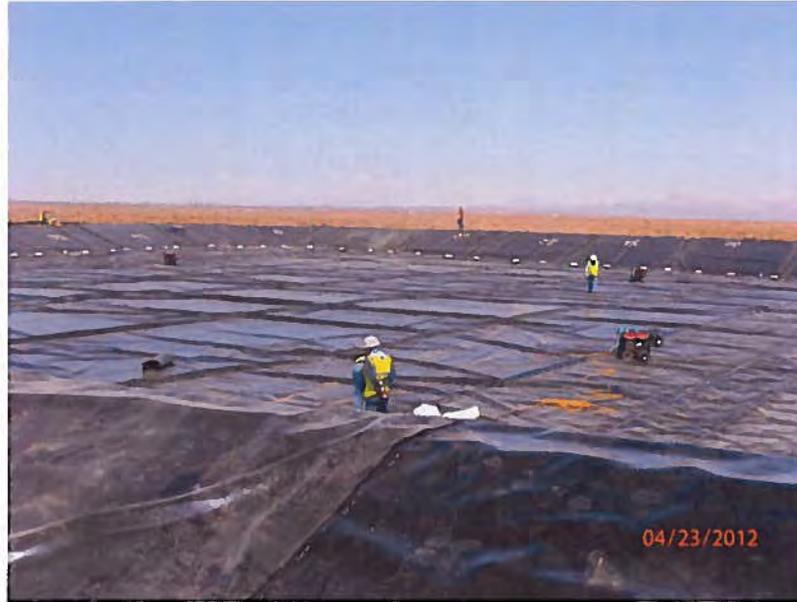
**Pond A Quality Control Destructive Seam Sampling**

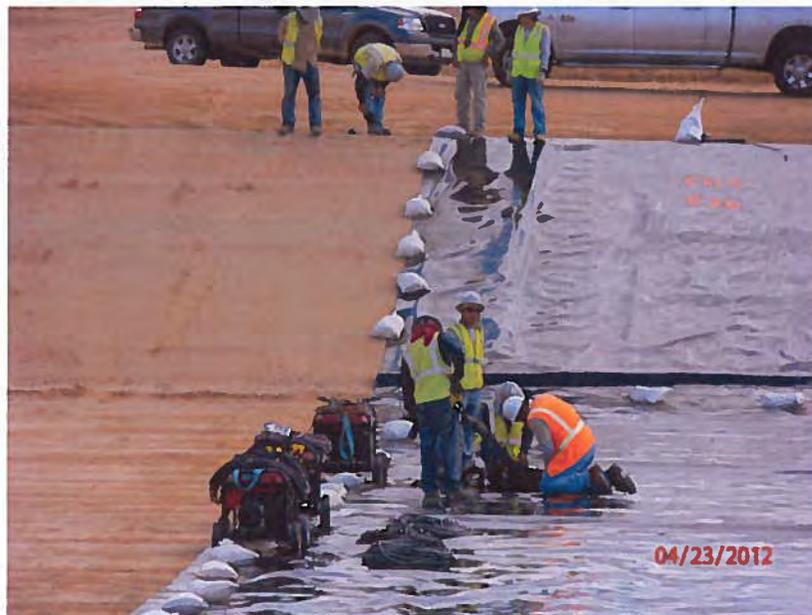
**Pond A HDPE Morning Trail "Pre-Weld" Samples**

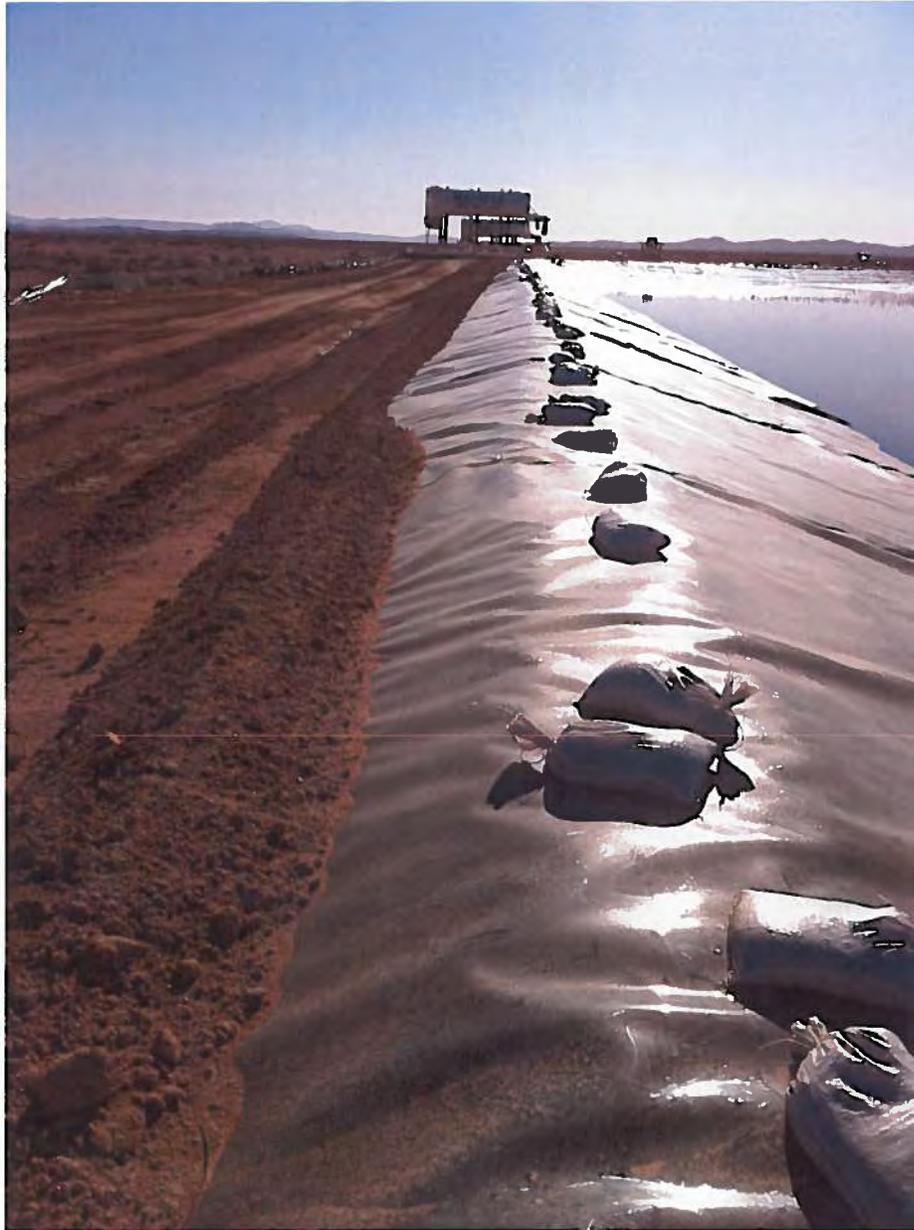
**Pond A HDPE Liner Anchor Trench fill and compaction**

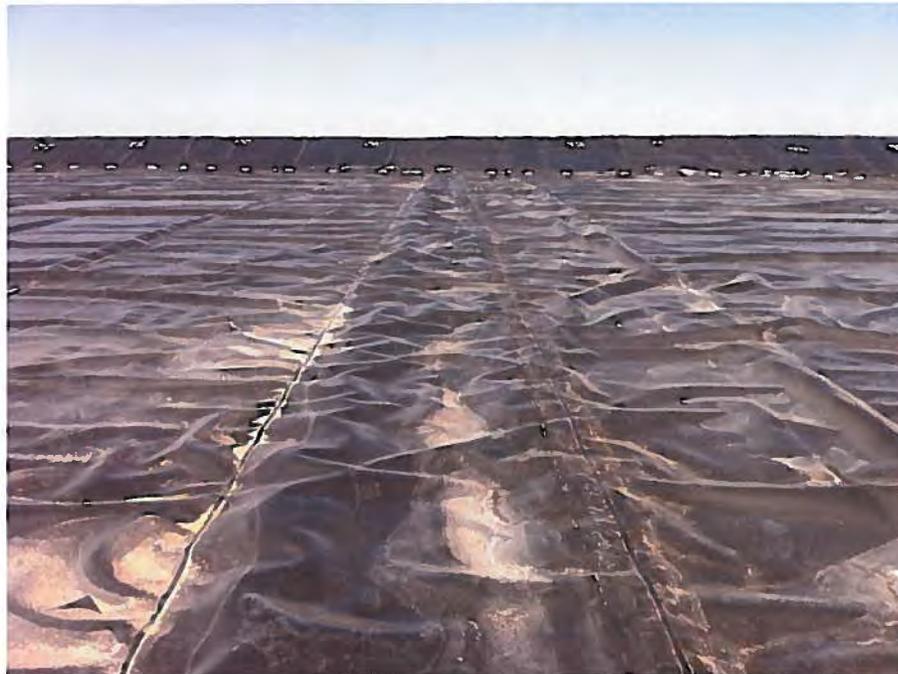
**Pond A HDPE Completed Liner Ballast System**

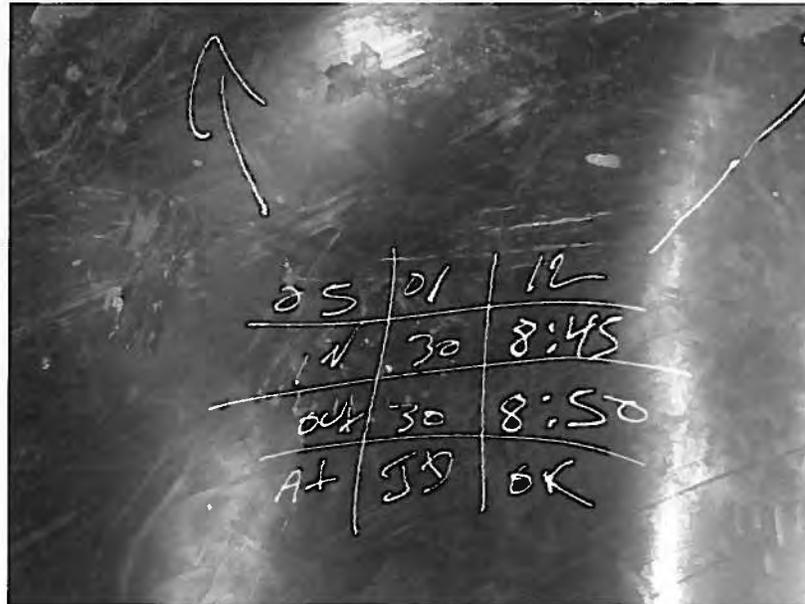
**Pond A Quality Control Air Test Data**

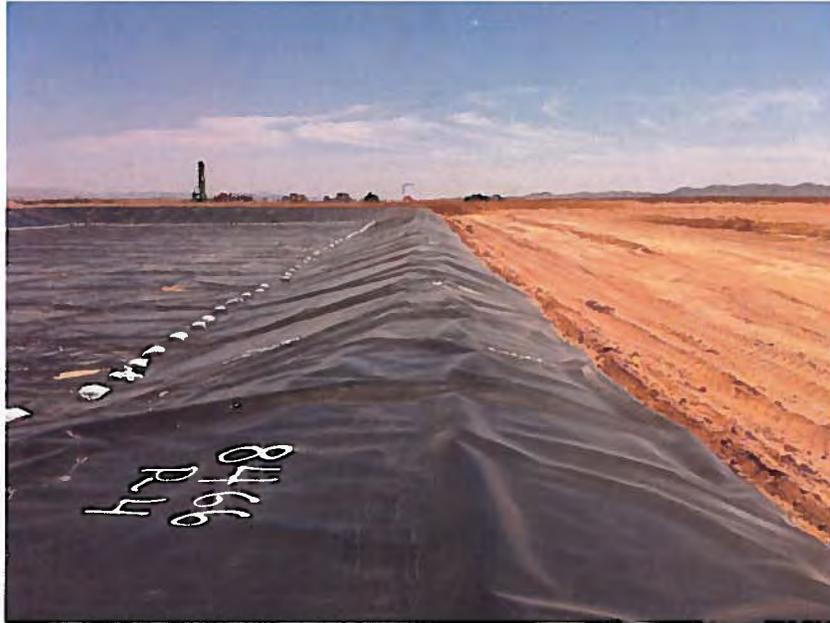
**Pond A Final Anchor Trench Backfill & Compaction**

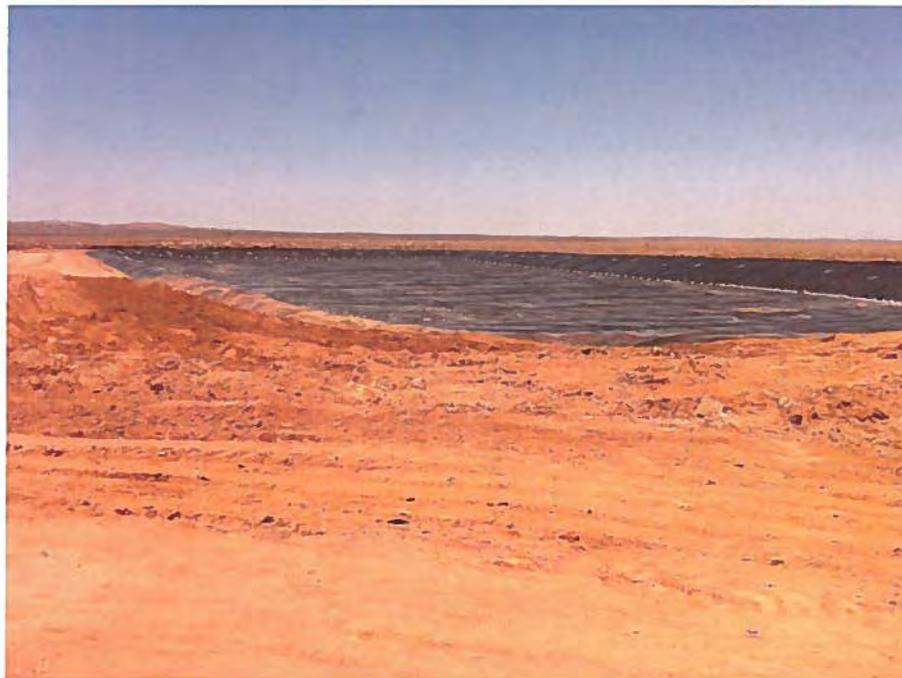
**Pond A Completed (looking west)**
