**CALIFORNIA REGIONAL WATER QUALITY CONTROL BOARD - SAN DIEGO REGION
WATERSHED MANAGEMENT PROGRAM**

FACILITY INSPECTION REPORT

Sprinter Rail Project
FACILITY OR DEVELOPER NAME (if different from owner)

FACILITY: __North County Transit District Sprinter Rail_ (WDID)_9 37C322900__ INSPECTION DATE: _11/30/07__

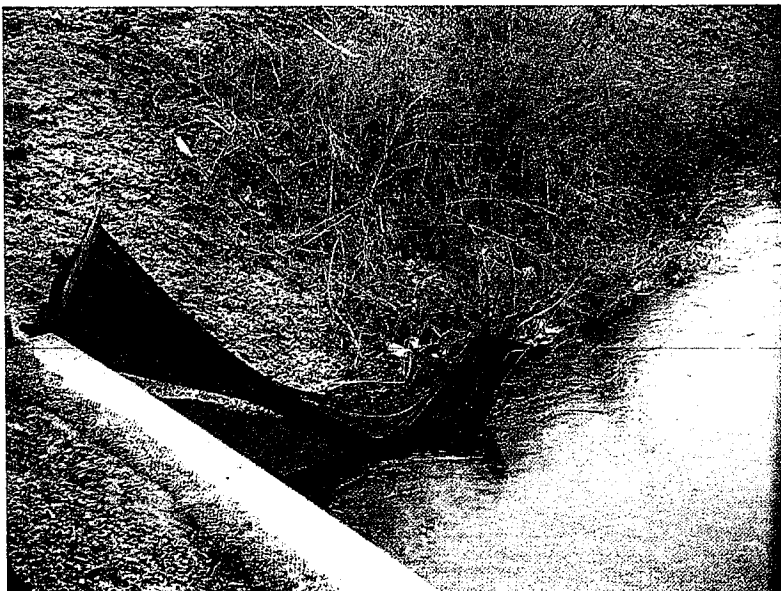
711. Silt fence is in need of maintenance.

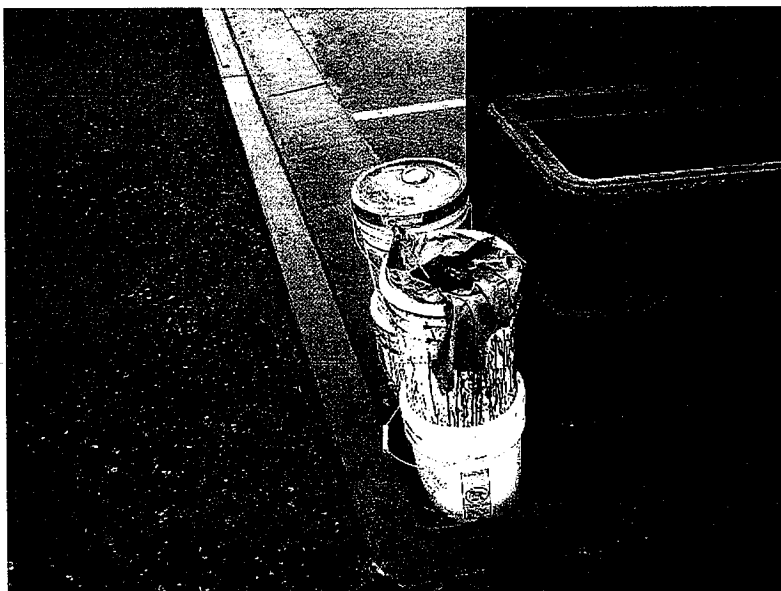
717. Construction material has been left out exposed to storm water.

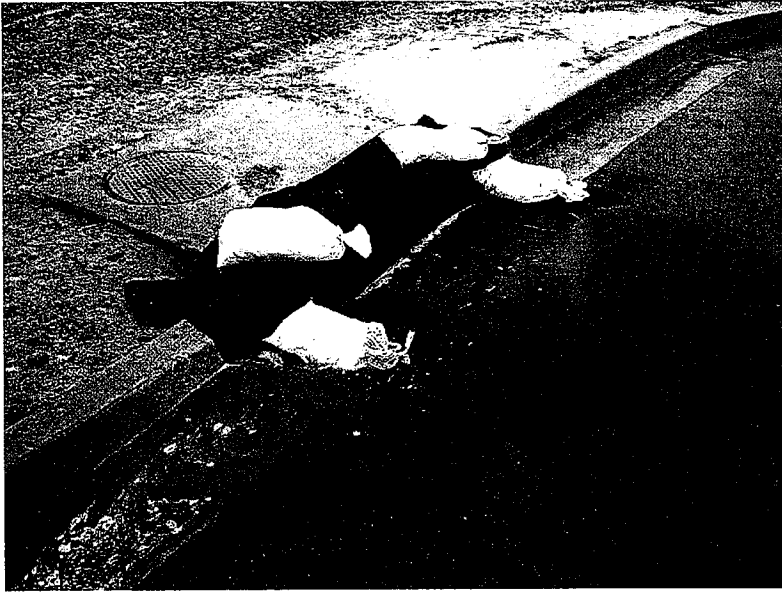
- 7. Melrose Station, Oceanside** – A storm drain inlet had inadequate levels of gravel bag protection (Photo 718). No gravel bag chevrons were present upstream from the flow seen in this photo. The construction exit had been stabilized since the last inspection (Photo 719). The storm water entering the storm drain inlet in photo 718 was sediment-laden (Photo 720). A soil stockpile had been covered since the last inspection (Photo 721). Erosion control was implemented on some of the slopes but the application ended and did not continue on slopes further down the tracks (Photo 722). A storm drain inlet near the station platform noted in a previous inspection was protected with filter fabric (Photo 723). The source of sediment entering the storm water in photos 718 and 720 was found to be from a curb cut out for handicap accessibility (Photo 724). The pavement had not been poured for the handicap ramp. Storm water entered the curb cut out; then the storm water mixed with the dirt pooled and spilled back out into the gutter. A storm drain inlet was without adequate gravel bag protections and needed maintenance (Photo 725). Another storm drain inlet in this station's parking lot did have adequate storm drain protections (Photo 726). The water entering the inlet appeared clear and free of turbidity, suspended solids or sediment. A storm drain inlet surrounded by non-stabilized soils was blocked off with gravel bags (Photo 727). Surprisingly although it had been raining all day, this storm drain did not have a pool of water around it. The erosion control applied in this area appeared to be light (Photo 728).

718. A storm drain inlet's protection needs maintenance.

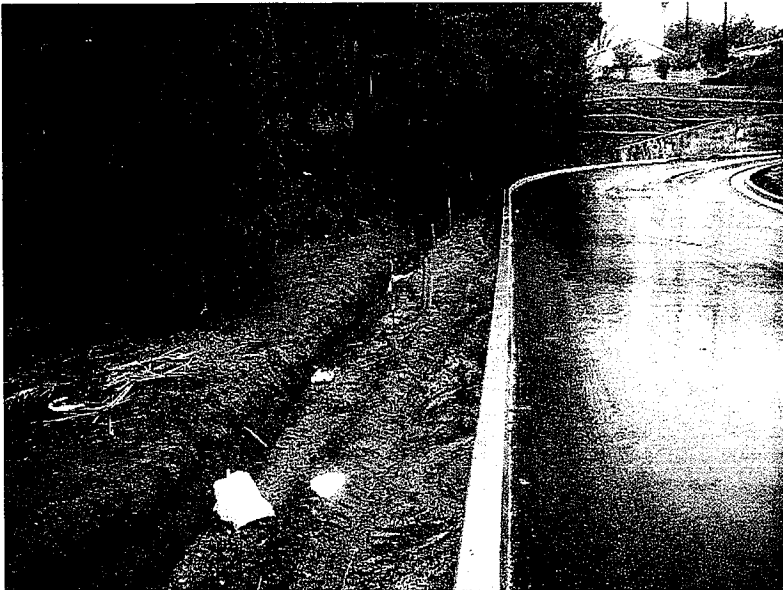
- 9. Escondido Avenue Station, Vista** – Two storm drain inlets were protected with filter fabric but that was inadequate to prevent sediment-laden flows from discharging (Photos 733 and 736). An unlined dirt channel without any sediment or erosion controls channeled storm water straight to one of these inlets (Photo 734). Corrected from a previous inspection, the slopes south of the parking lot had some erosion control applied and fiber rolls implemented (Photo 735).

734. An unlined dirt channel down the hill leads to the storm drain inlet in photo 733.

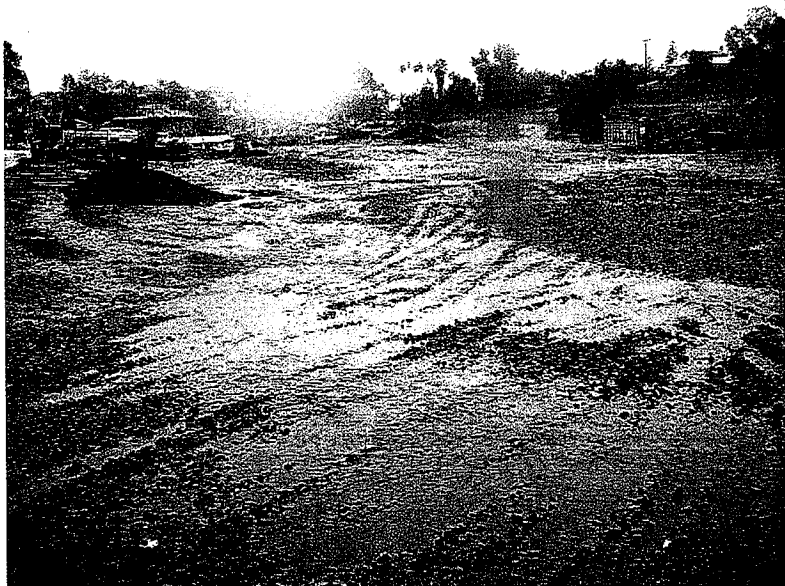
742. Sediment laden water from the construction storage yard flowing towards the storm drain inlet in photo 746.

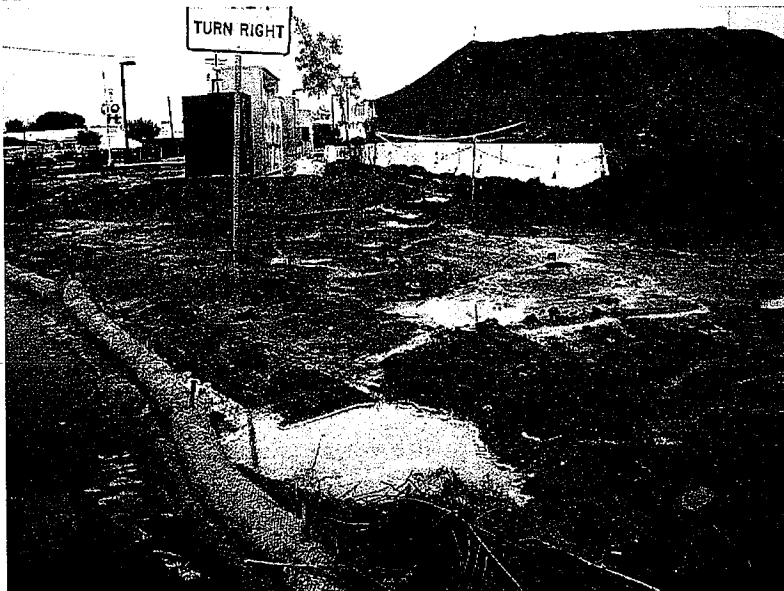
14. Nordahl Road Station, Escondido – Sediment-laden water was discharging off the site into the City's storm drain gutter (Photos 764 and 766). Fiber roll was not trenched in and failed to prevent discharge (Photo 765). Throughout all of the Sprinter Rail construction site, construction equipment did not have drip pans under them when not in use to prevent oil and grease leaks from contacting storm water (Photo 770). A water truck was improperly parked in a low area with ponded water (Photo 772).

765. The source of the sediment laden water discharging in photo 764.
